FINAL REPORT

IRISE-22-P21-02-01 • SEPTEMBER 2022

**Preliminary Evaluation of  
Pavement Surface Distresses  
Related to Pavement Markings**

**PITT | IRISE**

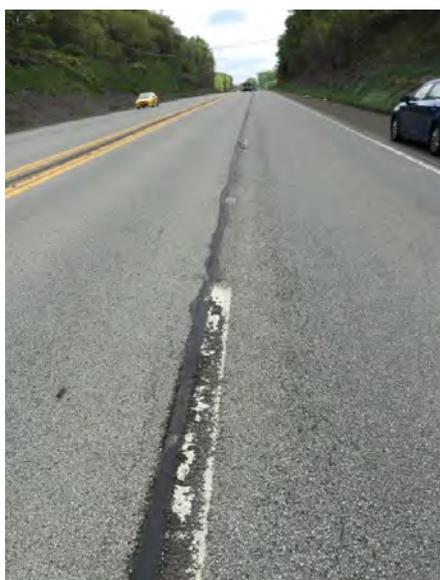
The memorandum hypothesizes on potential causes of the distresses mentioning joint density issues, moisture retained in the asphalt mat under the marking, temperature differences between asphalt surface and marking, and chemical incompatibility between marking material and asphalt.

Figure 10: Surface delamination on US 422 skip line

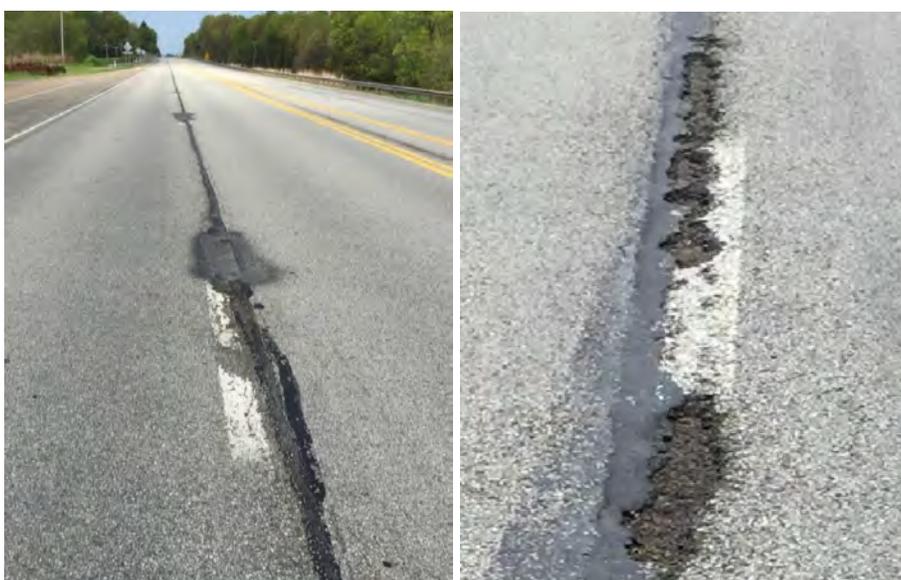
Figure 11: Potholes on US 422 skip line

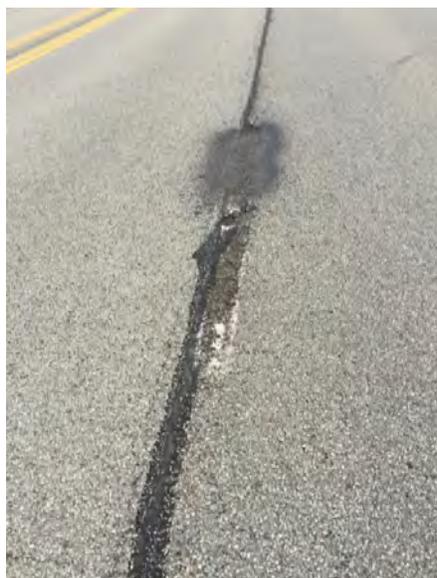
Figure 12: Aggregate pop out and pothole on US 422 skip lines

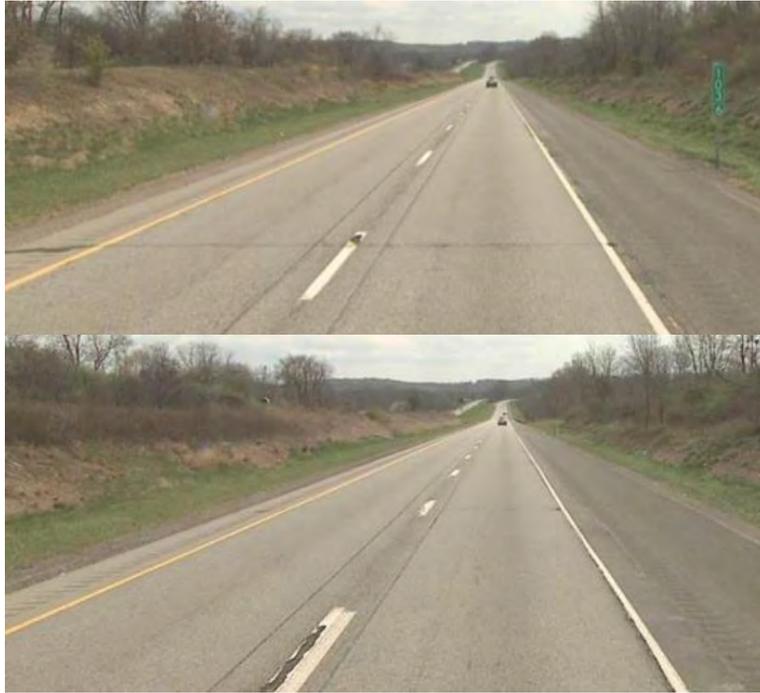
I-79 presented similar distresses as the ones observed in US 422 as previously described. Figure 13 shows initial stages of potholes in the white skip line makings in two locations.

Figure 13: Pothole forming on I-79 skip lines

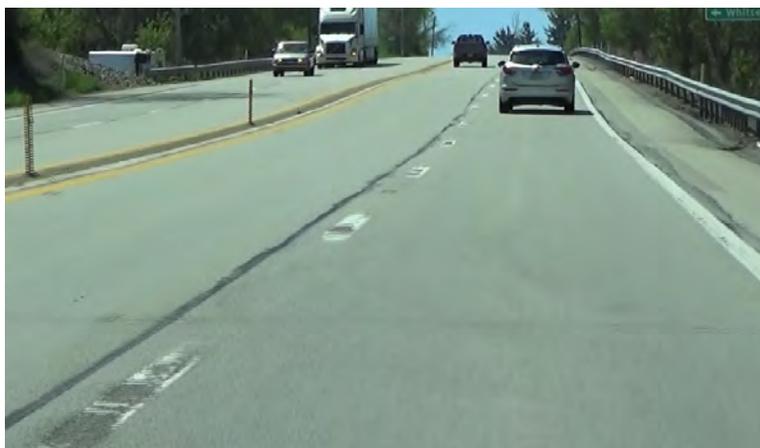
District 12 provided a video survey of PA-51 in between Westmoreland and Fayette Counties. The video (Figure 14) shows evidence of what appears to be asphalt raveling located at the skip marking lines. Evidence of longitudinal joint issues are also present.

Figure 14: Asphalt raveling on PA-51 skip lines

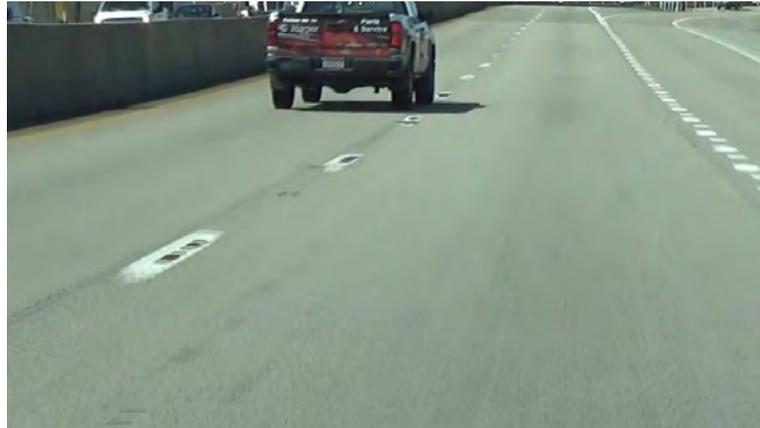
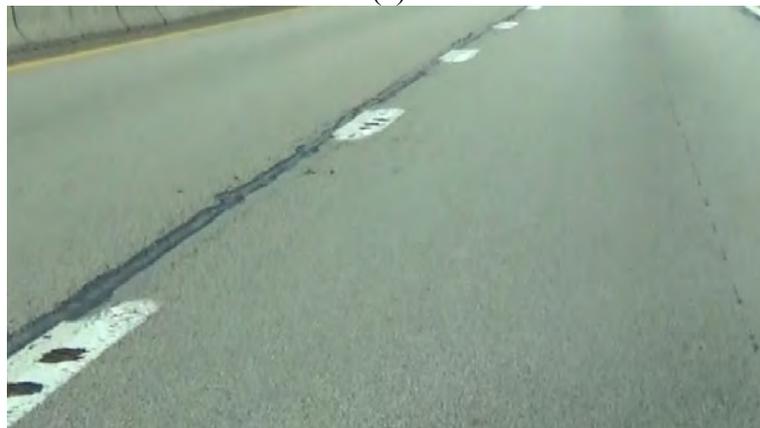
District 12 provided a video survey of I-70 in Westmoreland County. Throughout video survey it is possible to observe asphalt distresses and potential pothole formation in I-70 skip lines in both west and eastbound lanes (Figure 15).

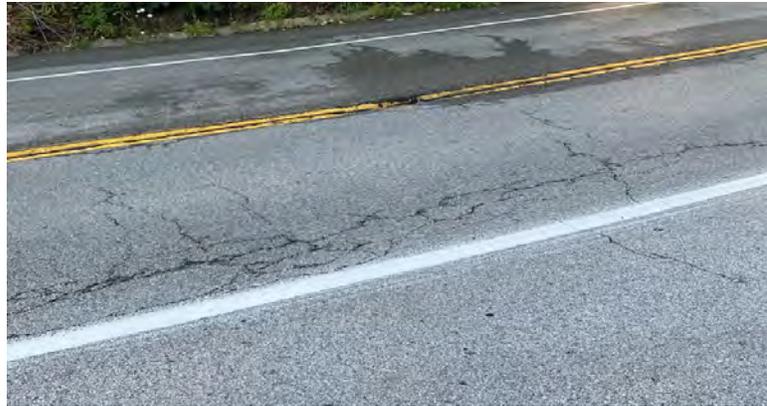
The pavement in this section presents several cracking distresses that connect to the cracking at the longitudinal joint – centerline marking (Figure 16). There is no indication that the markings are the cause of such distresses. Interestingly, the double continuous line in the lane center contains a longitudinal crack in only the line closest to the longitudinal joint. The other line is intact as seen in Figure 17.

Figure 16: Cracking in pavement lane connecting to cracking in longitudinal joint

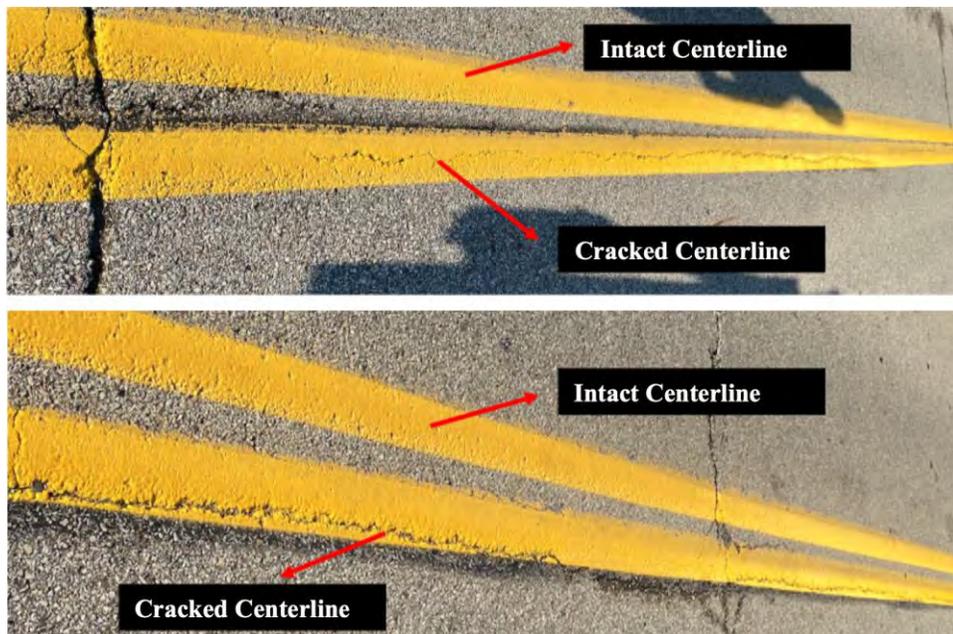
Figure 17: Examples of longitudinal crack in only one of the centerlines

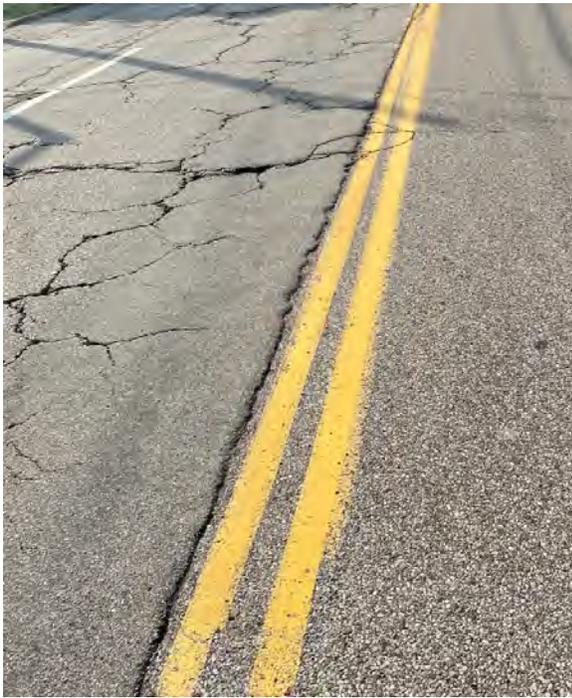
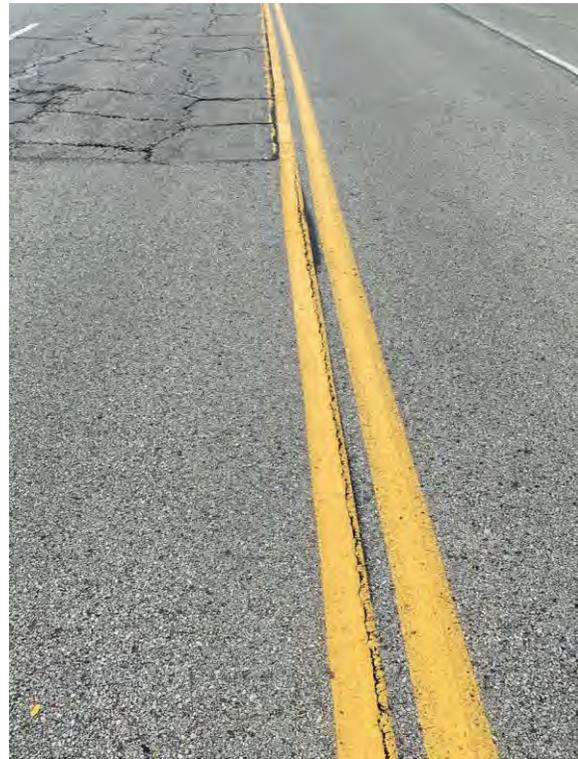
The pavement in this section presents severe cracking in several segments (Figure 18a). Some segments were rehabilitated due to the severity of distress. Again, there is no indication that the markings are the cause of such distresses. As with the previous section, several segments present a longitudinal crack on only one of the centerline markings (Figure 18b).

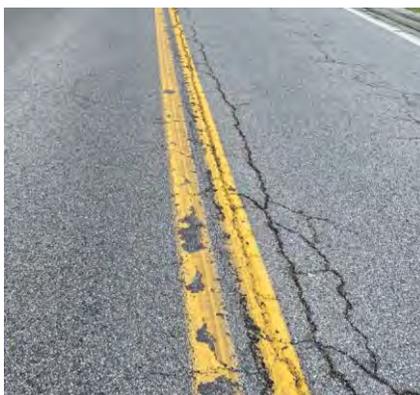
The pavement in this section presents several cracked segments with wide-open longitudinal cracks (Figure 19). Several cracks are also present in the centerline marking with some loss in material.

Figure 19: Centerline presenting cracking and losing marking material

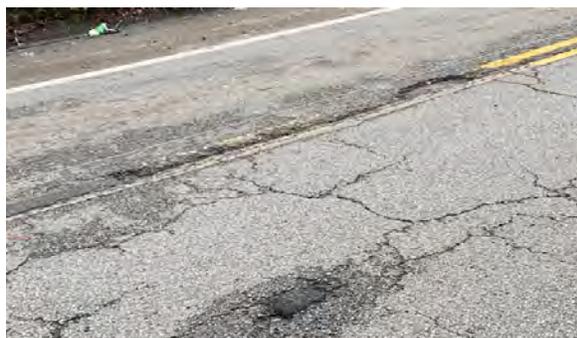
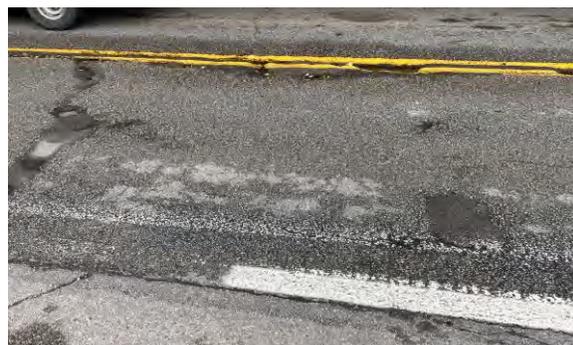
This section is located at the intersection with Banksville Road. The pavement presents severe cracking with fully formed potholes on both sides of the intersection (Figure 20). The distresses extend to the centerline and edge markings. Several cracks are also present in the centerline marking with some loss of material.

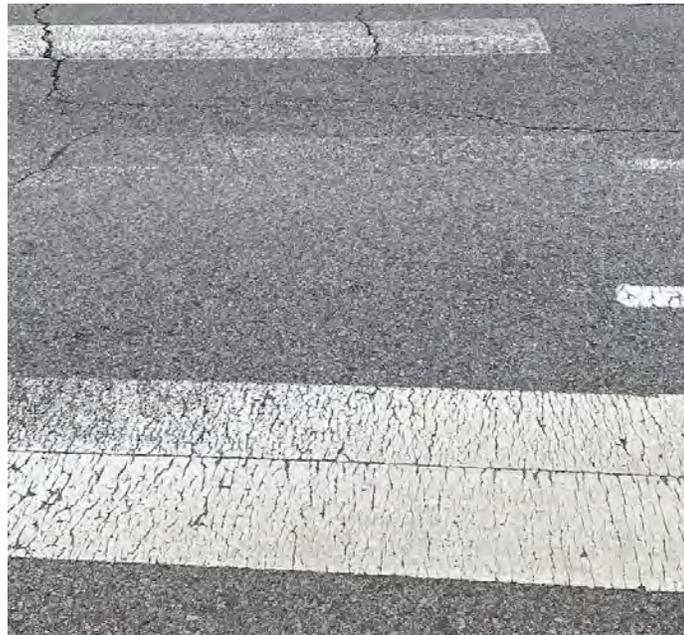
The pedestrian crossing markings present several hairline cracks and loss of marking material (Figure 21) due to the marking material deterioration from heavy exposure to traffic. In Figure 21, the marking in the wheel path has been completely removed by traffic. These cracks are limited to the markings and do not seem to affect the pavement surface. The pavement presents larger transverse and longitudinal fatigue cracking that is unrelated to the markings.

Figure 21: Pedestrian crossing markings with different levels of deterioration.

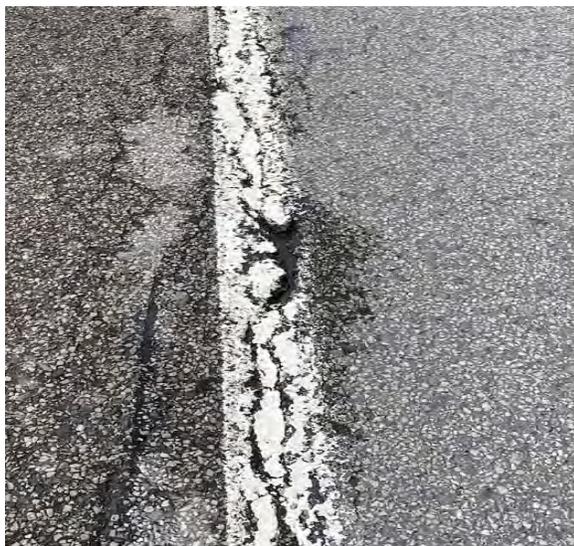
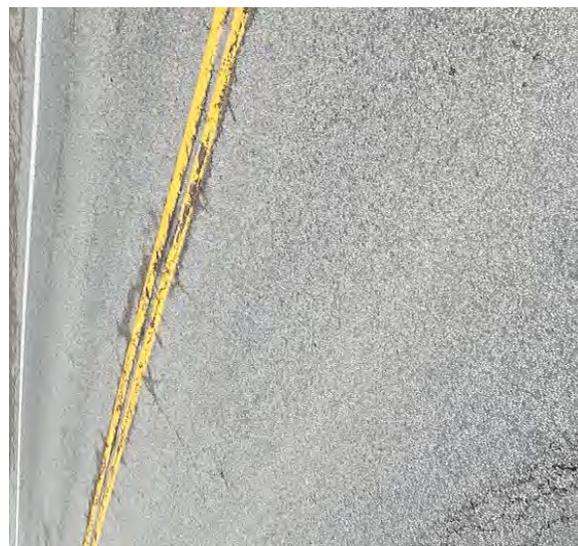
The pavement presents severe distresses at the pavement – shoulder joint and therefore distresses are located at the edge marking (Figure 22a). Distresses are also present at the centerline marking (Figure 22b).

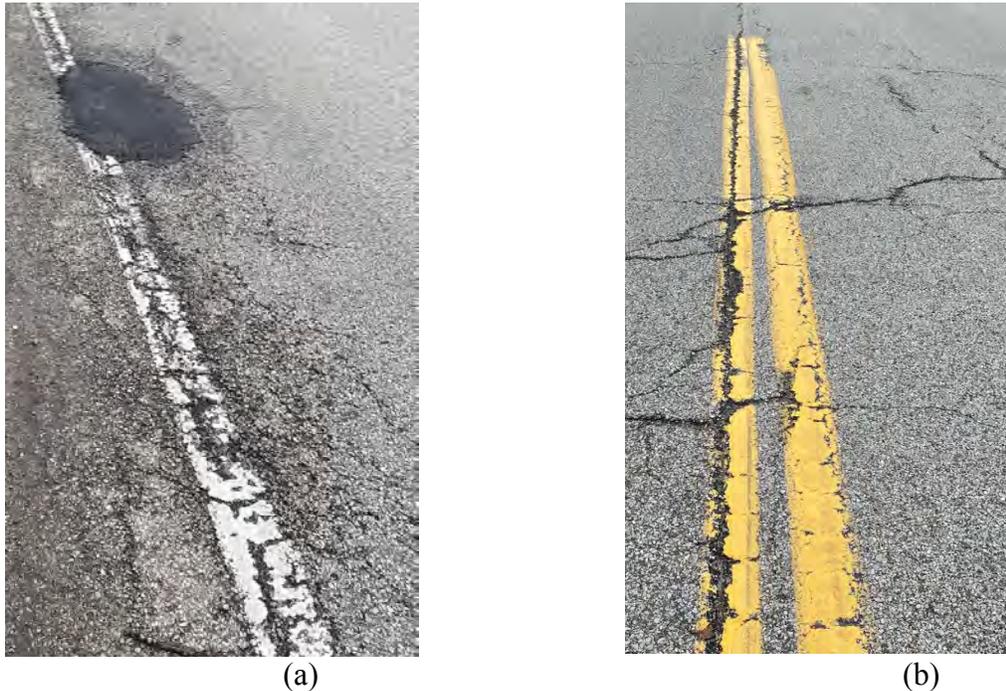
Similar to the previous section, this pavement presents severe cracking at the edge and centerline (Figure 23).

Figure 23: (a) cracking and potholes in the pavement shoulder joint and (b) cracking at the longitudinal joint

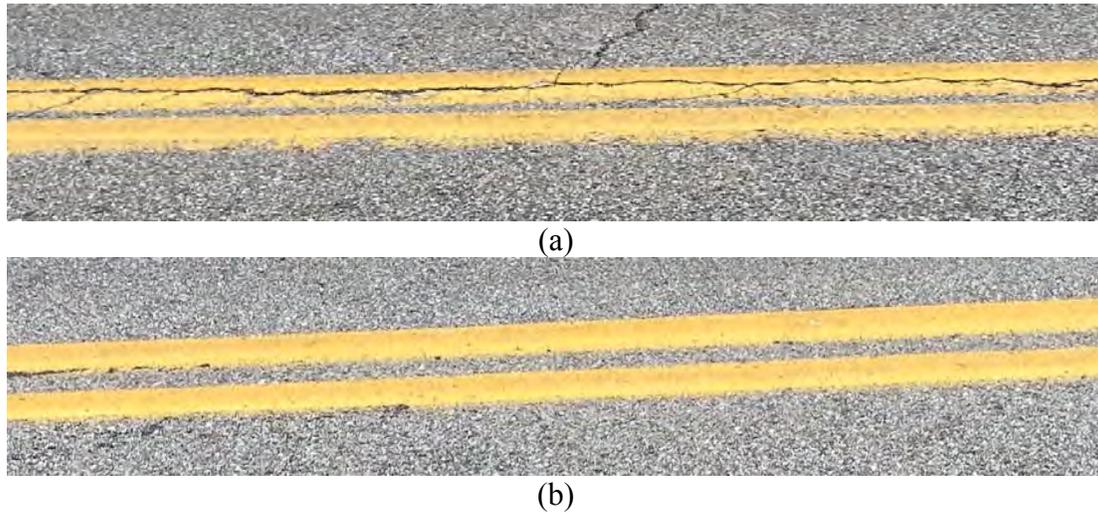
Several segments of each section were tested. The segments were selected based on the level of visible deterioration of the longitudinal joint. Segments presenting surface cracks at the longitudinal joint were classified as “deteriorated” whereas segments without surface distress were classified as “intact”. Figure 26 shows this classification in two segments from Section 1. It should be noted that even if there are no clear distresses on the pavement surface, the pavement structural integrity may still be affected by potential underlying distresses (for example bottom-up cracking).

Figure 26: Segments presenting (a) deteriorated and (b) intact longitudinal joint area in Section 1

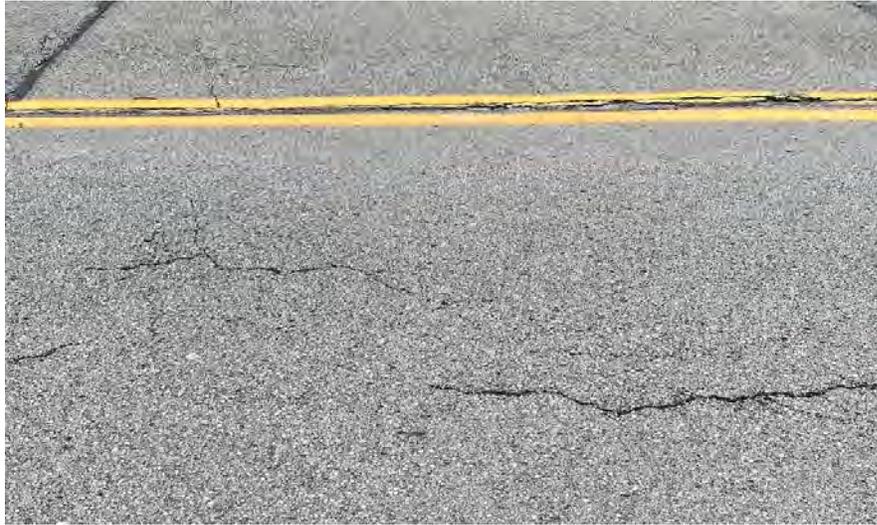
Section 3 differed from the previous sections by showing similar pulse velocity between the wheel path and the longitudinal joint with averages of 3479 and 3498 m/s, respectively. This can indicate that the construction of the longitudinal joint for this section was more successful in achieving similar density levels when compared to the center of the lane. However, from all the tested sections, Section 3 segments present significantly more deterioration at the wheel path (Figure 30) even when the longitudinal joint area seemed intact. The presence of distress in the wheel path, as seen in Figure 31 can also help explain the lower pulse velocity in comparison with the other Sections although comparison between sections can be misleading.

Figure 31: Pavement deterioration at the wheel path in Section 3
