Corrosion Repair Strategies for Steel Girder Ends Using High Performance and Traditional Materials

FINAL REPORT

By Kent A. Harries, PhD, PEng
University of Pittsburgh

CONTRACT # 4400018535 / 511801
WORK ORDER # PIT 002

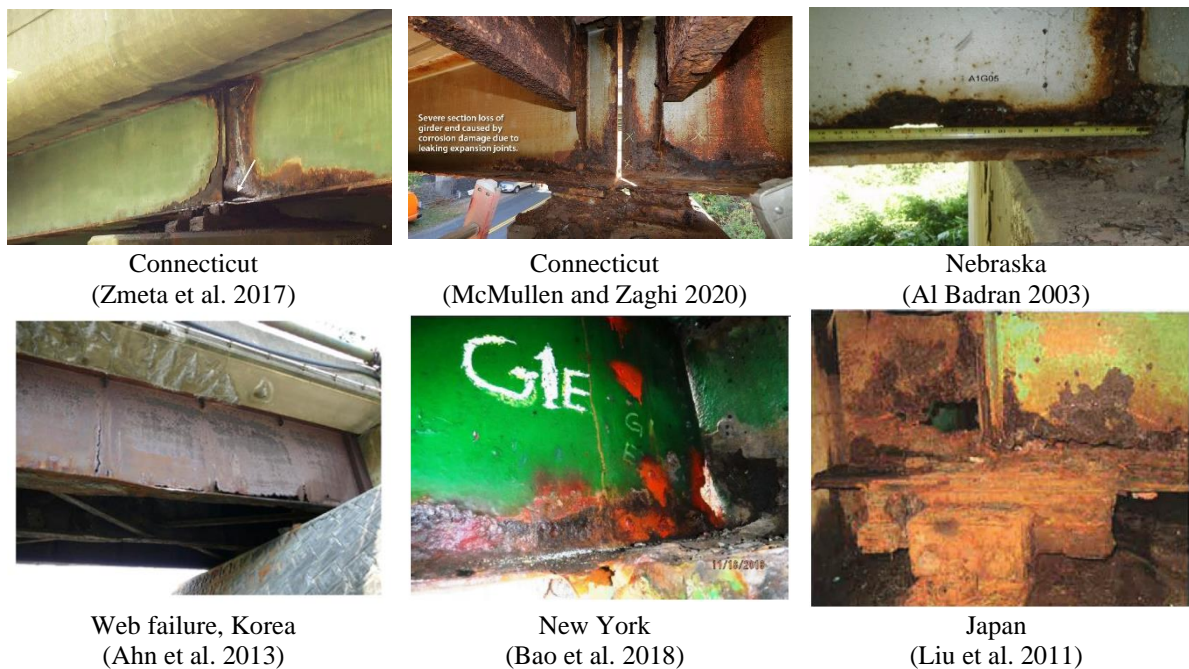
Figure 2 Examples of beam end corrosion.

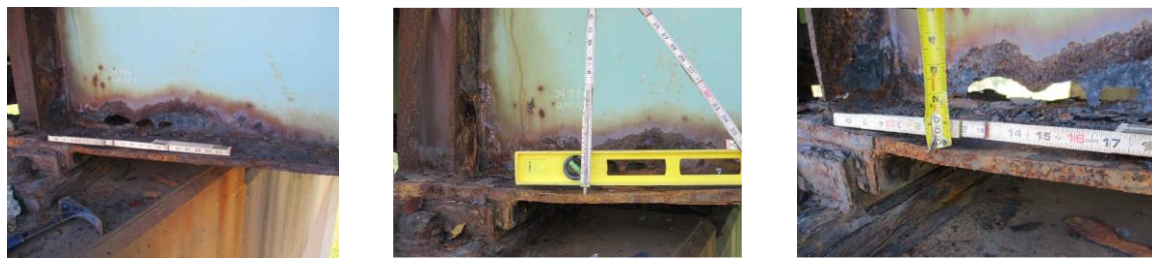
The loss of web support at the bearing – particularly associated with Pattern M1 damage – leads to the lower flange being placed in flexure about its own weak axis as long as some bearing resistance remains. Bridge J, shown in Figure 6, has bearing stiffeners. In this case, the loss of web section has resulted in an unsupported flange as shown by the obvious flexural distortion seen in Figure 6.

a) Pattern M1 damage
(b = 10 in.; a = 2 in.)

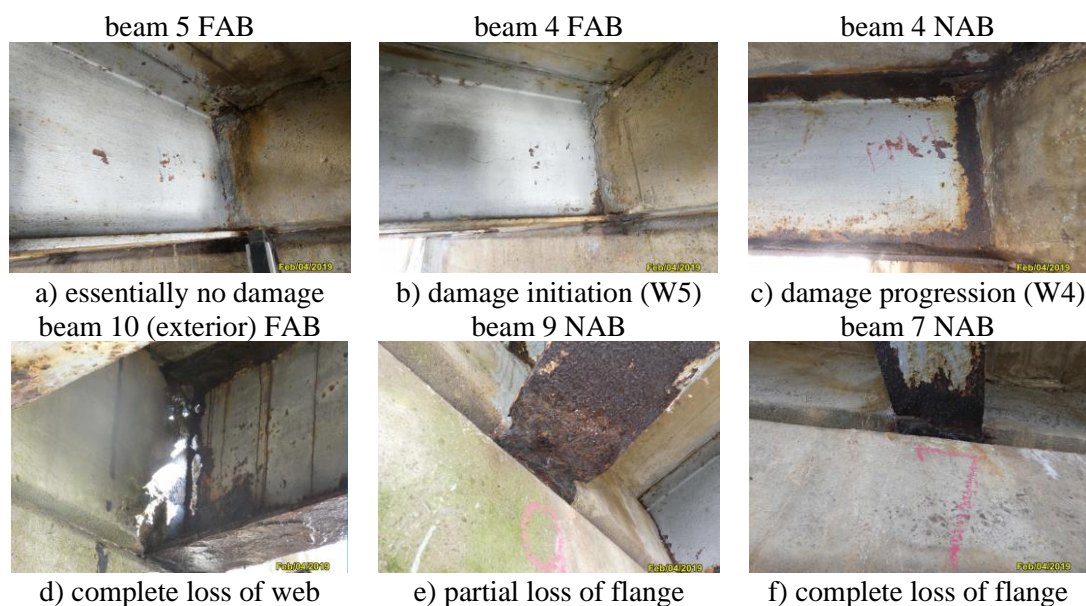
Each of the bridges having embedded bearings exhibited significant damage at the face of the embedment, up to and including complete loss of the web section. Figure 7 shows the spectra of such damage observed in single structure (Bridge O).

Figure 7 Spectra of damage at embedded beam ends of single bridge (Bridge O)

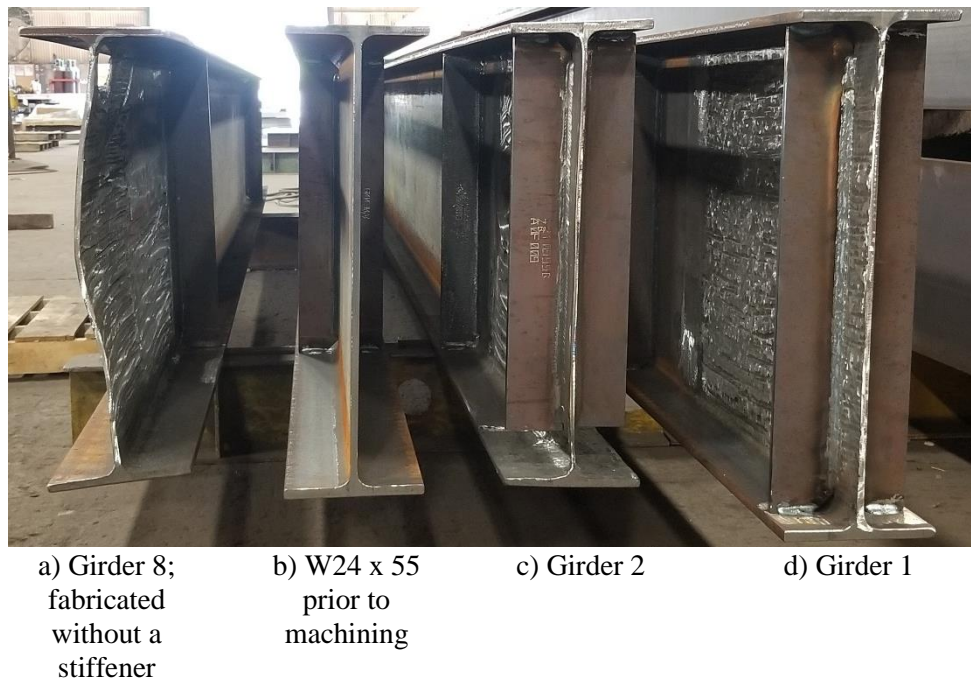
Figure 40 Section distortion of girder specimens.
(photo: High Steel Structures)

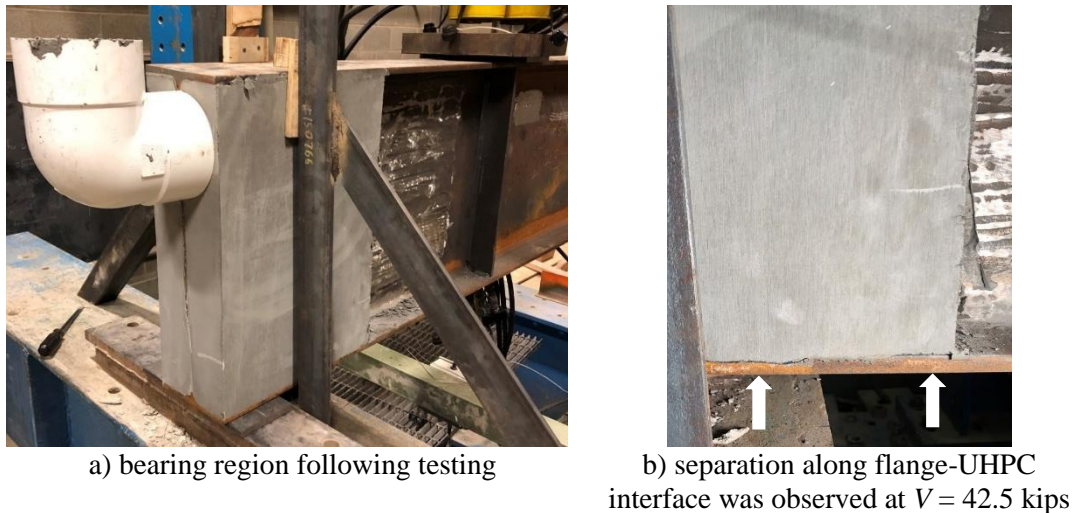
Figure 52 Girder 4A following testing.

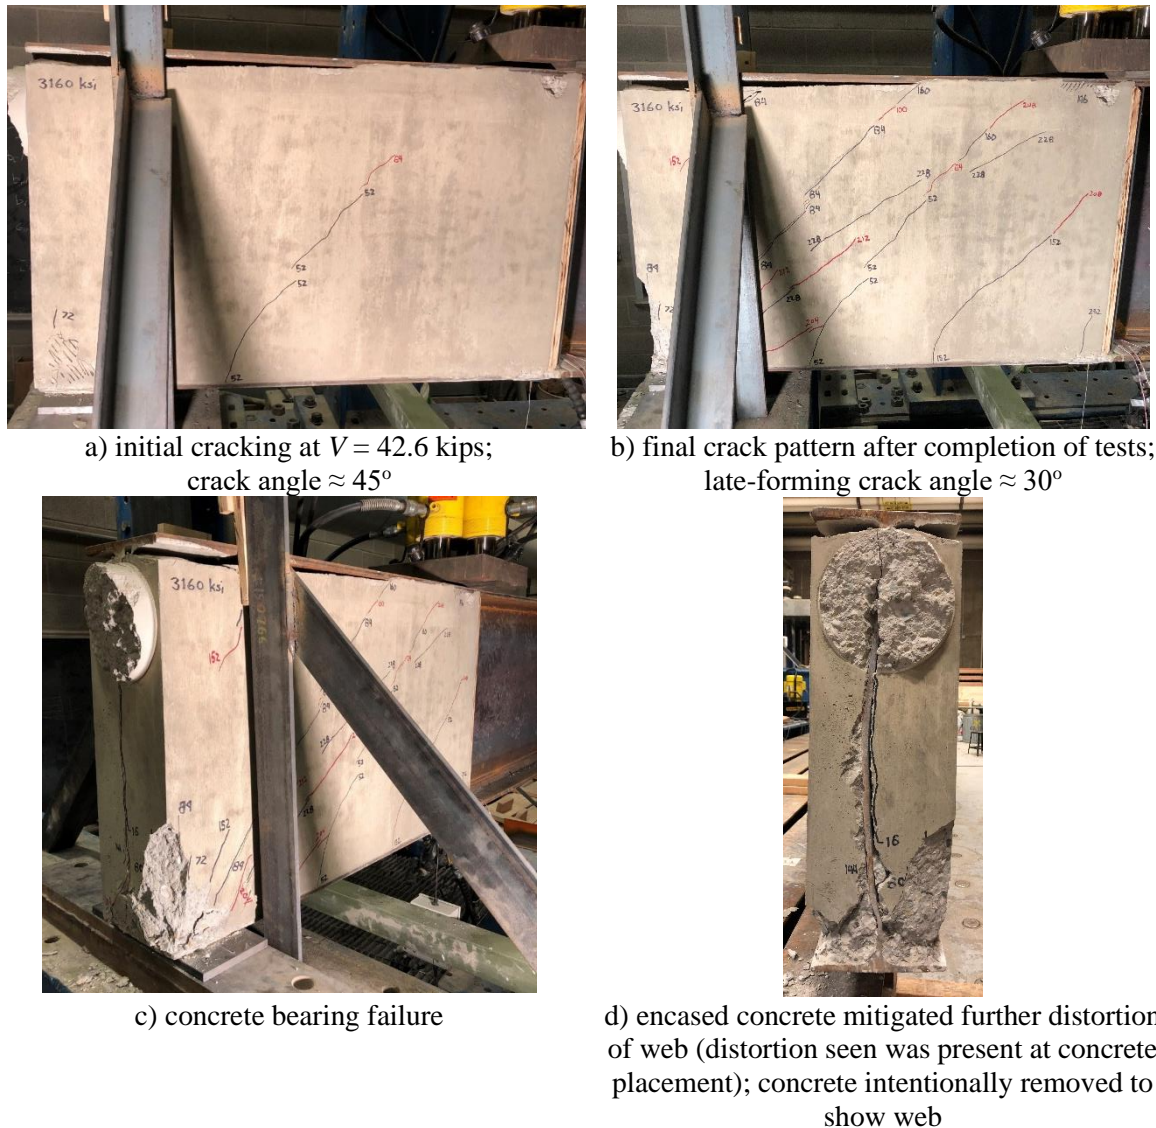
Figure 53 Girder 5A during and following testing.

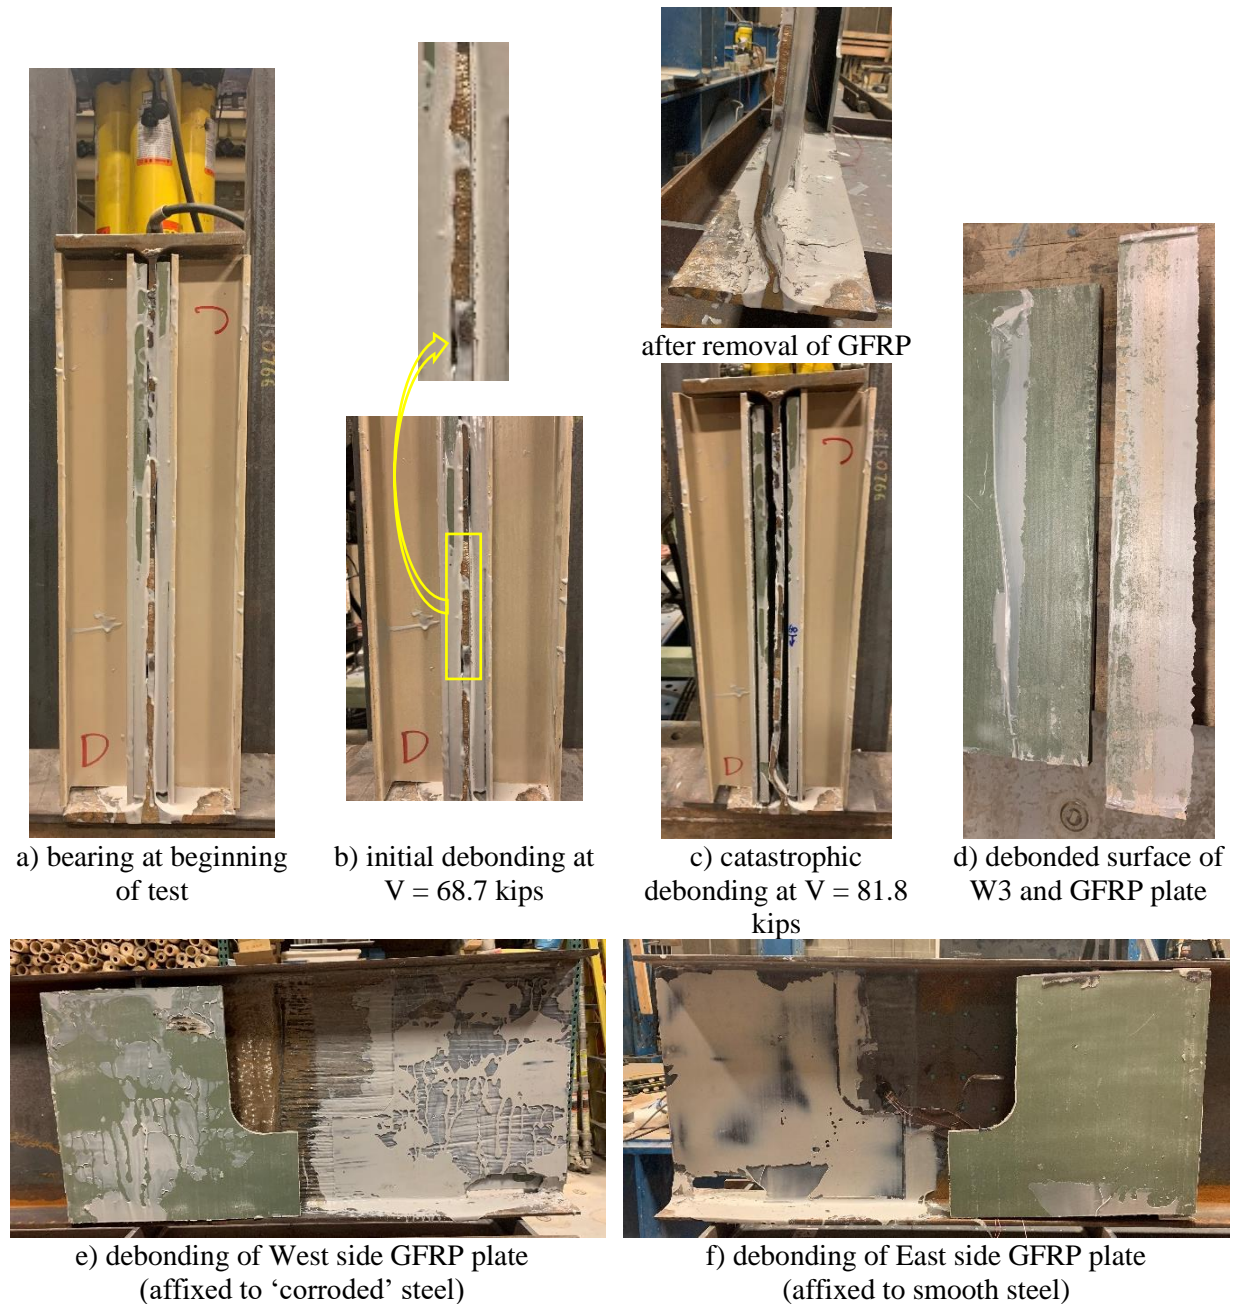
Figure 54 Girder 6A following testing.

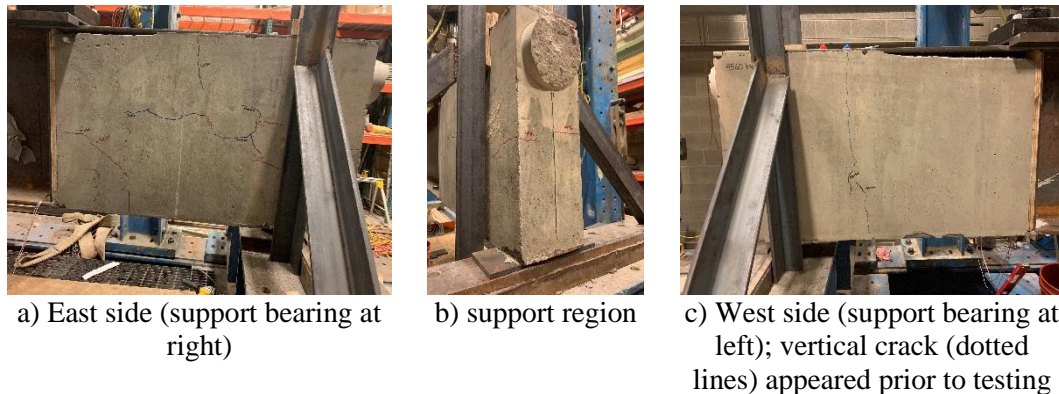
Figure 56 Cracking observed during fatigue conditioning of Girder 5B.

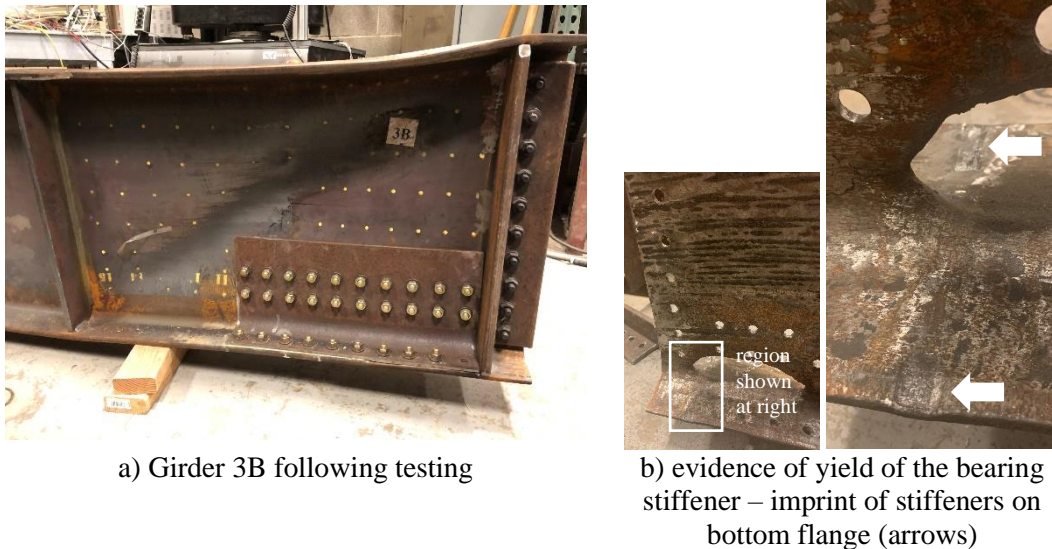
Figure 59 Girder 3B following testing.

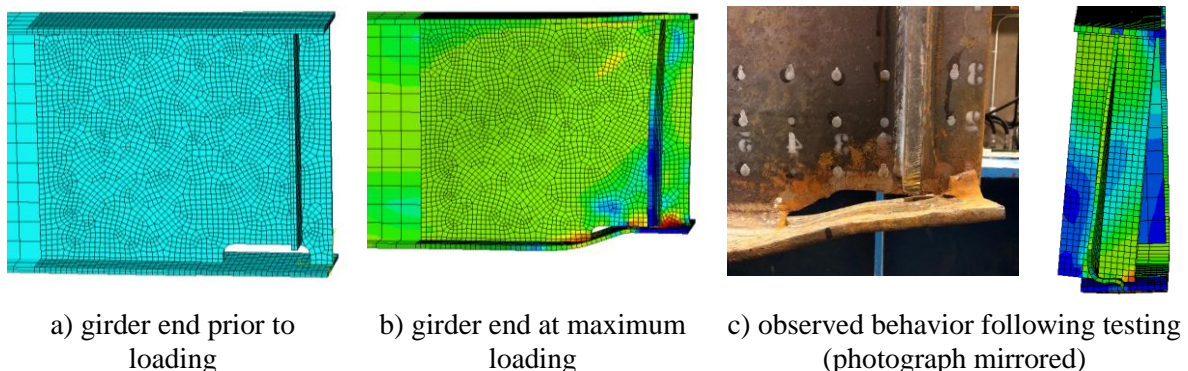
Figure 70 Bearing region failure of Girder 2A.

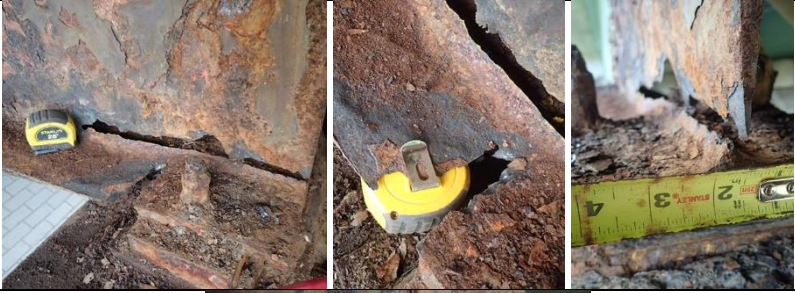
Pier 3 Span 4 Beam 2	M1: $b = 4$; $a = 0.5$; inboard of bearing CL M1: $b = 3$; $a = 3$; end of beam

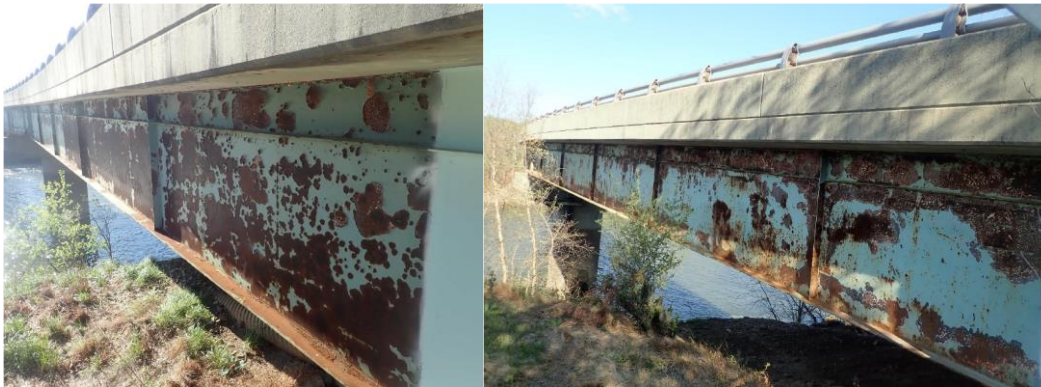
Near Abutment	Beam	Far Abutment
M1: b = 7; a = 3.5 M1: b = 5; a = 4 no other details provided	1	beam end corrosion noted, no other details provided
beam end corrosion and section loss noted, no other details provided	2	M1: b = 9; a = 3 M1: b = 9; a = 4 no other details provided
M1: b = 5; a = 1.5 M1: b = 3.5; a = 1.5 M1: b = 9; a = 4 $t_{w \min} = 0.113''$ (15%) $t_{bf \min} = 0.528''$ (70%) no other details provided	3	M1: b = 10.5; a = 2 M1: b = 9; a = 7 no other details provided
$t_{w \min} = 0.299''$ (40%) $t_{bf \min} = 0.528''$ (70%) no other details provided	4	M1: b = 7; a = 2 no other details provided
beam end corrosion and section loss noted, no other details provided	5	beam end corrosion noted, no other details provided
