Interim Risk Reduction Measures for Seepage Mitigation and Stability Improvement at Laurel Mountain State Park Water Supply Impoundment

For: PITT IRISE

By: Fatma Ciloglu, Ph.D., P.E.
Geotechnical Department Manager

November 2020

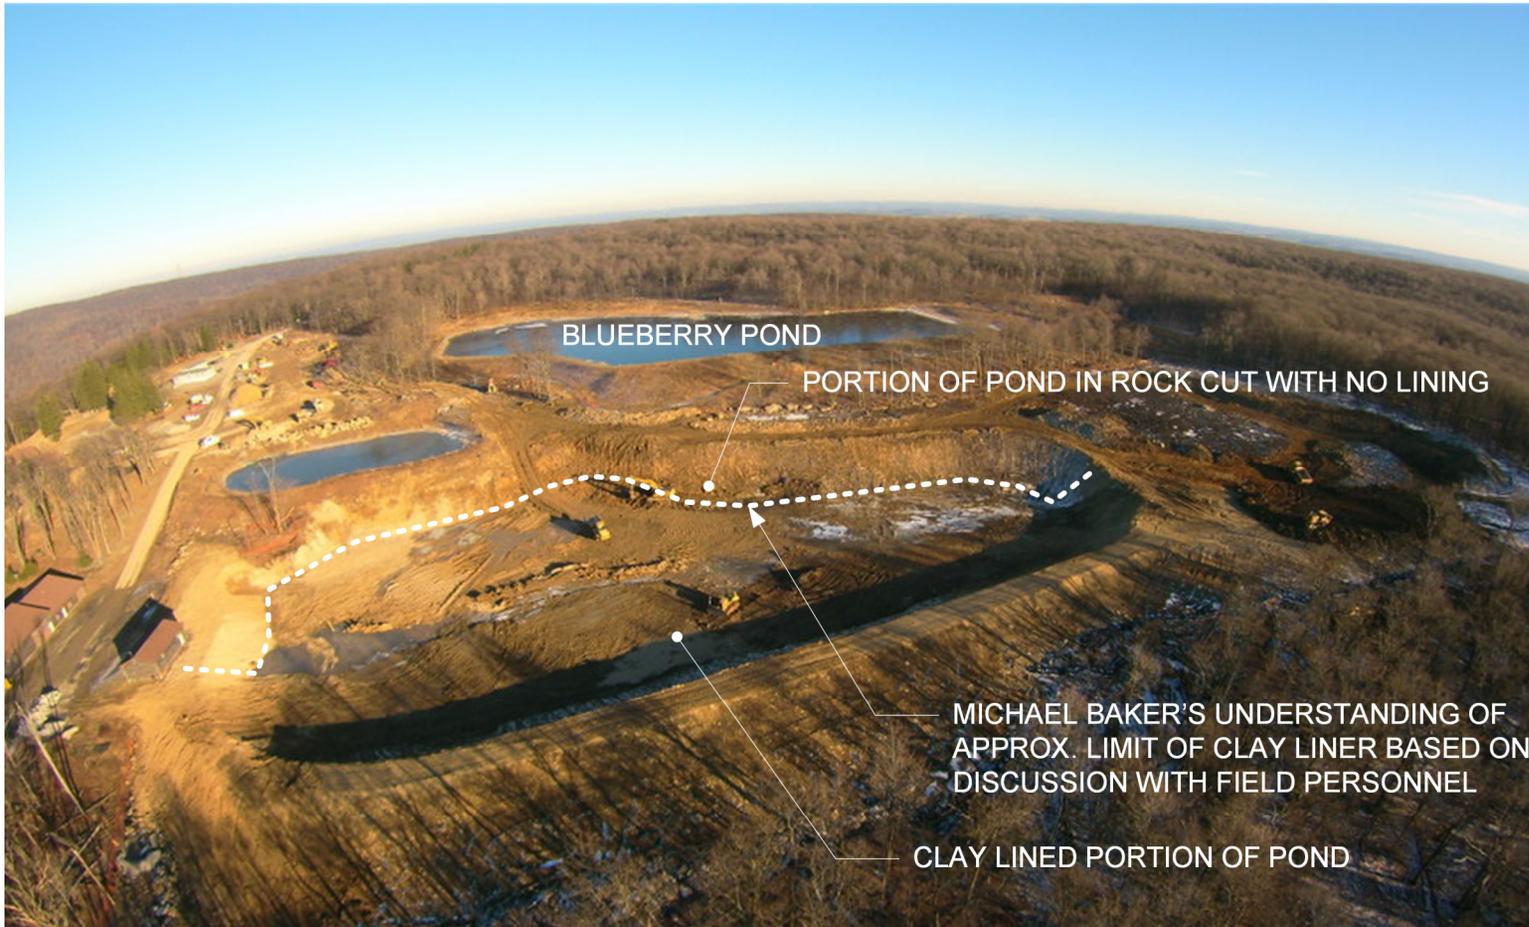
Review of Project Records

Sandstone was excavated and fractured sandstone may be exposed below the water surface near the easterly edge of the enlarged pond

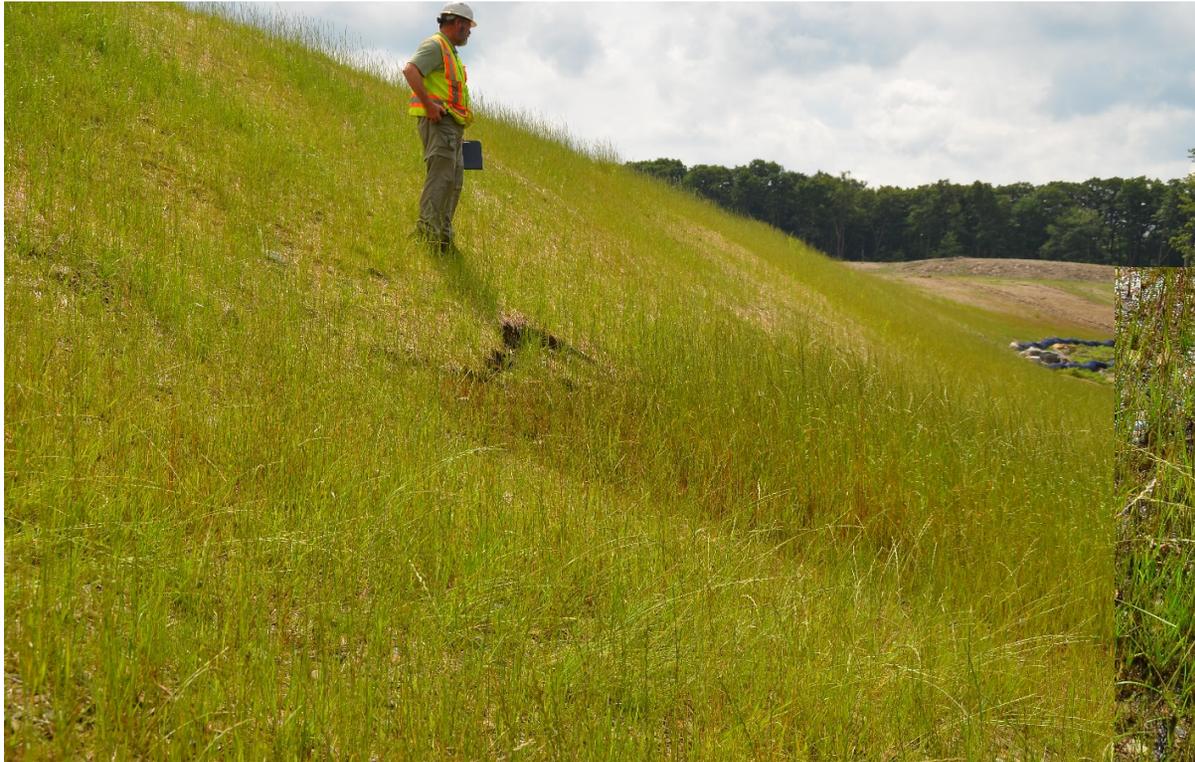
Seepage Flow:
Downstream Face of
Embankment

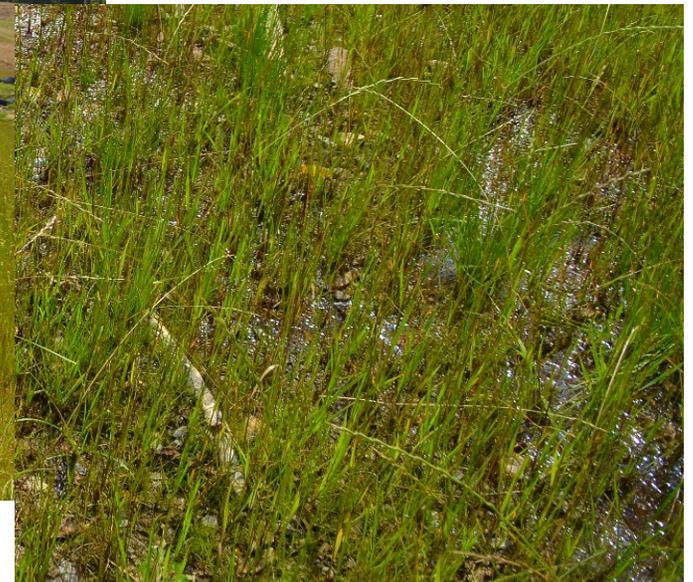
Slumps: Observed during Site Reconnaissance

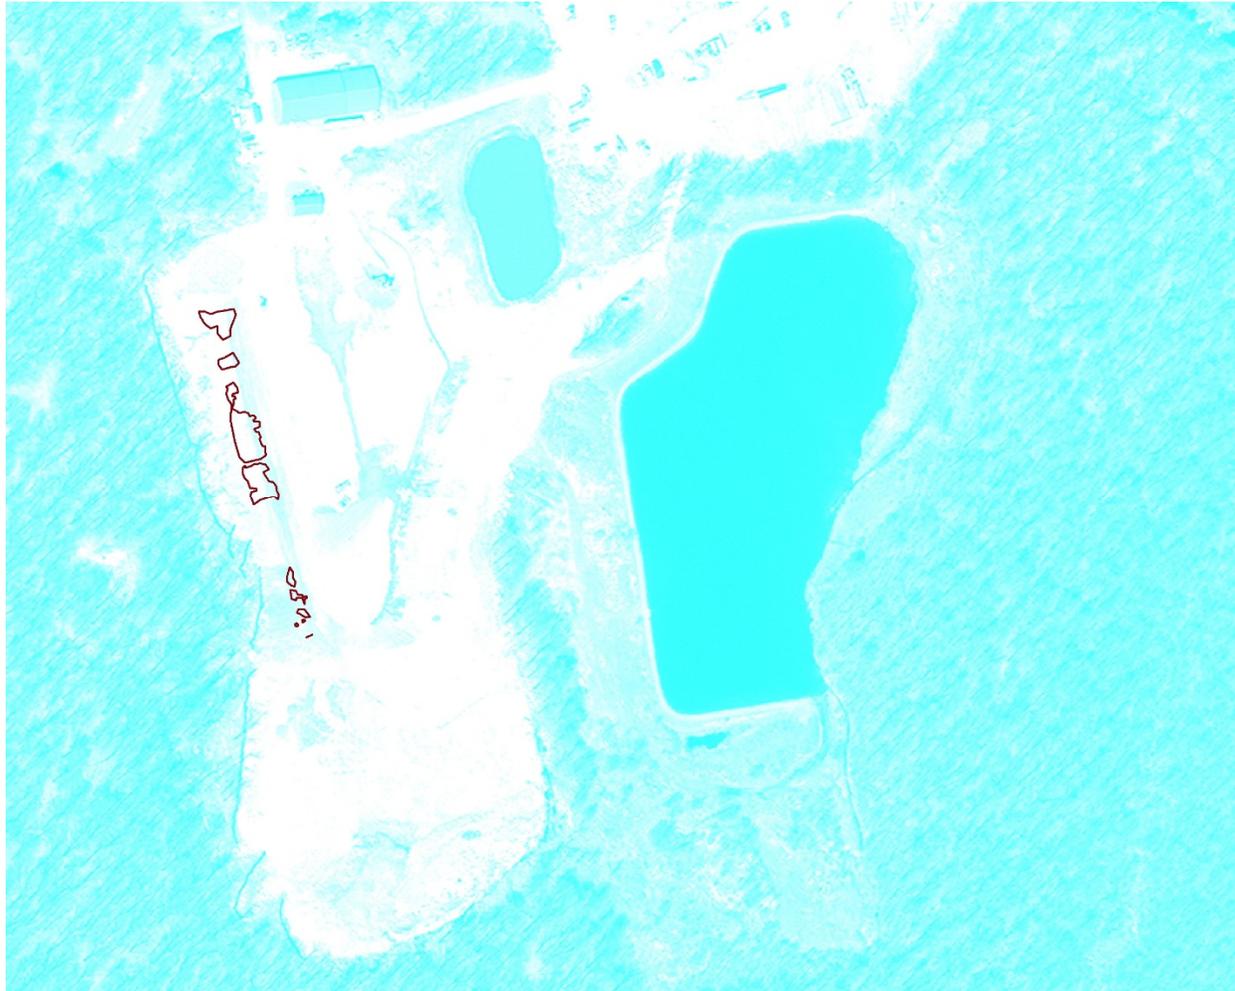
NDVI (Normalized Difference Vegetation Index), NWDI (Normalized Water Difference Index) and Density Slices

seepage was not apparent prior to pond filling

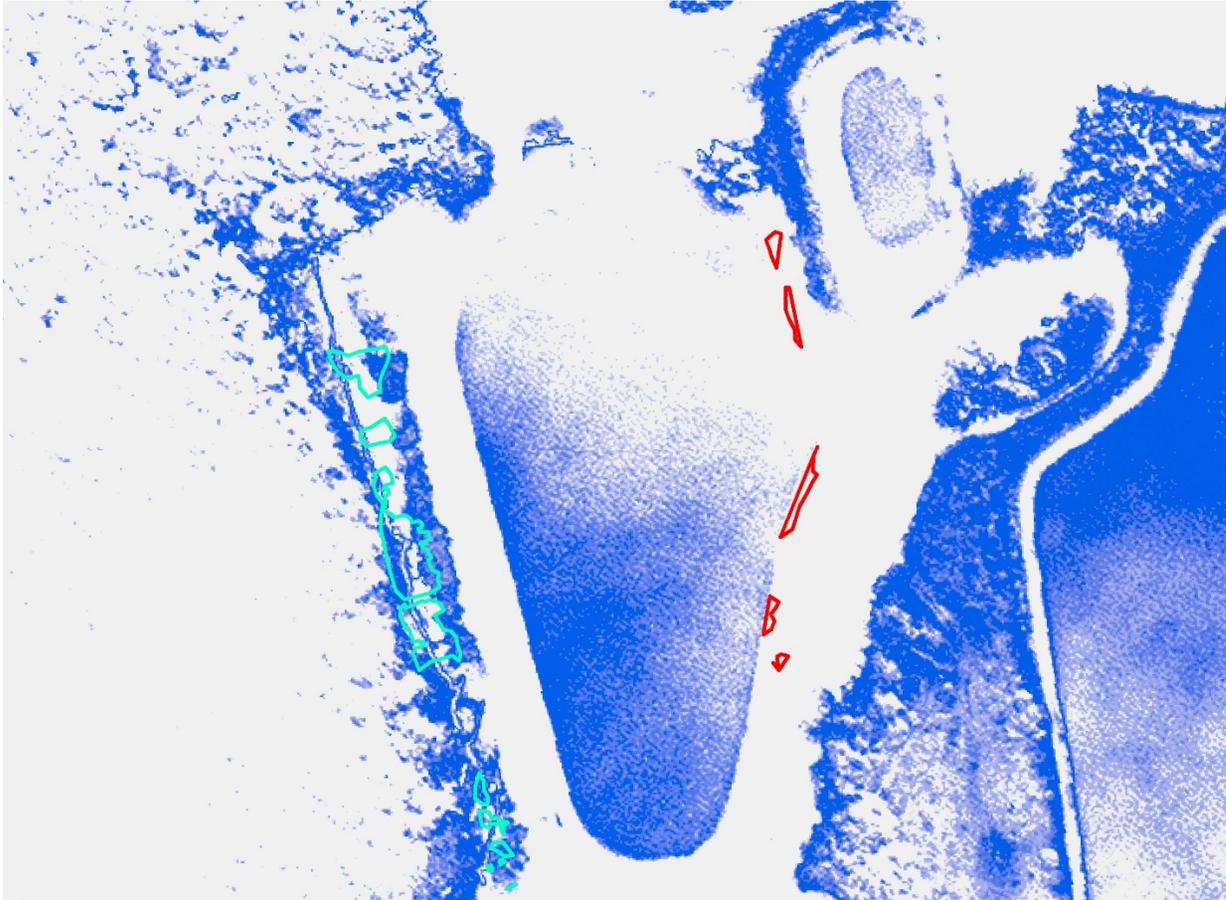
NDVI (Normalized Difference Vegetation Index), NWDI (Normalized Water Difference Index) and Density Slices

Seepage was apparent after pond filling . The red shapes were created using density slices, multiple imagery band combinations using NDVI and NWDI results.

Interpretation of the infrared imagery suggests that the seepage had penetrated the dike within an approximate 2 to 3-month period after the pond was filled.

- Seepage may be emanating from the two adjacent existing ponds and flowing into the enlarged pond.
- Dike seepage is originating from the easterly edge of the clay liner, which is then flowing under the clay liner and then along a fill-lift interface within the dike embankment.
- It is possible that a portion of the seepage is migrating through open bedrock fractures and then flowing upward as underseepage below the dike.

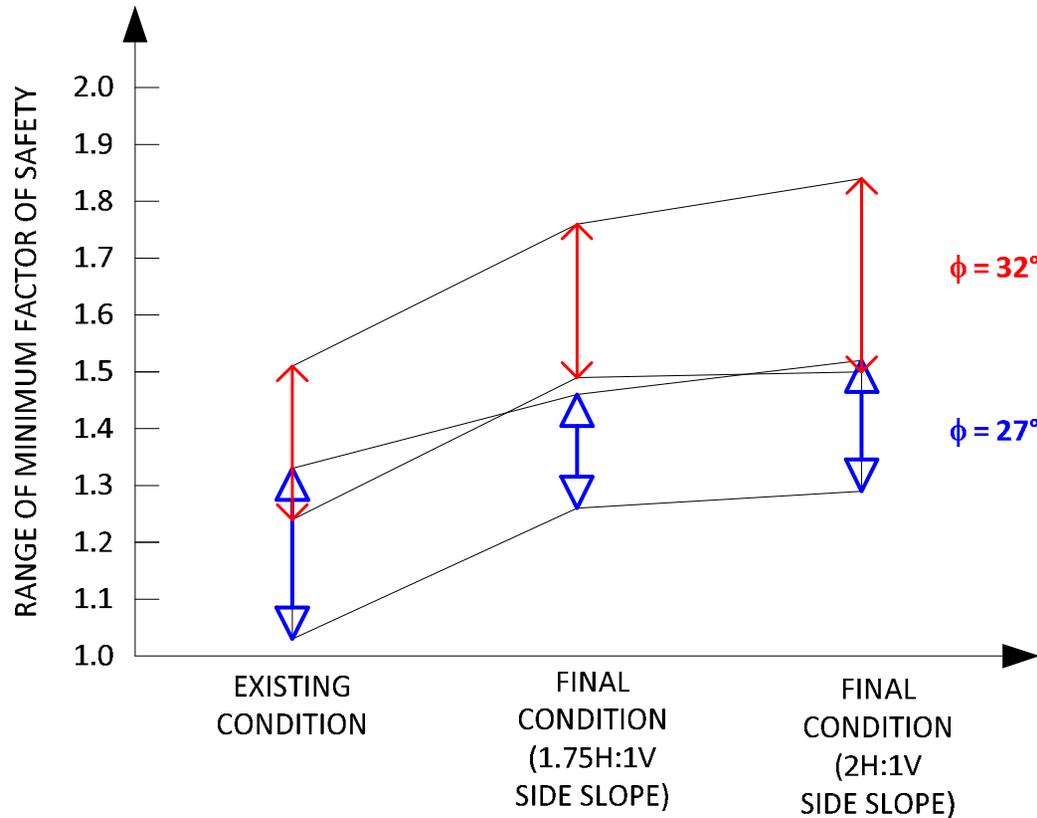
Sensitivity Analysis

Stability analyses were completed to assess the sensitivity and relative improvement for a variety of conditions, seepage cases, material properties and seepage toe berm geometry
