S.R. 4099 Emergency Slide Repair
Westmoreland County
Segment 40 Offset 0000-1800

Designing a Pipe Dowel System

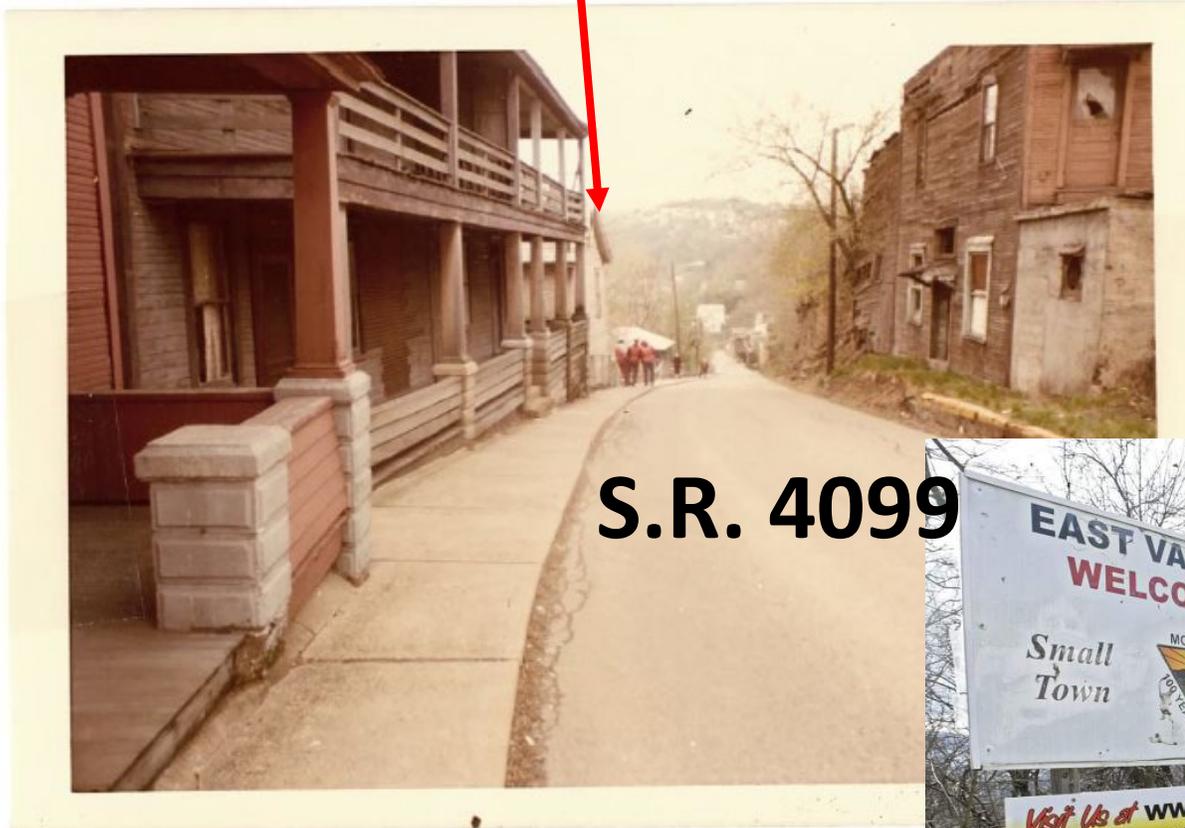
Evidences of Slope Movement

April 23, 1974

(note white house)

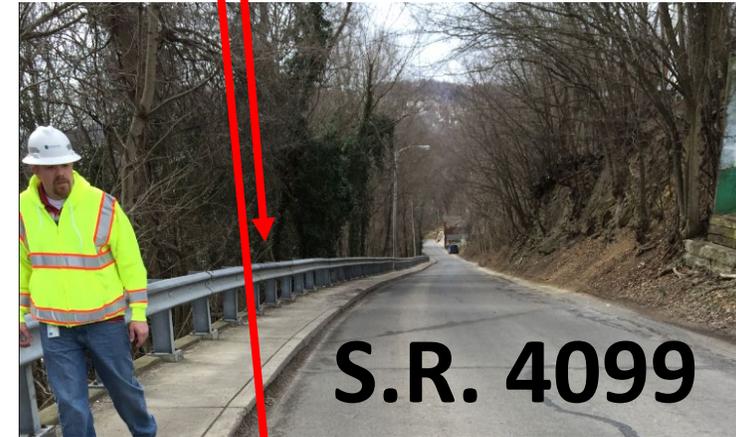
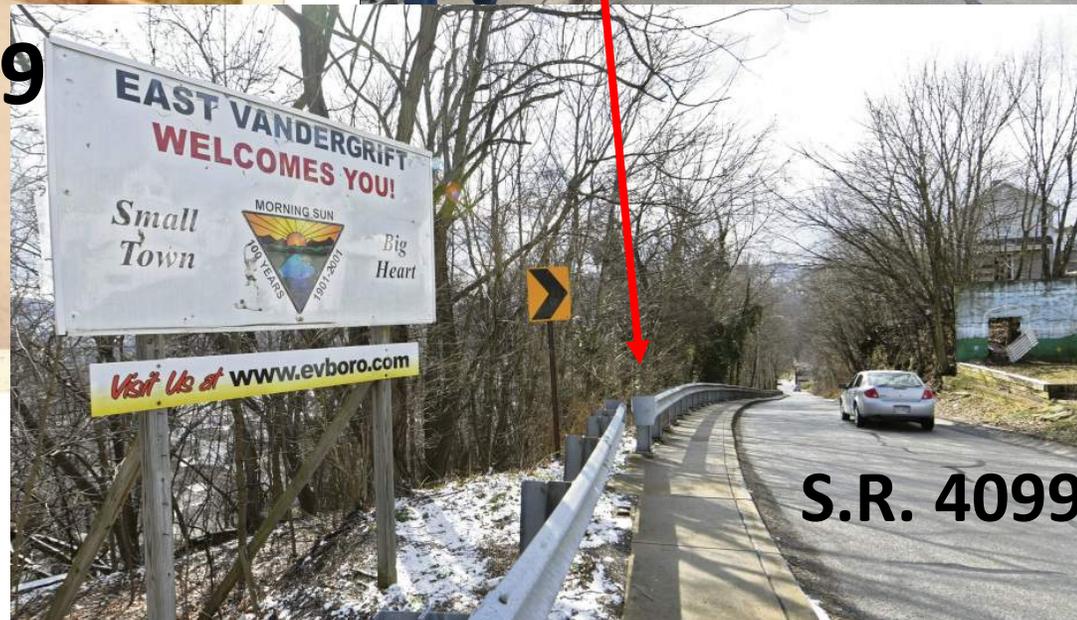
April 23, 1974
Large foundation
movement in white house
near top of S.R. 4099

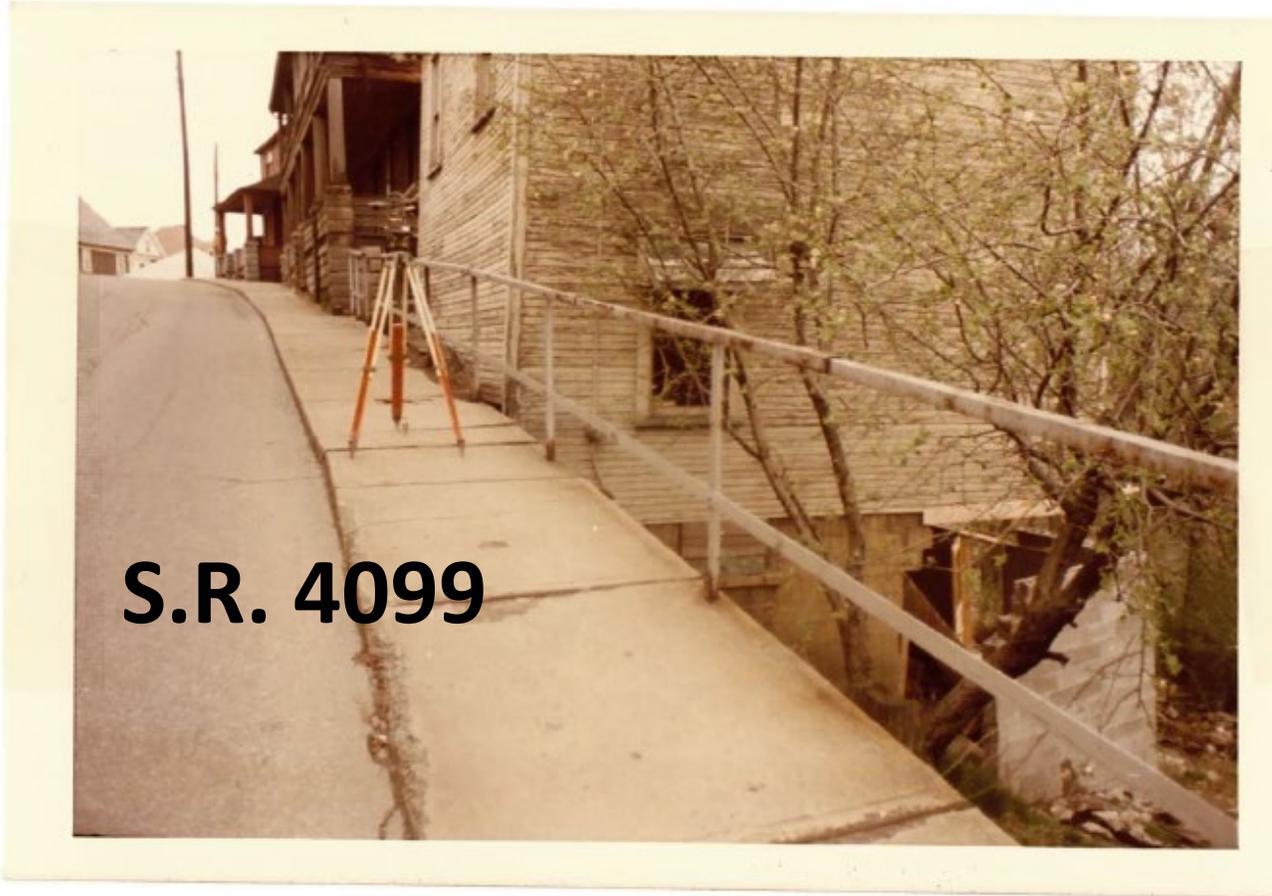
April 13, 2017

(Pole#1 also in photo)

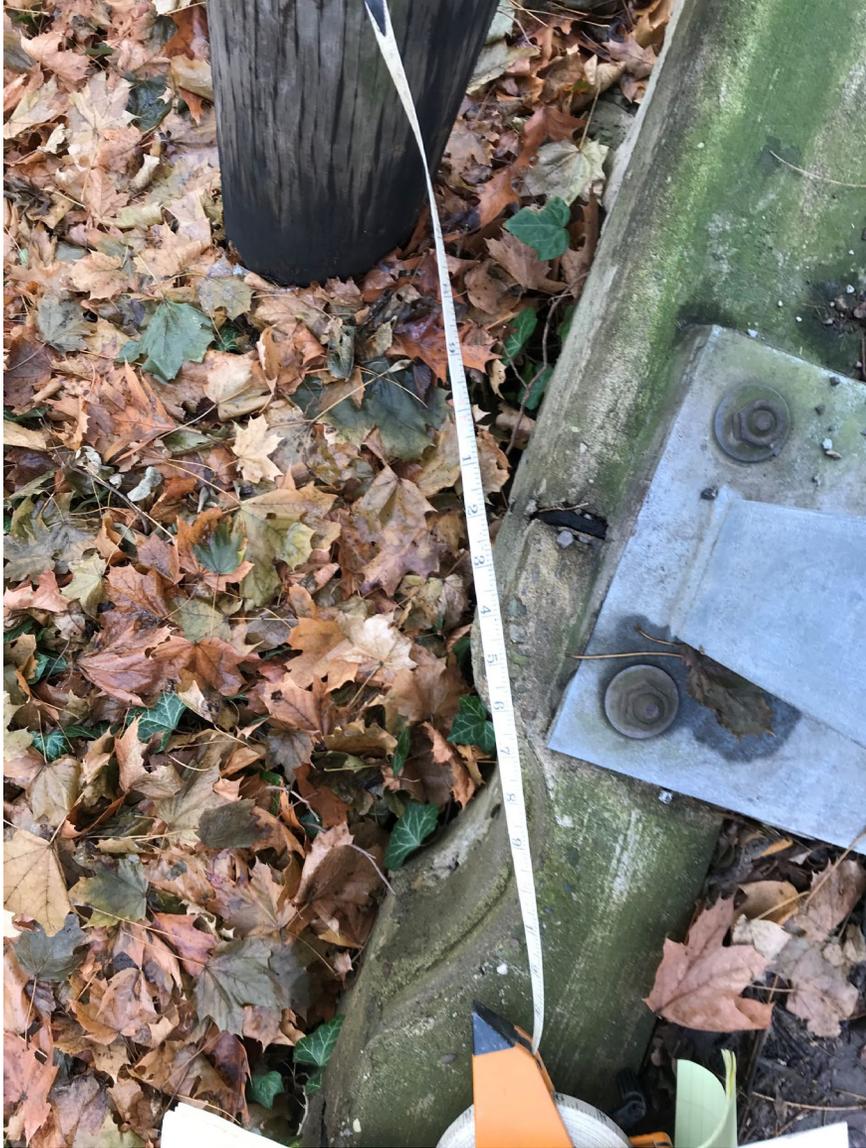
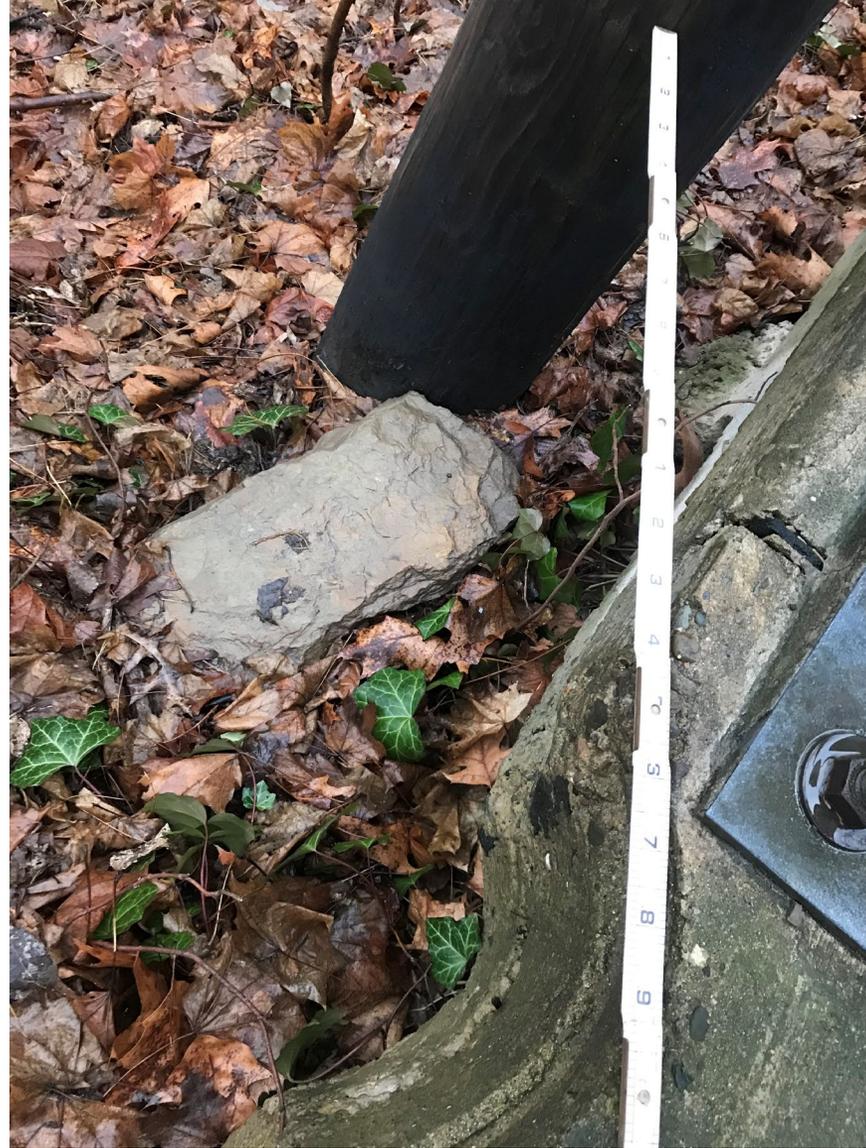
Sidewalk notch out for Pole #1, slope movement obvious
December 5, 2019
February 26, 2020

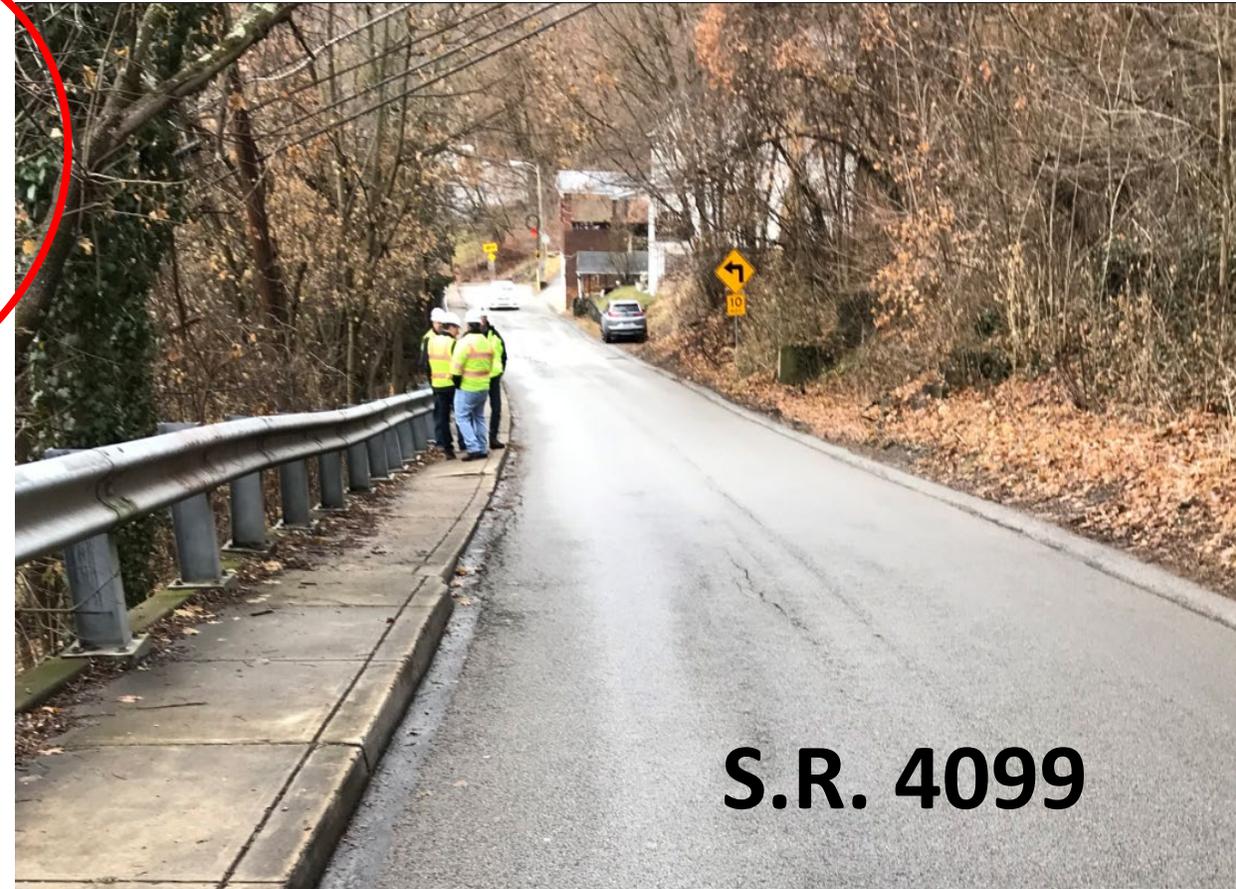
December 5, 2019

(three structures removed in 14 years)

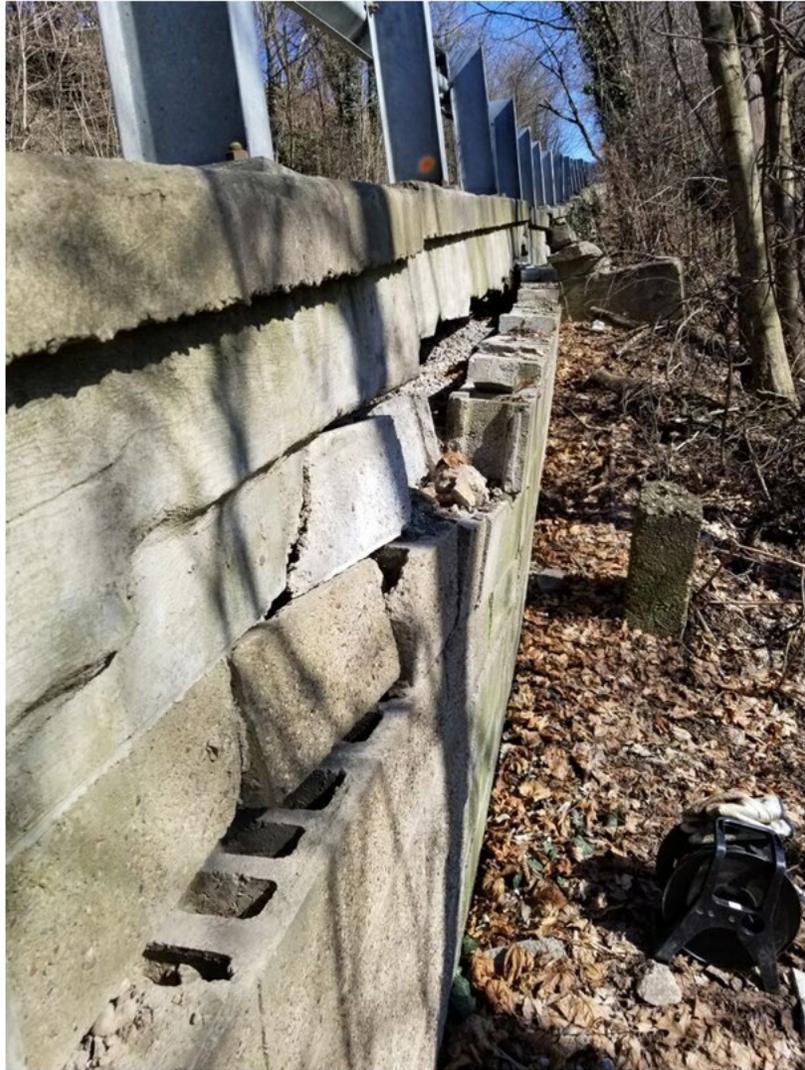
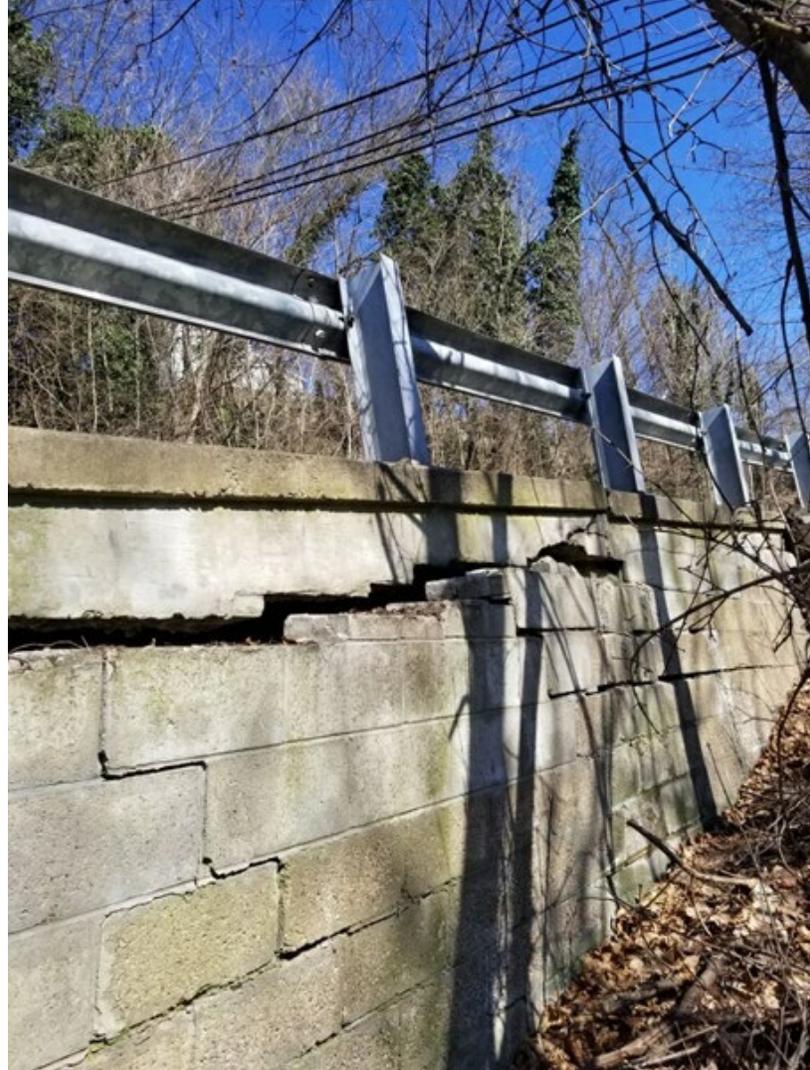
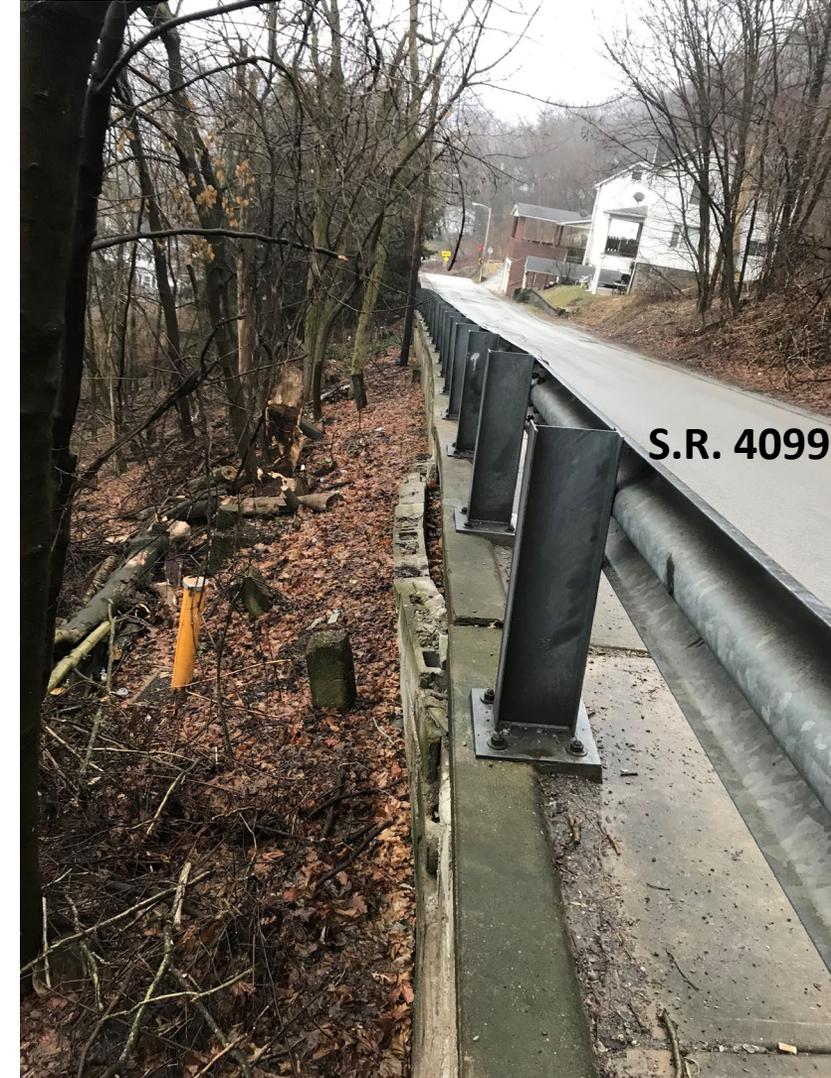
Sidewalk wall movement near F-9 Inclinometer

June 2017 Repair-

2' wide, 8' deep, 40' long trench filled with Class C Concrete and bottom of excavation sloped towards the slope above the roadway (so as to force the concrete to 'fall back towards the uphill side of the trench')

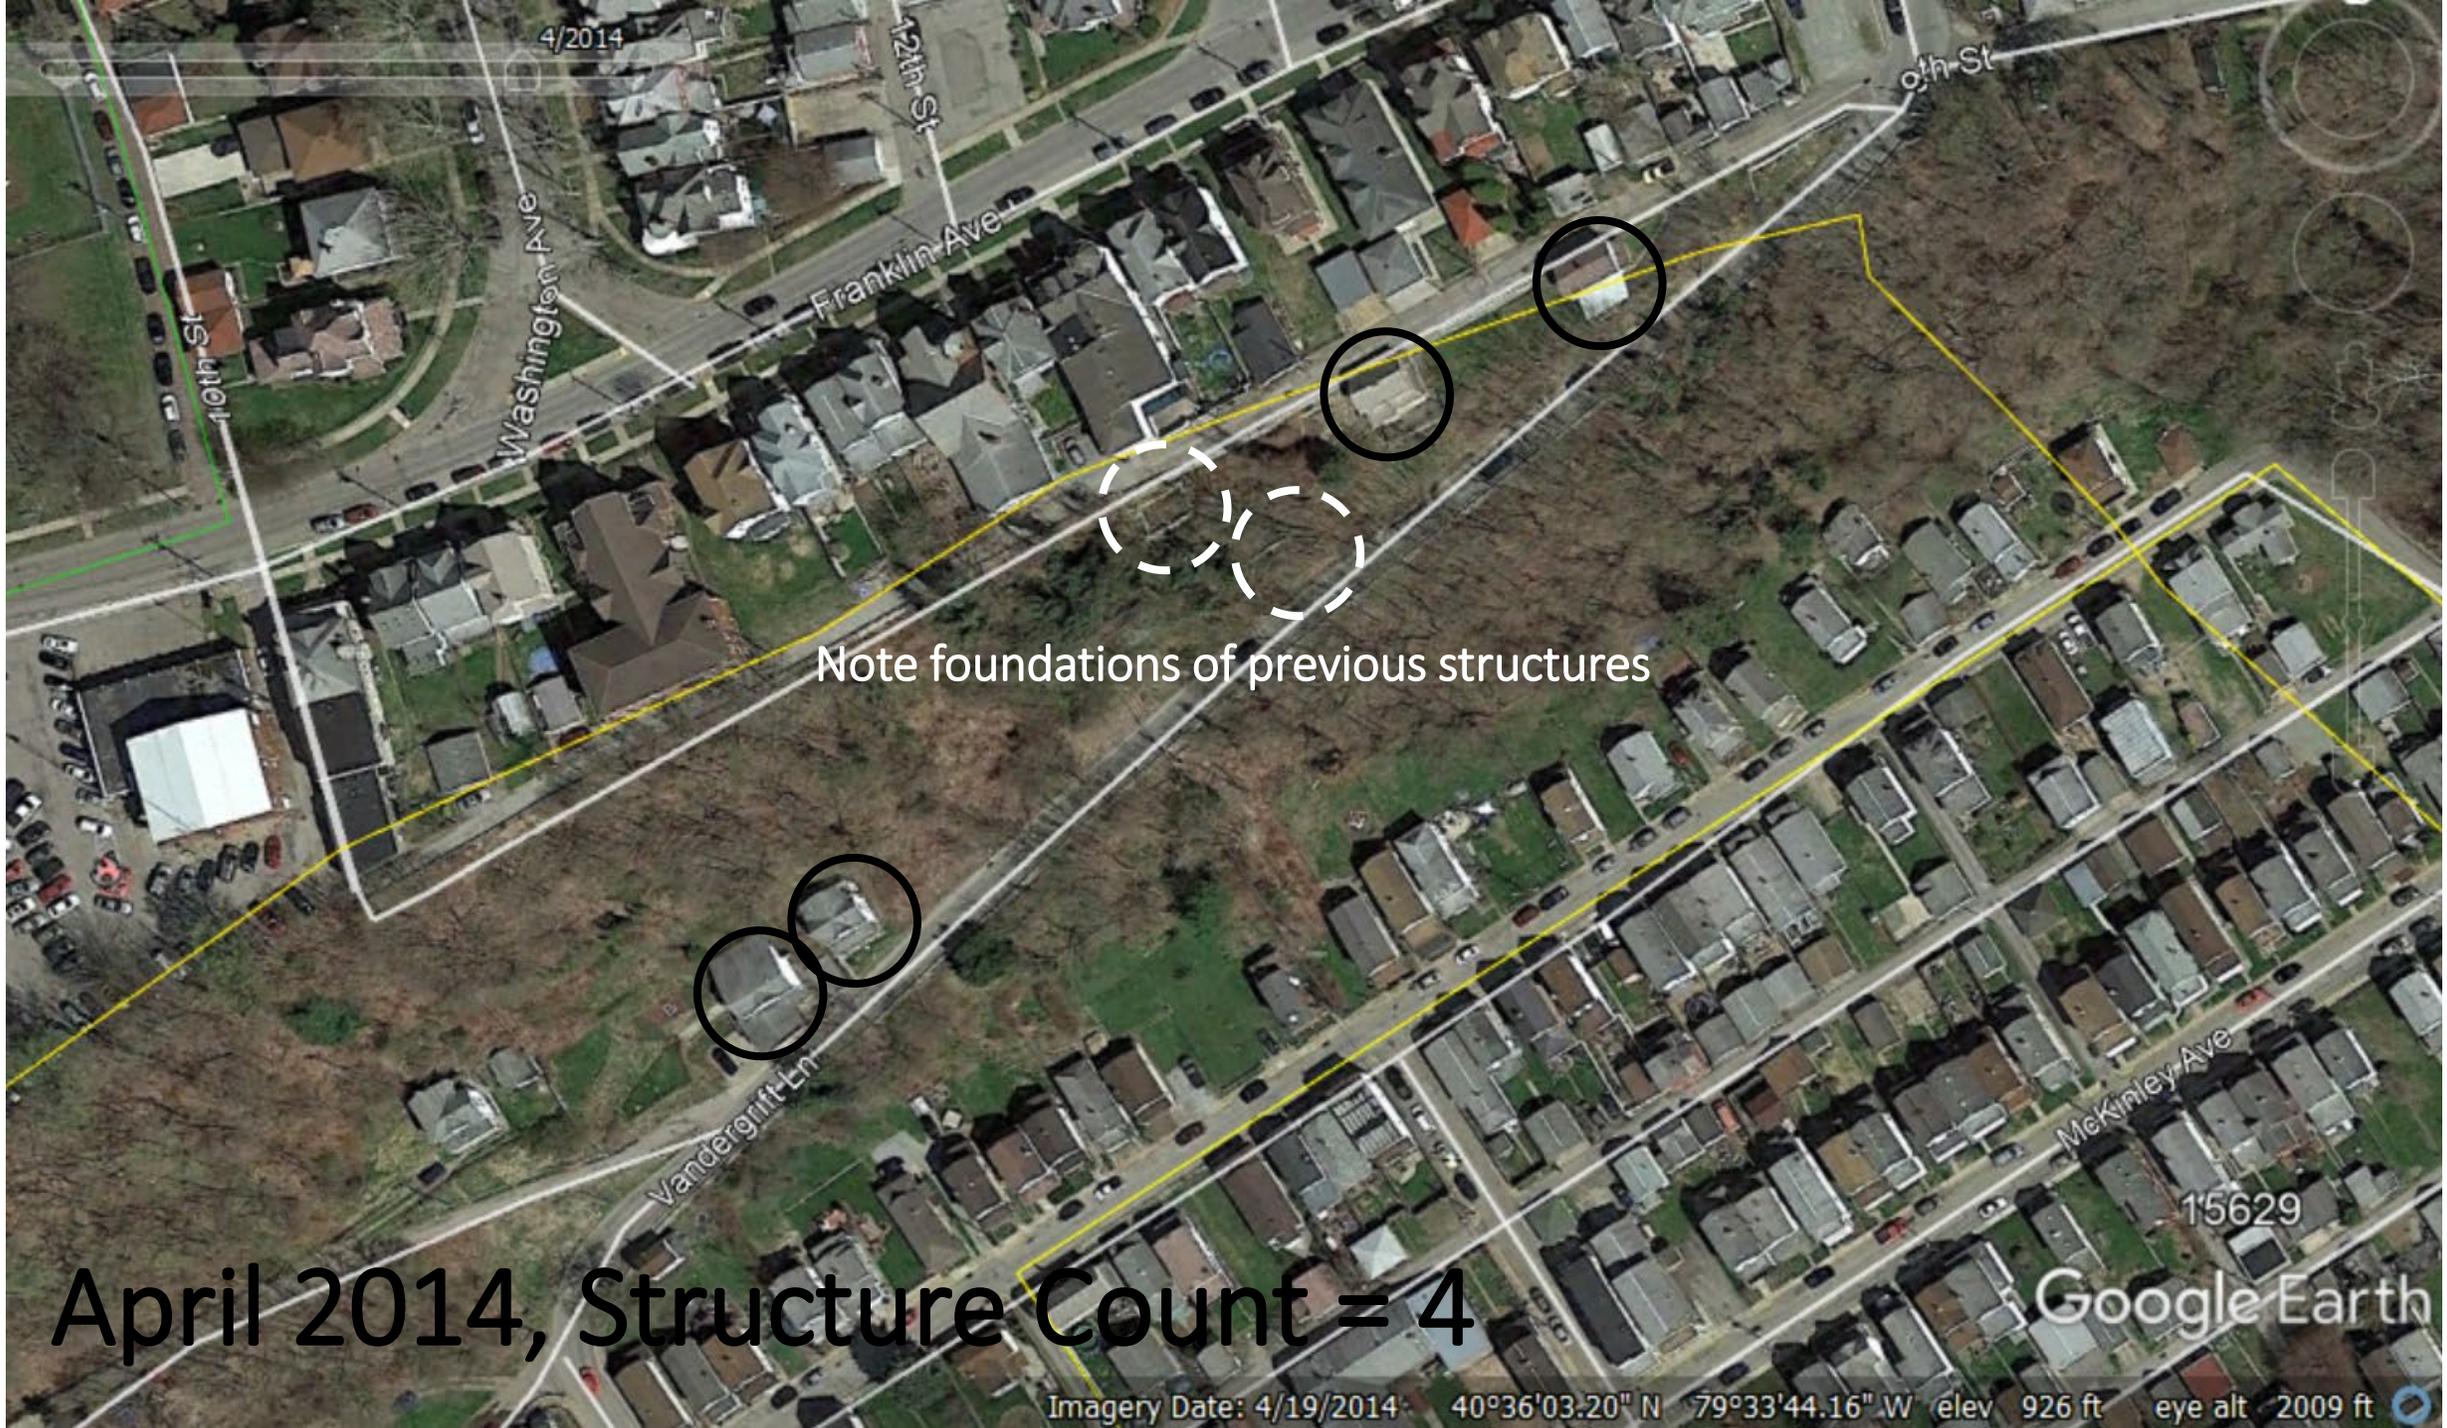
Note foundations of previous structures

April 2014, Structure Count = 4

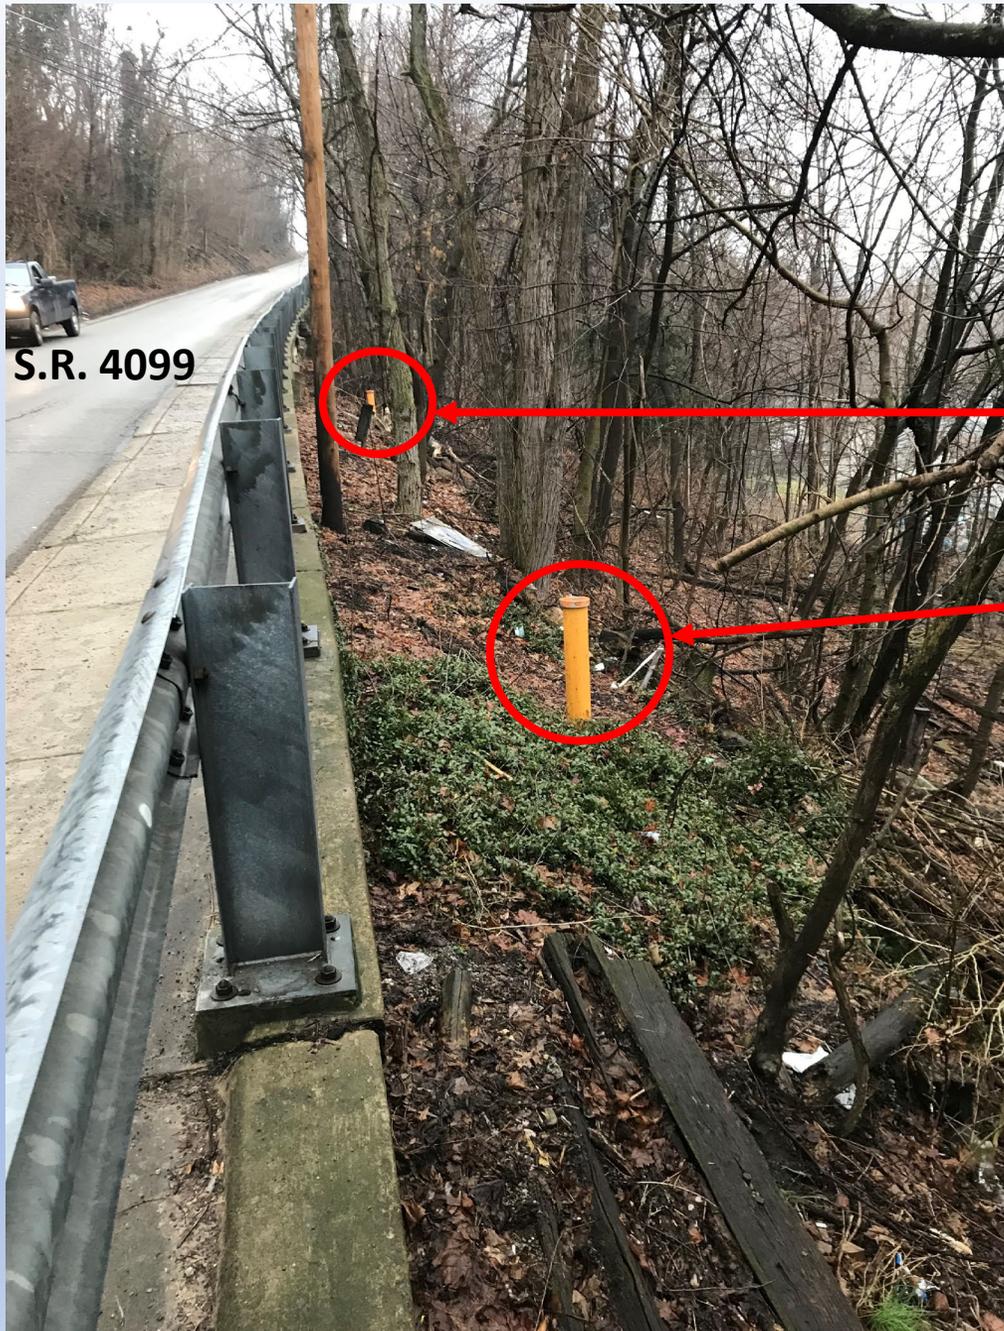
F-9 Inclinometer in background (0.45"/year movement on top of rock up until May 2020, 4.8"/year from May to August 2020)

F-11 Inclinometer in foreground (1.025"/year movement on top of rock based on last obtainable reading in February 2020, wall was fully collapsing in May 2020)

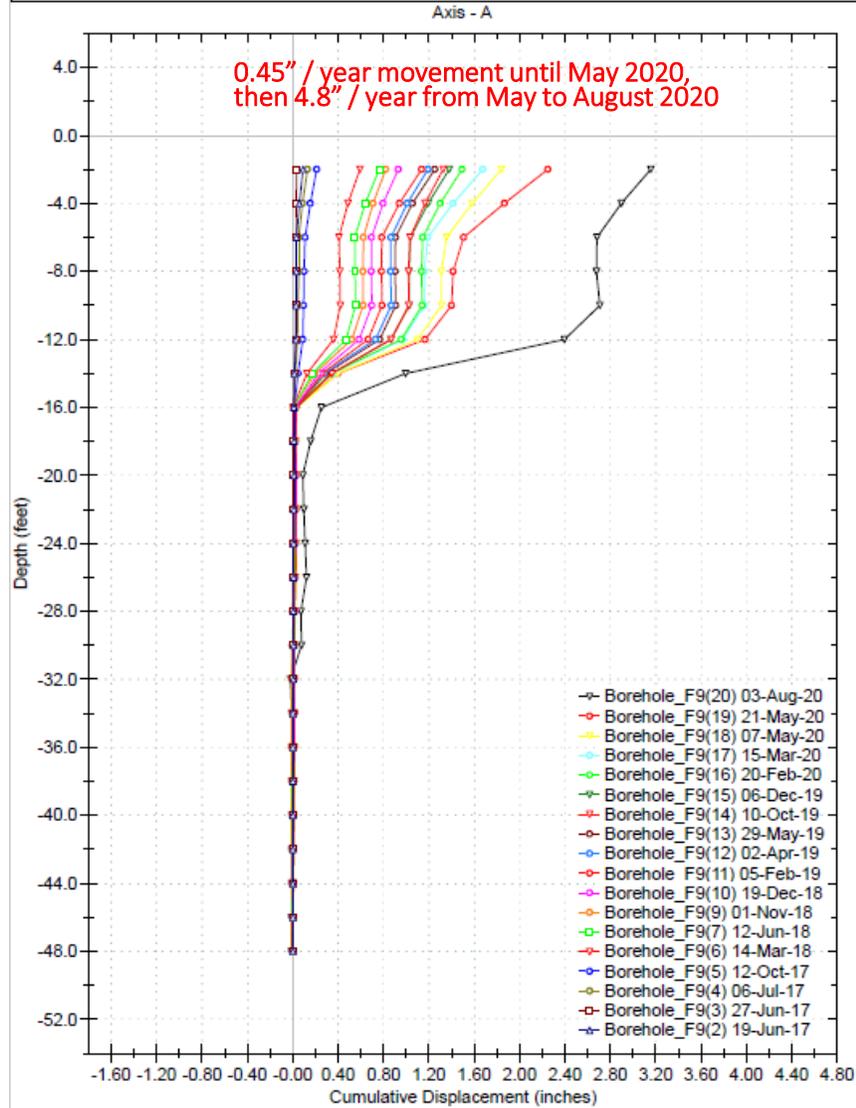
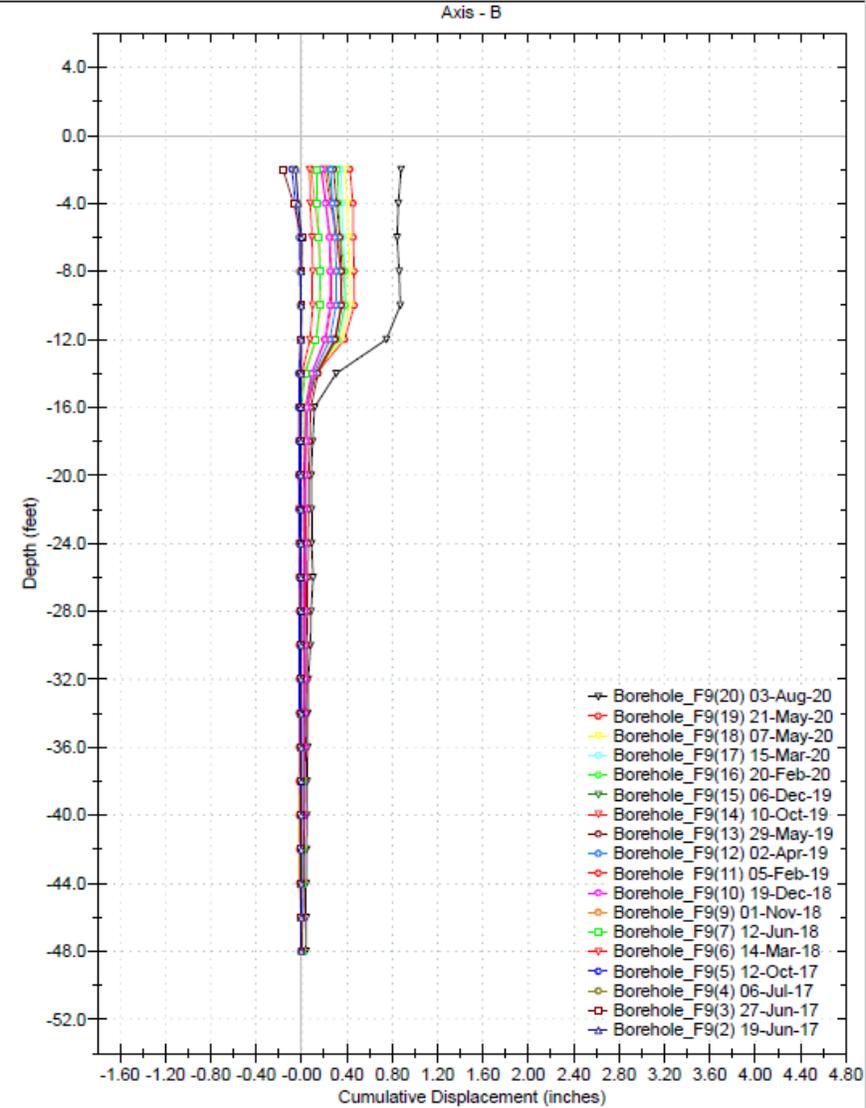
Borehole : F-9
Project : SR 4099_0040_000_E VANDERGRIFT
Location :
Northing :
Easting :
Collar :

← Sliding occurring here

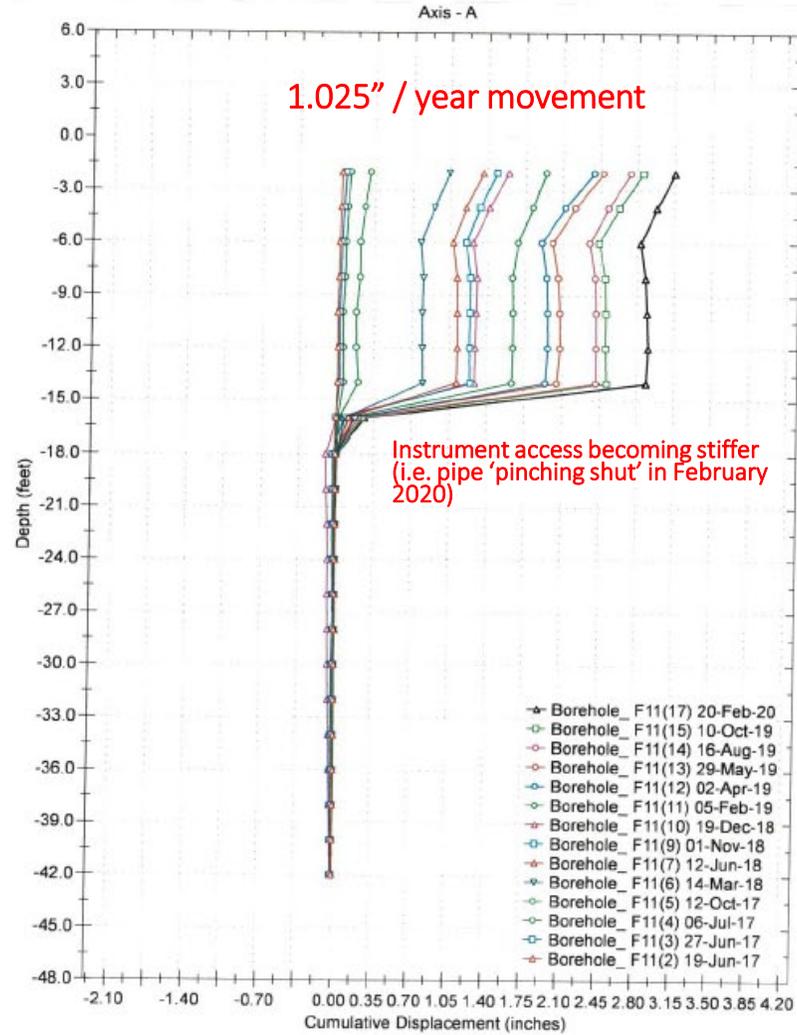
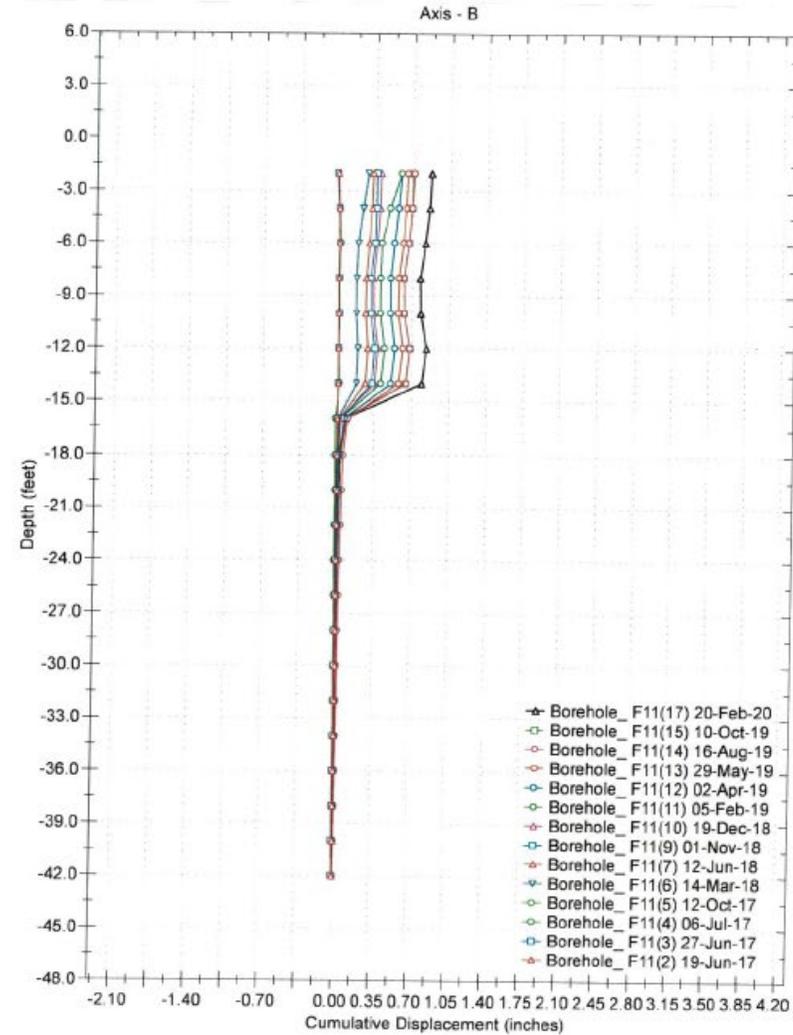
Borehole : F-11
Project : SR 4099_0040_000_E VANDERGRIFT
Location :
Northing :
Easting :
Collar :

← Sliding occurring here

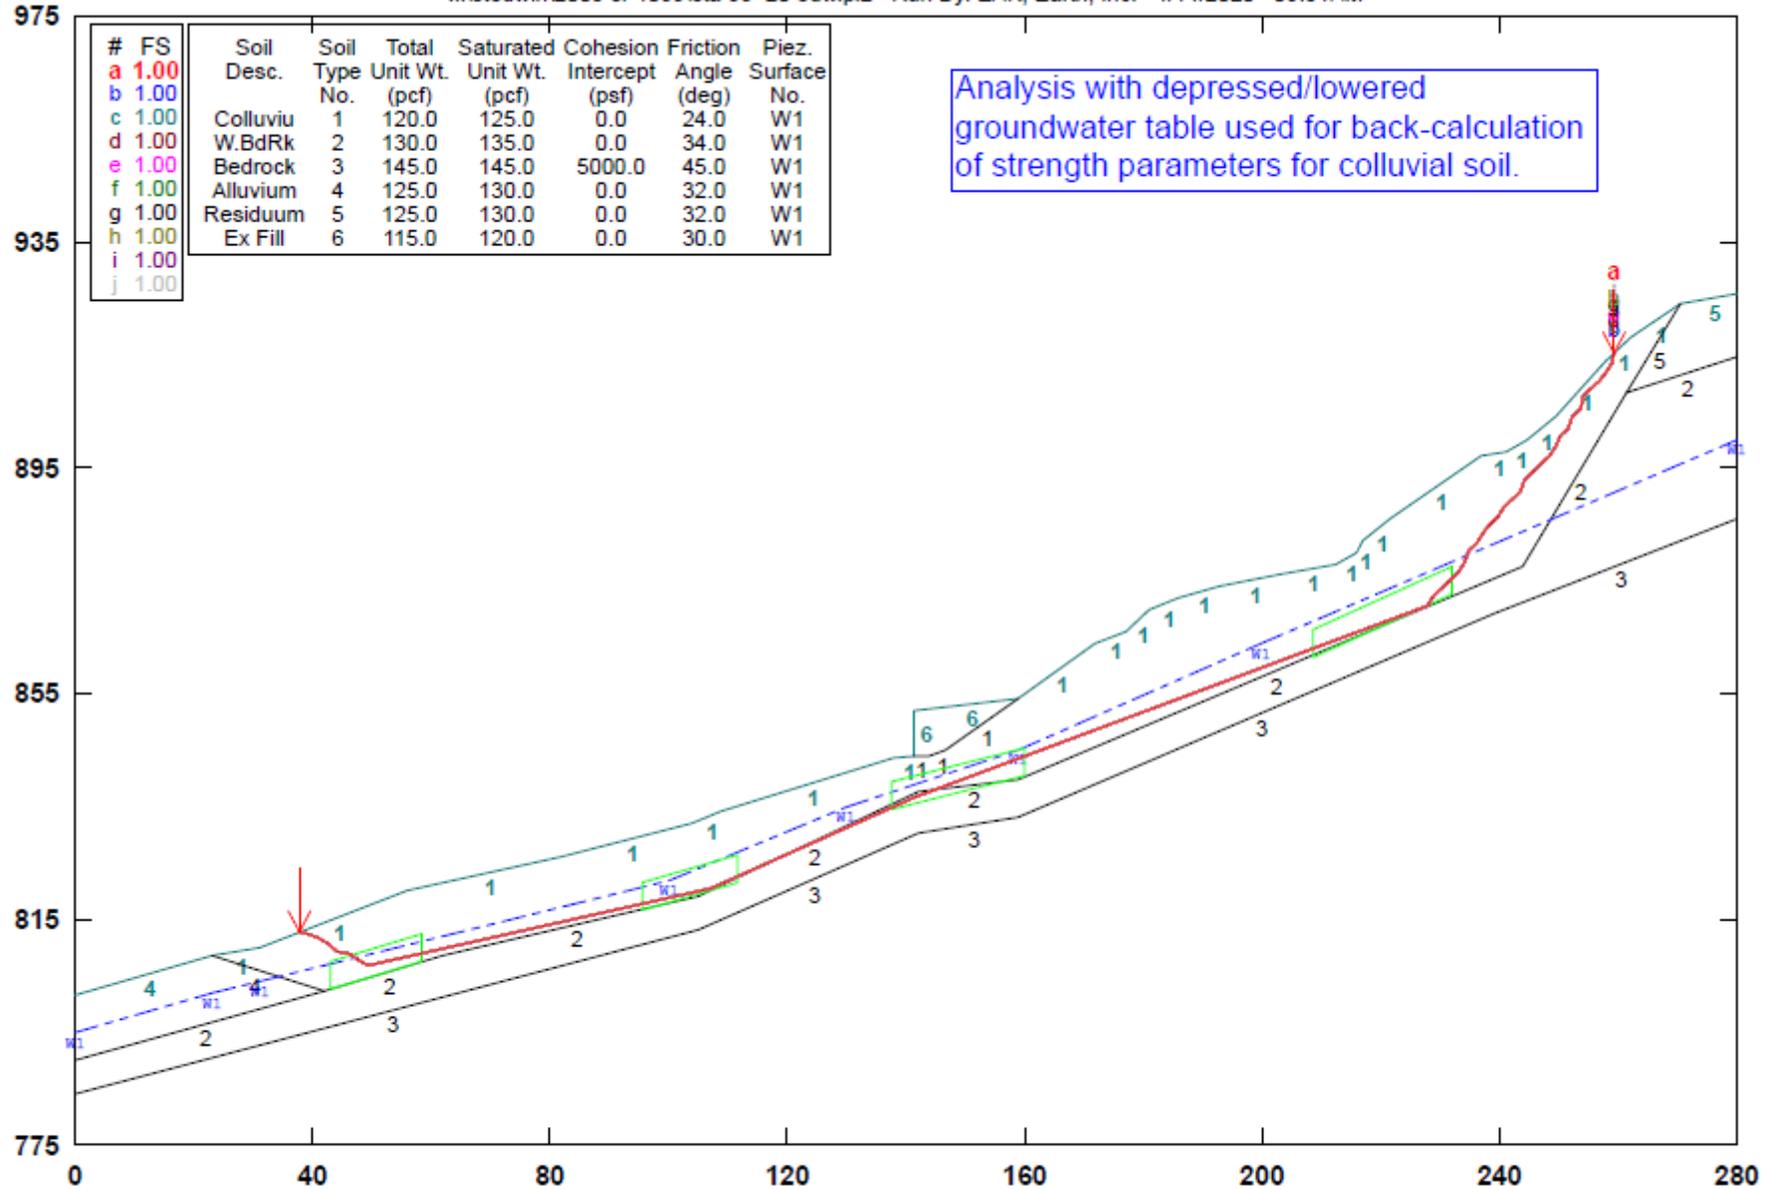
SR 4099 Slide @ Sta 88+20 - Existing Condition with Depressed Water Table

GSTABL7 v.2 FSmin=1.00

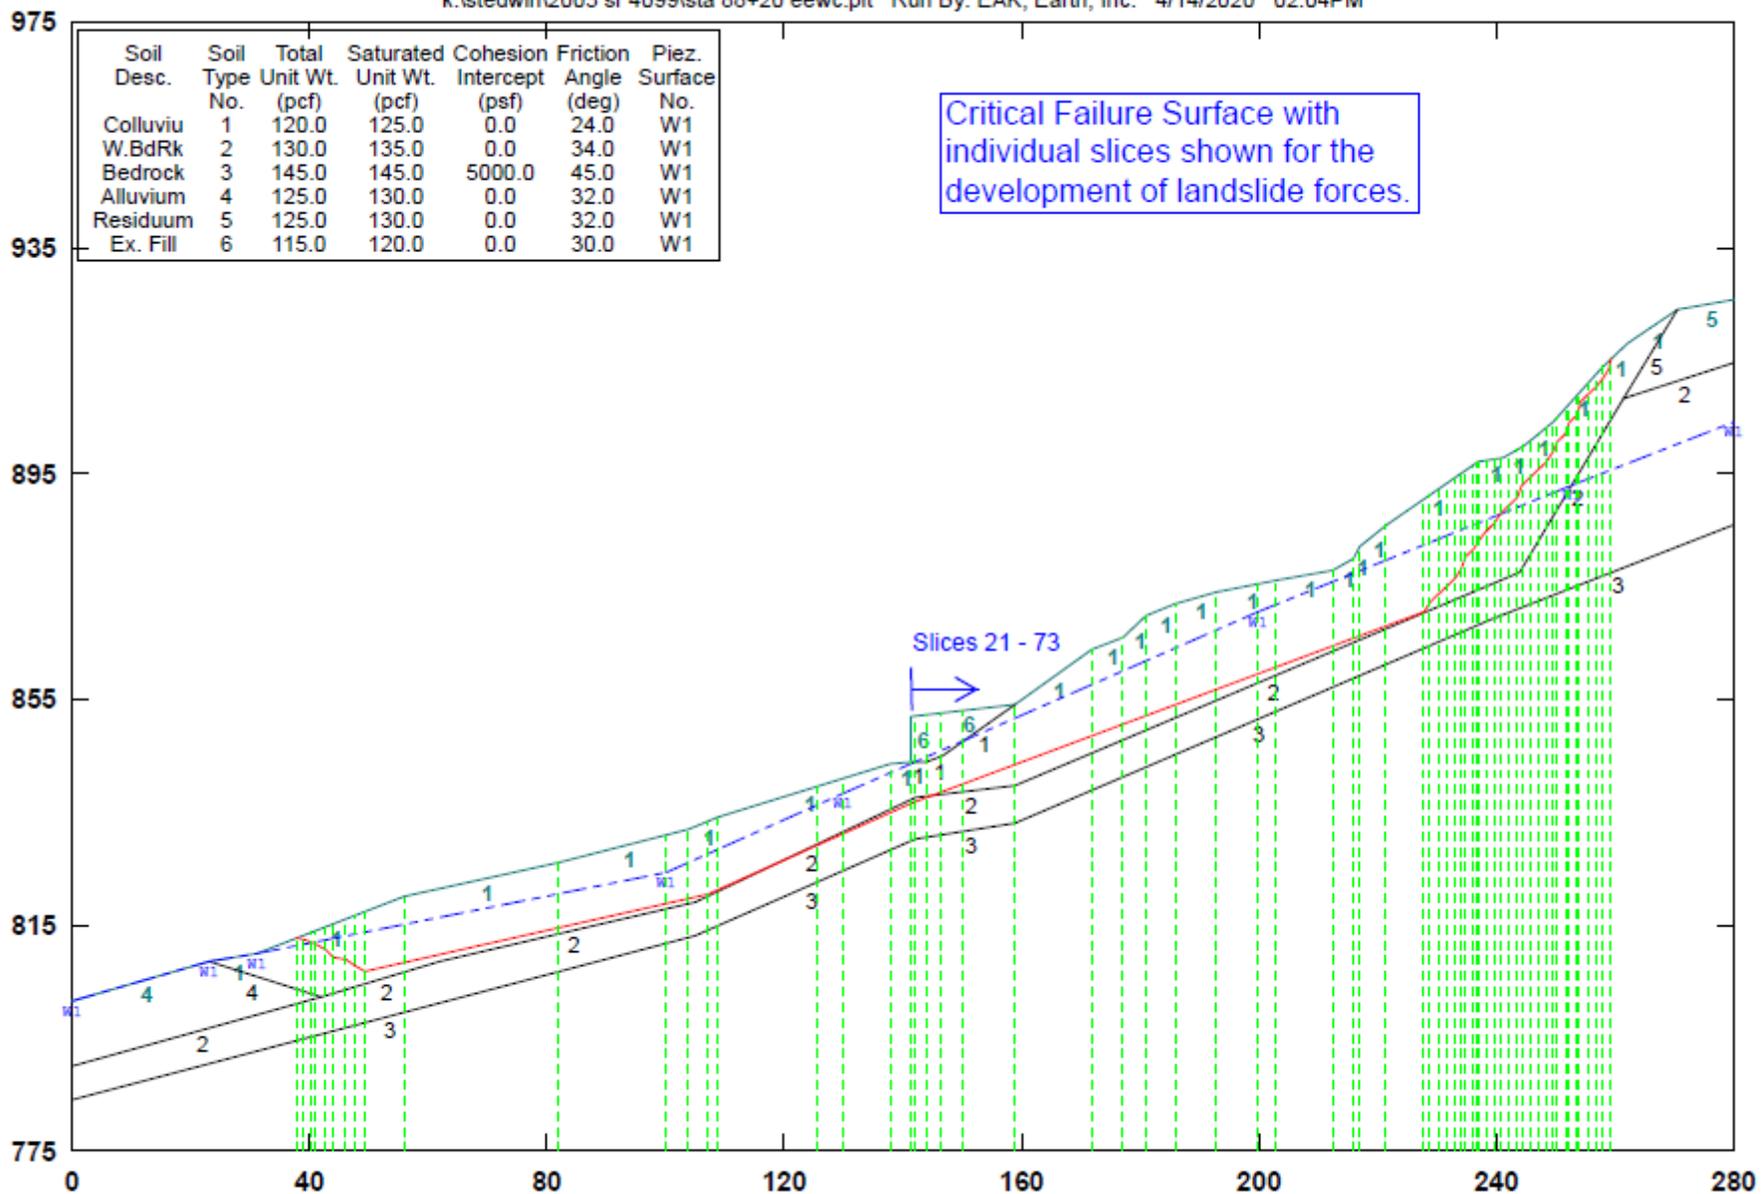
SR 4099 Slide @ Sta 88+20 - Existing Condition with Elevated Water Table

GSTABL7 v.2 FSmin=0.79
