S.R. 4099 Emergency Slide Repair
Westmoreland County
Segment 40 Offset 0000-1800

Designing a Pipe Dowel System

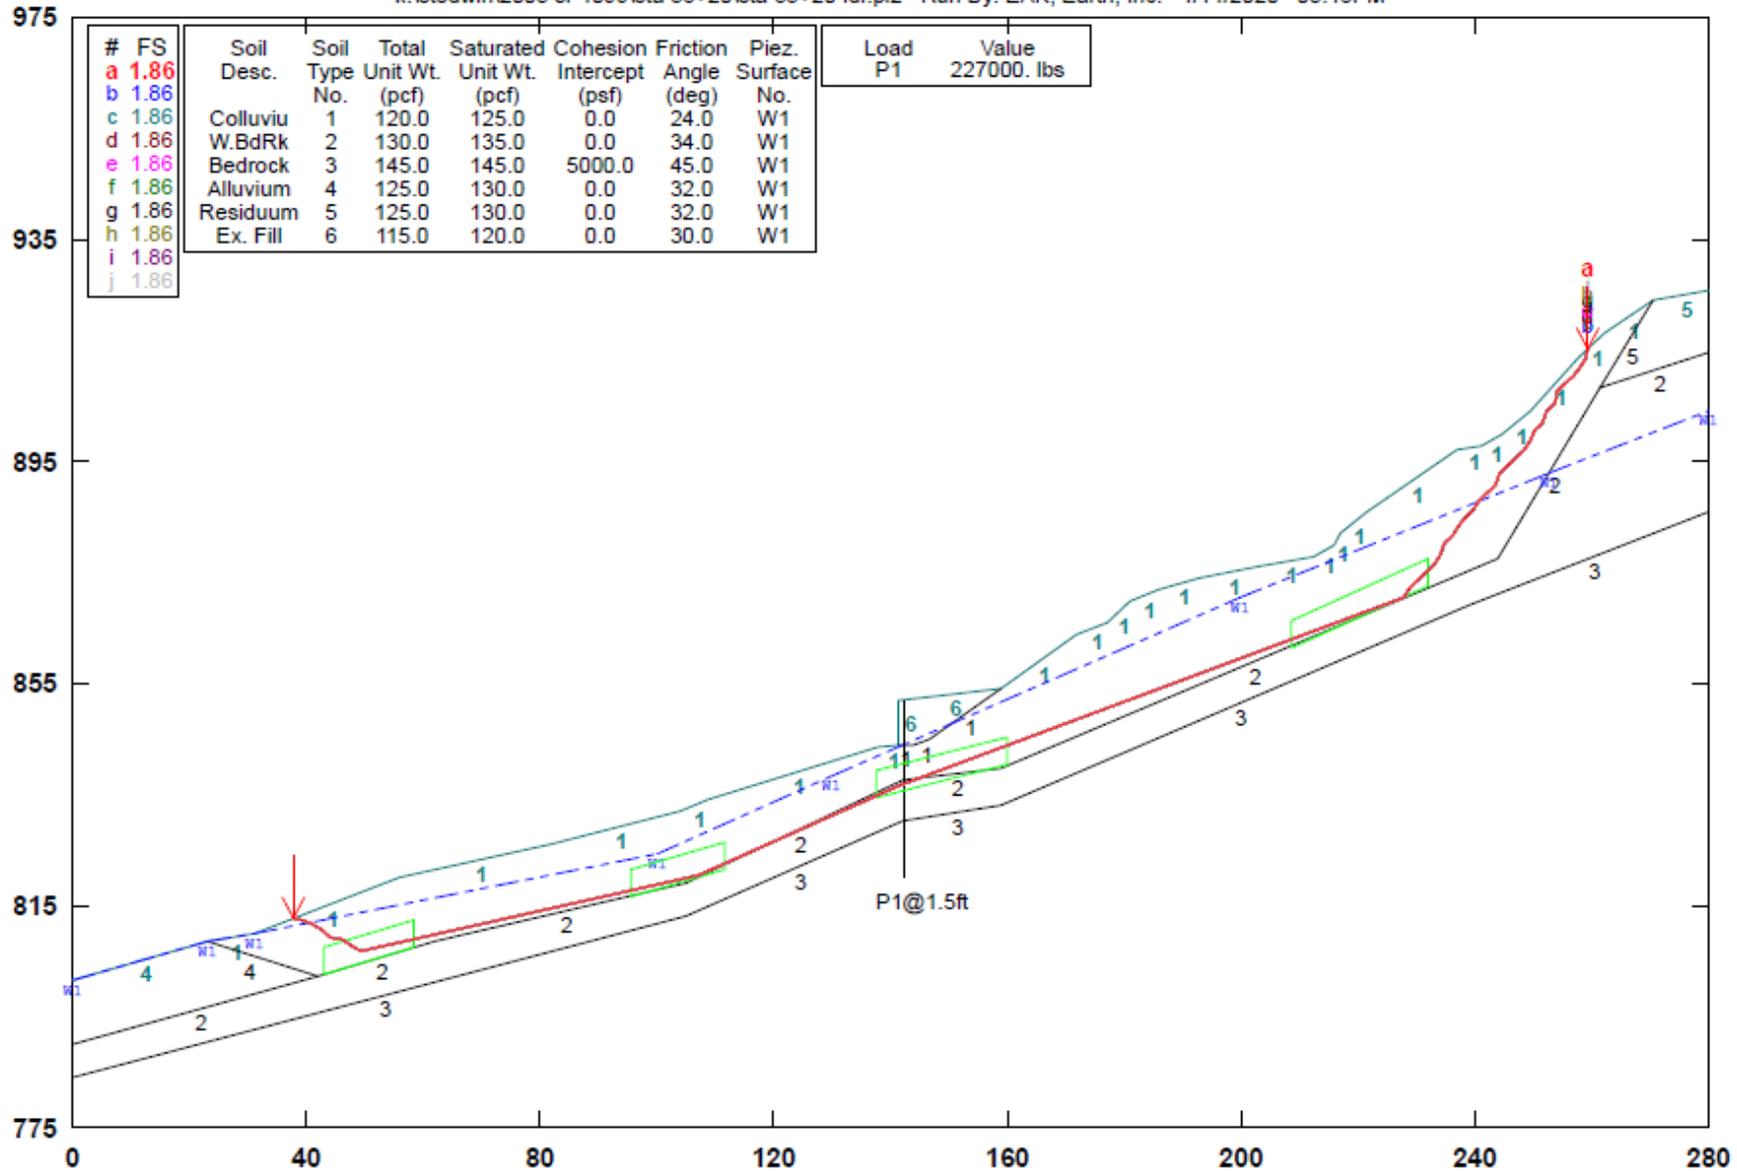
SR 4099 Slide @ Sta 88+20 - Final Condition with Pipe Dowel System

GSTABL7 v.2 FSmin=1.86

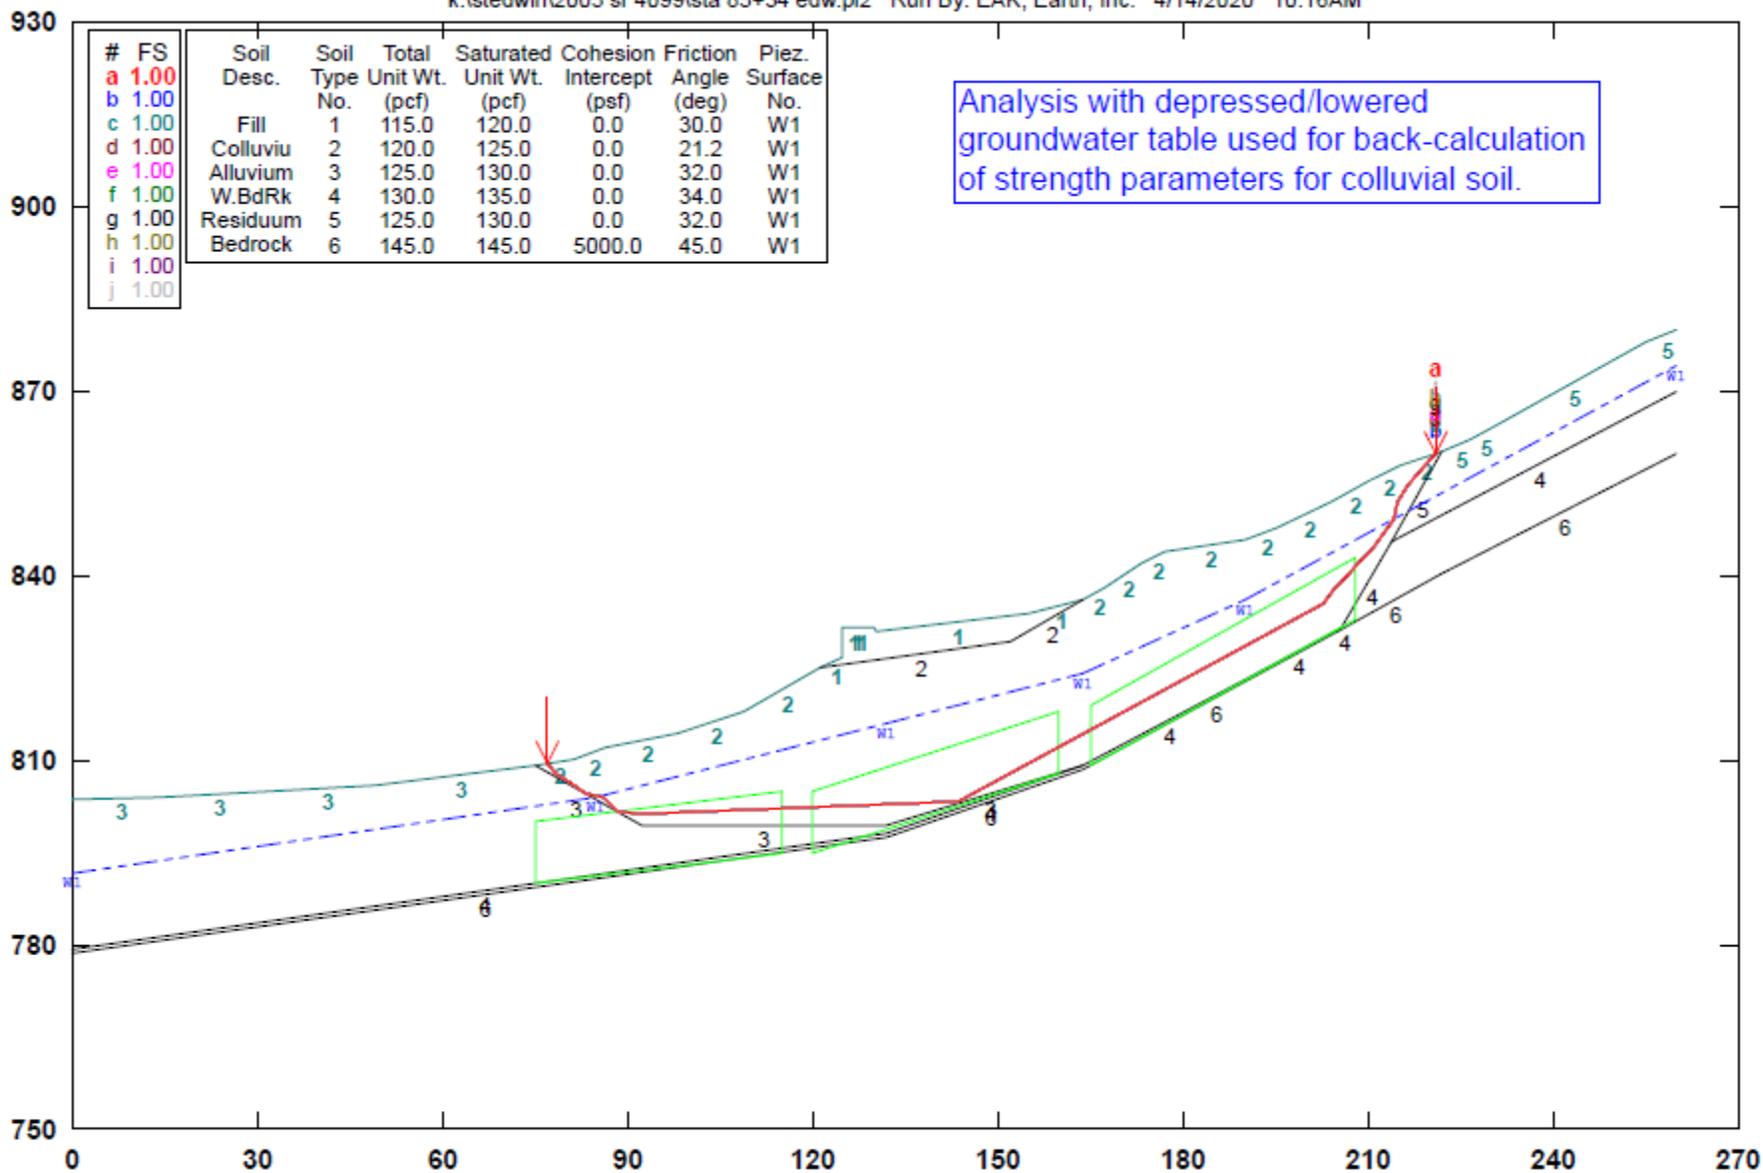
SR 4099 Slide @ Sta 85+34 - Existing Condition with Depressed Water Table

GSTABL7 v.2 FSmin=1.00

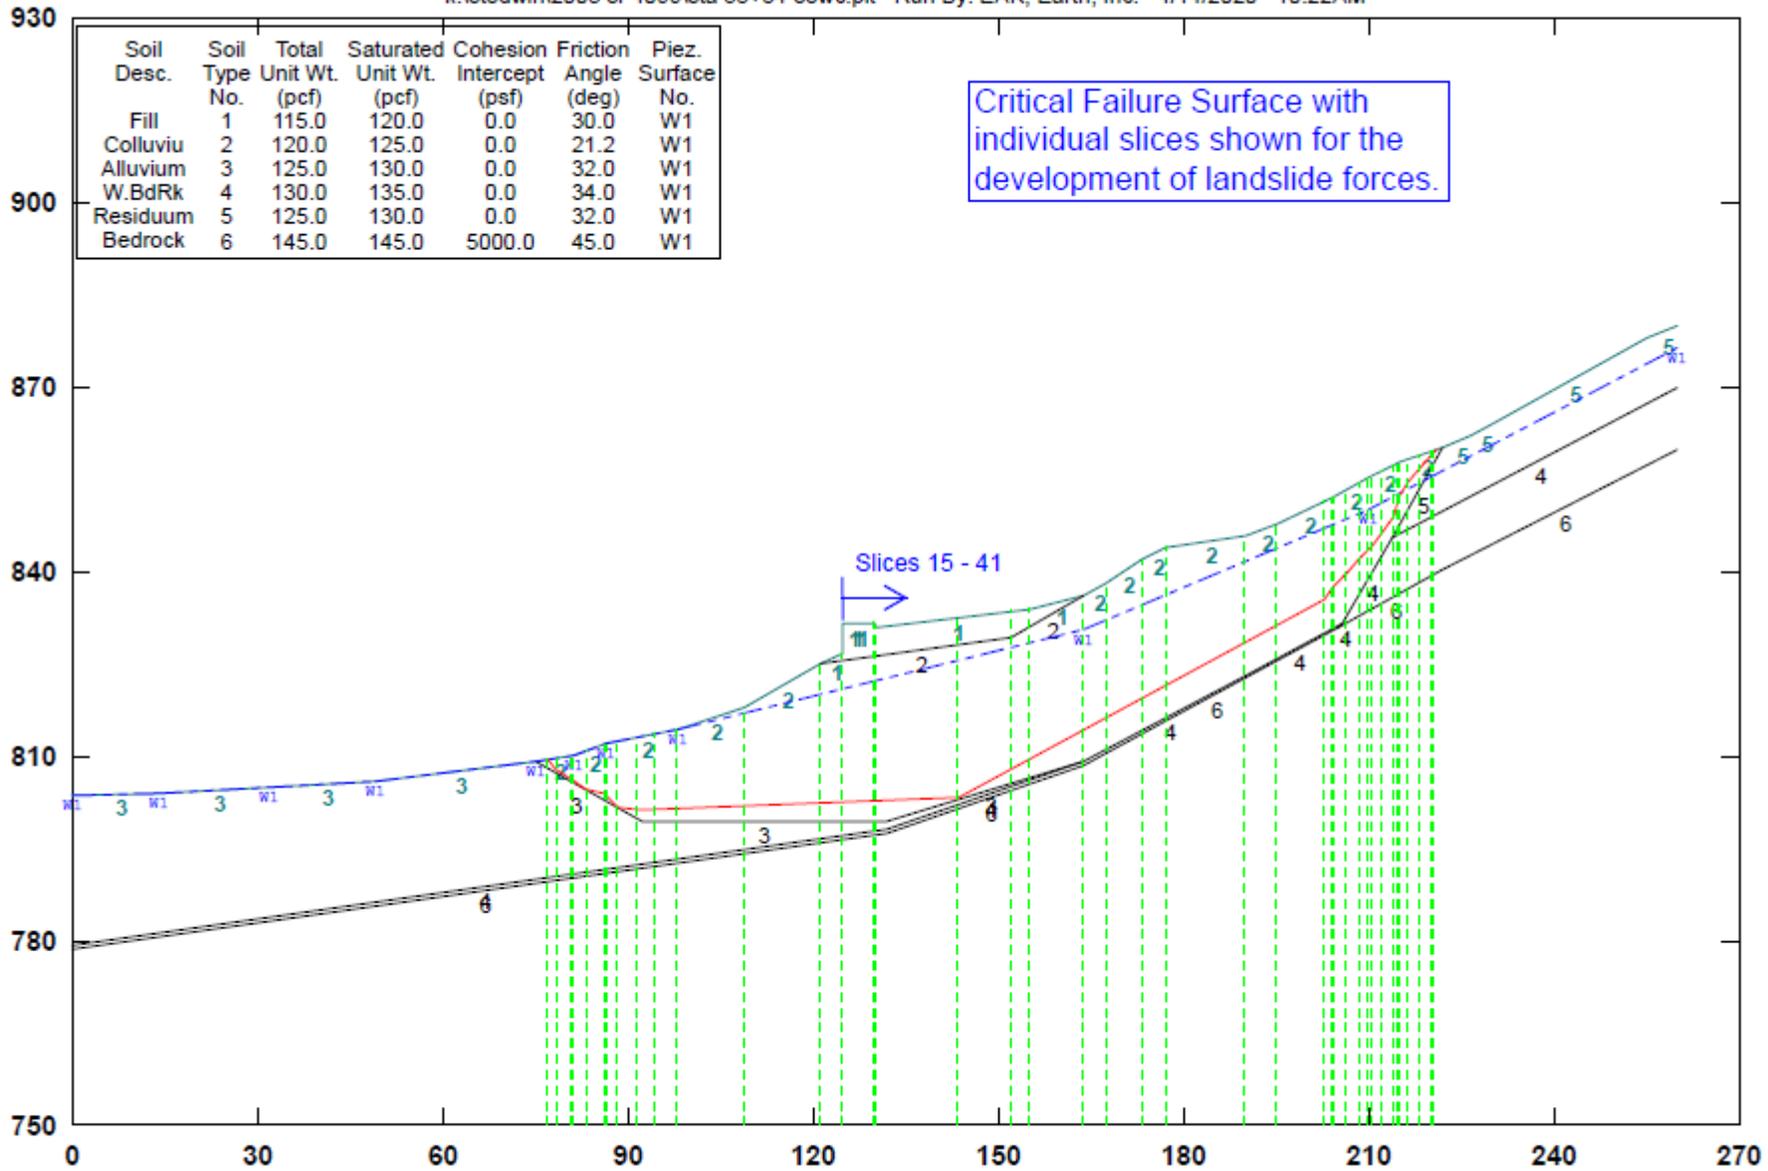
SR 4099 Slide @ Sta 85+34 - Existing Condition with Elevated Water Table

GSTABL7 v.2 FSmin=0.78

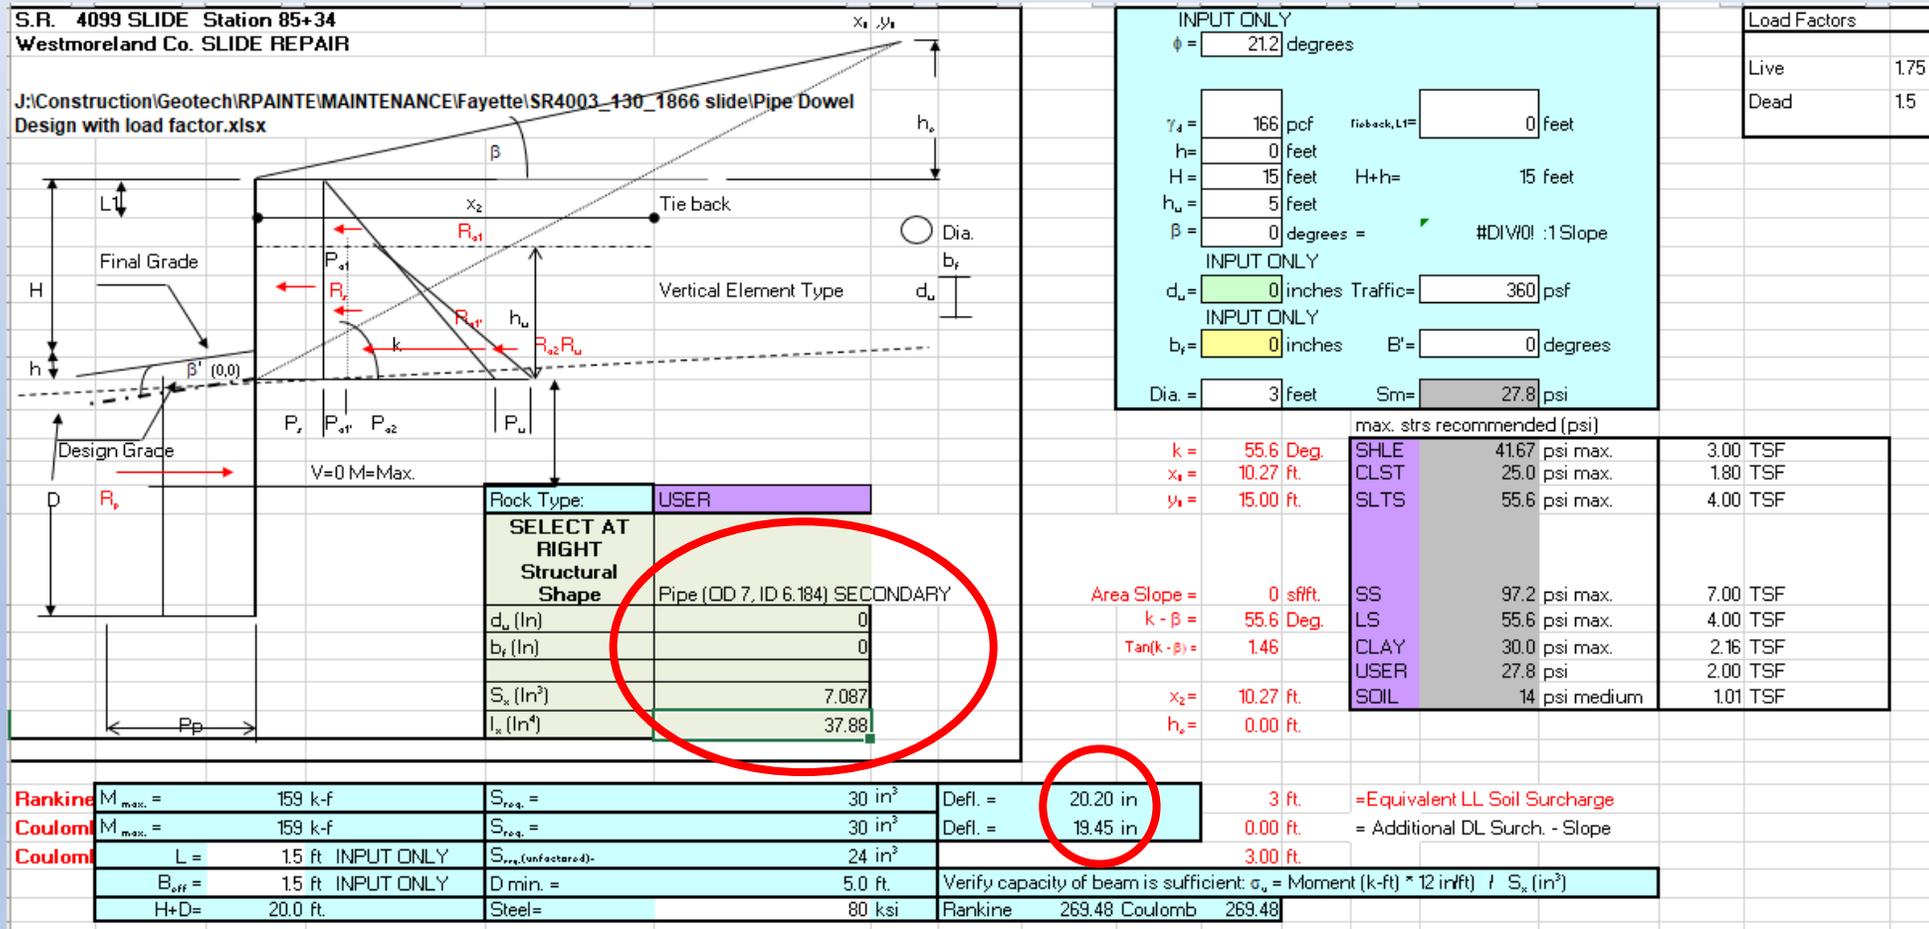
Tops of Pipes not connected: 20" deflection

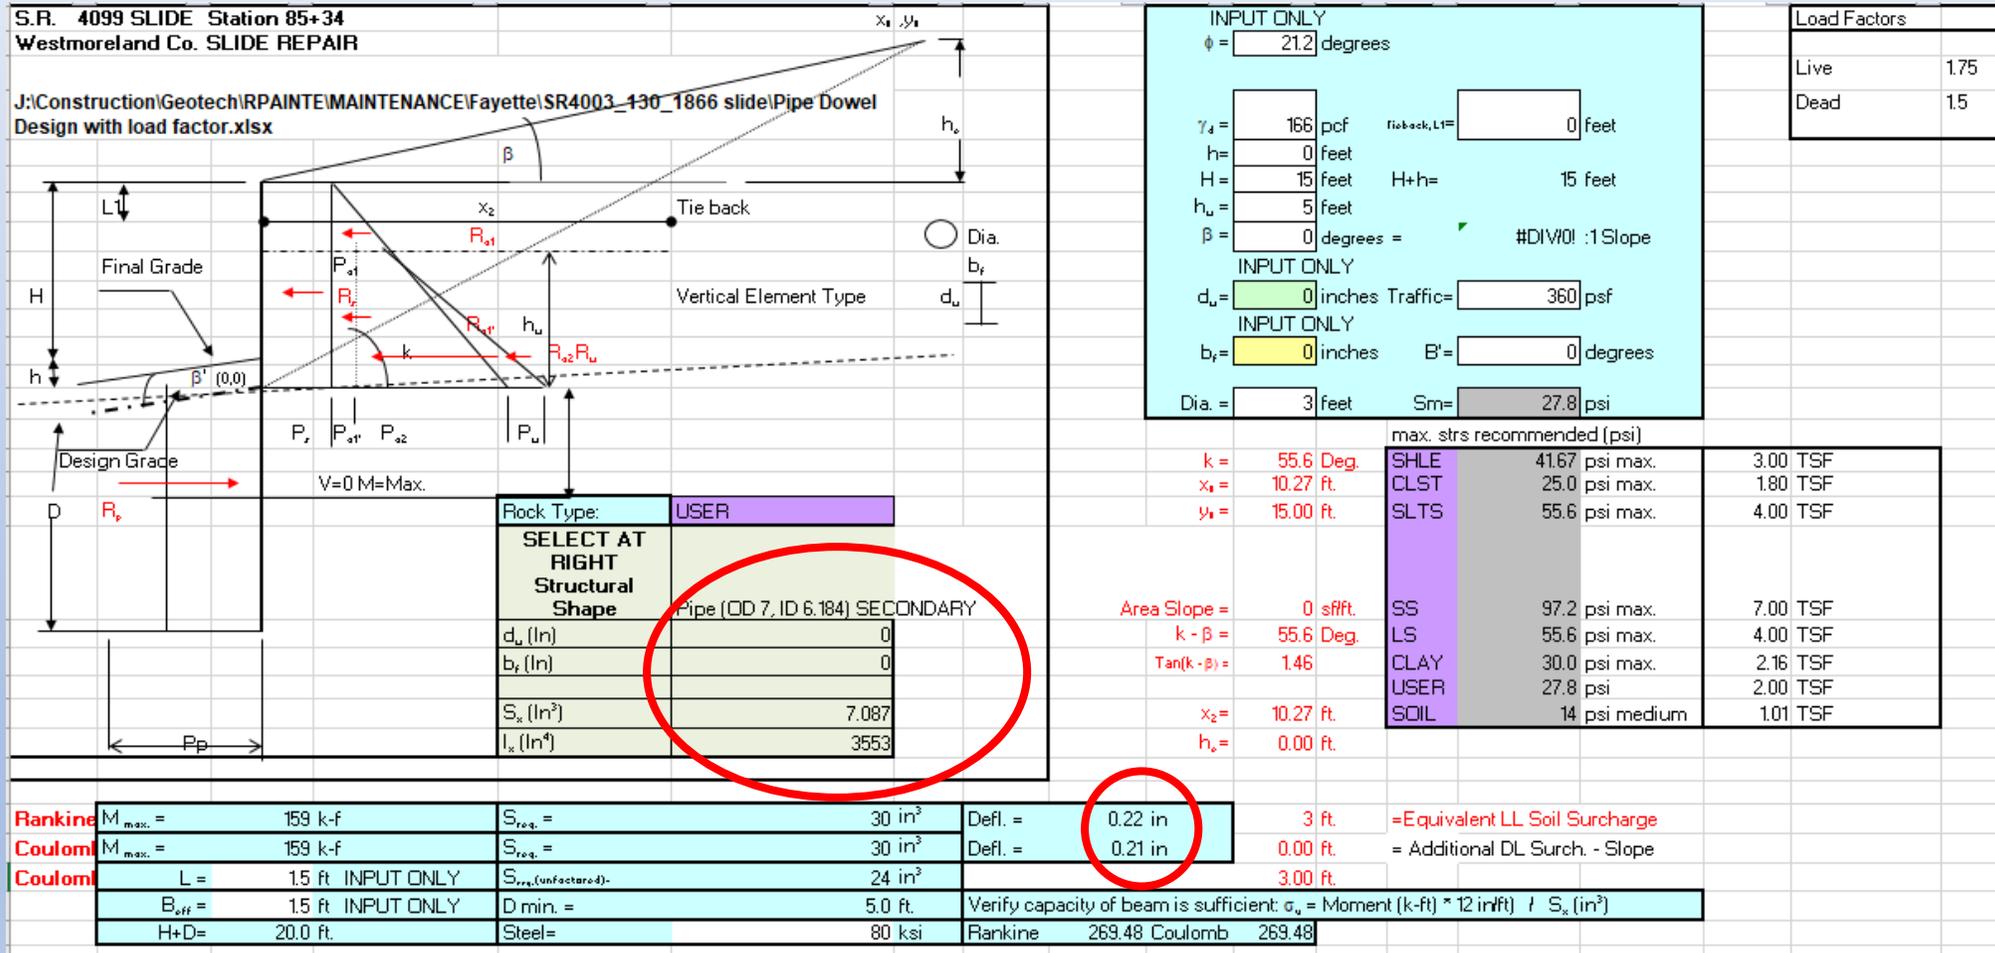
Tops of Pipes connected: 0.20" deflection

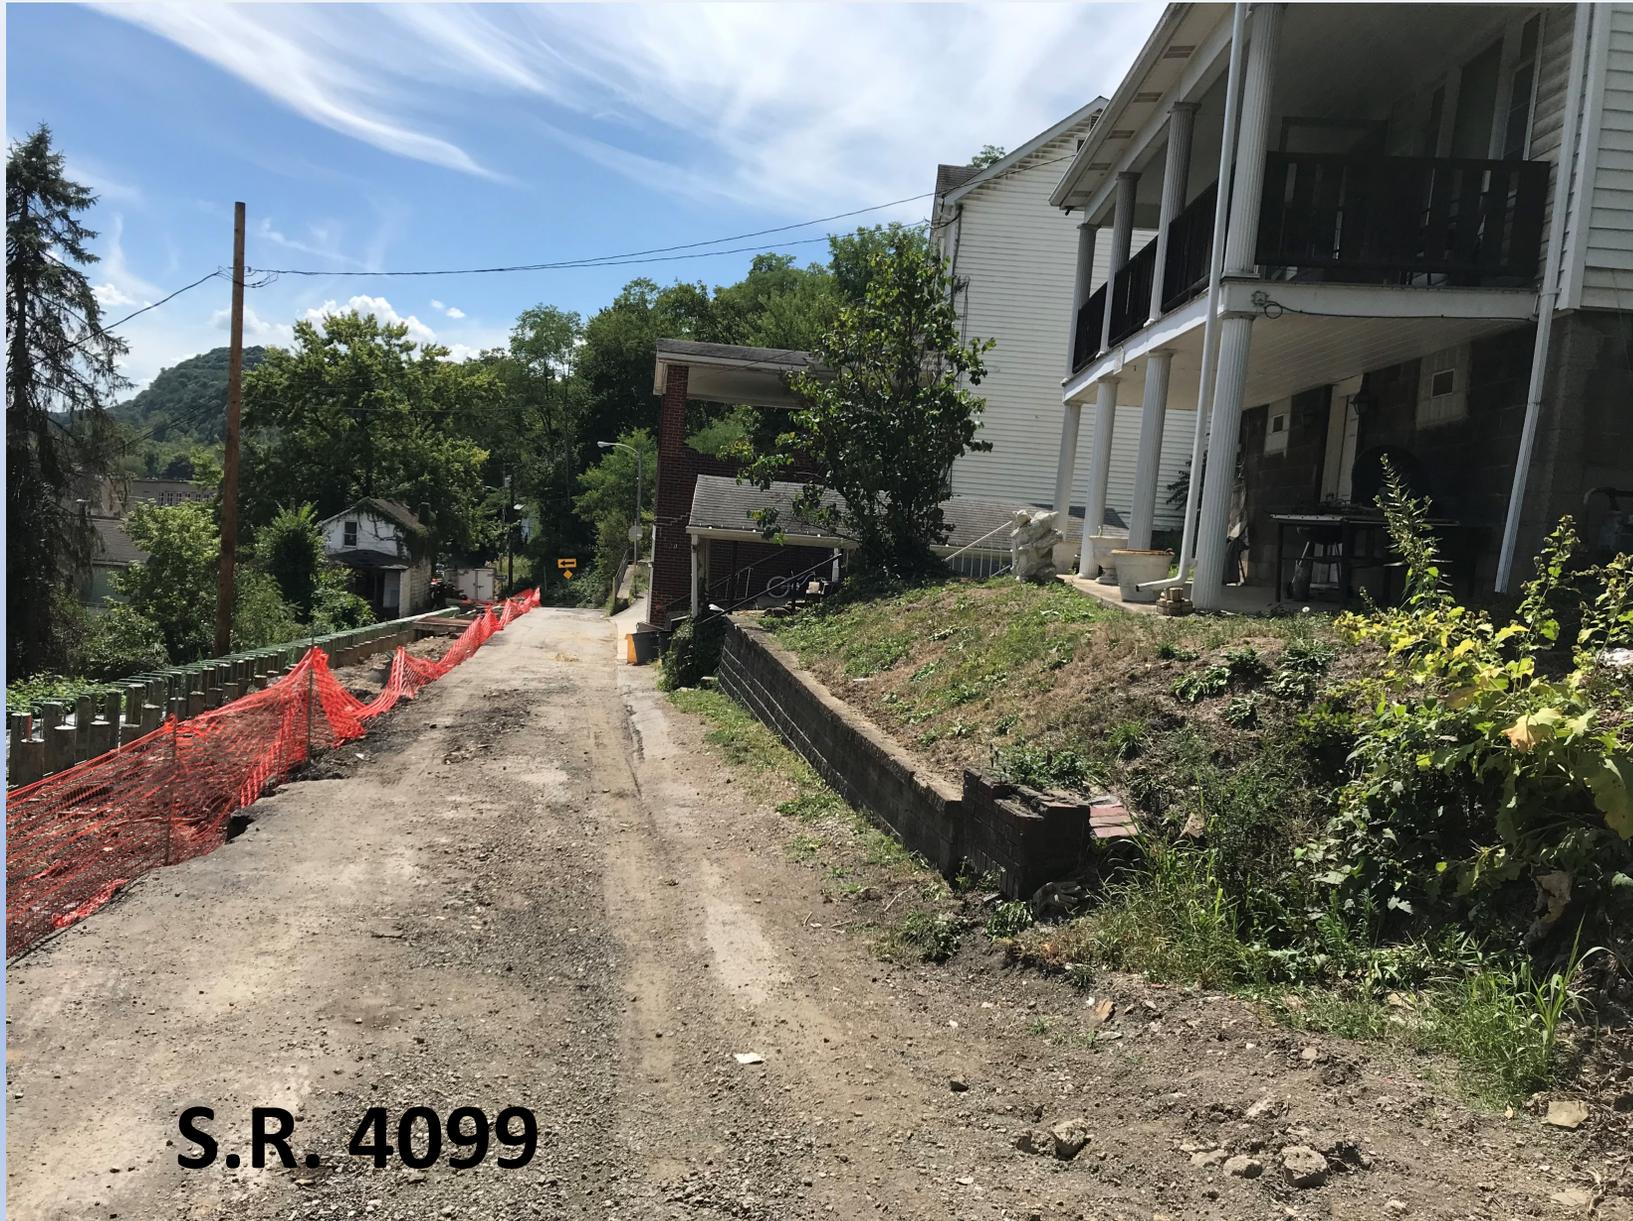
Photo of northern most remaining house along this corridor.

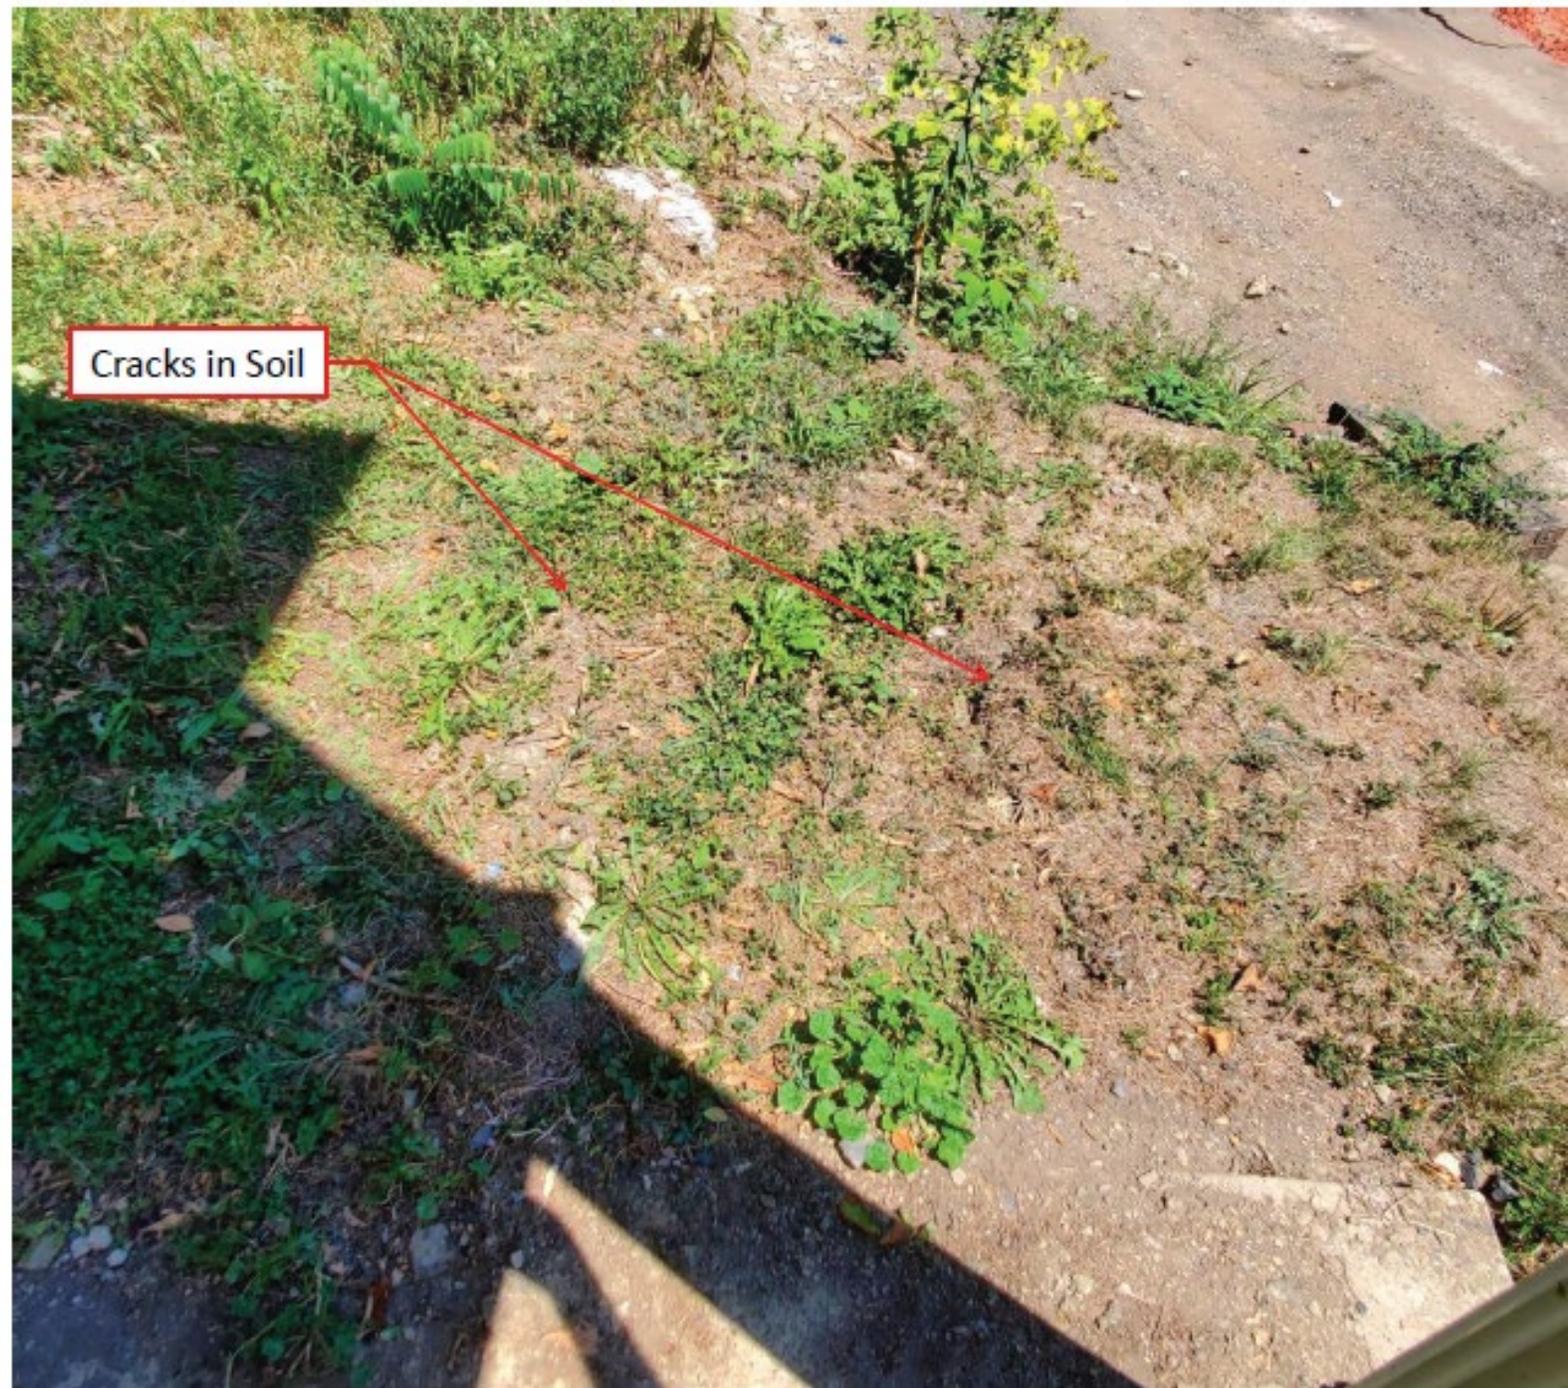
Cracks in soil occurring during construction in the front yard of the northern most remaining house.
