# Improved Performance of JPCP Through a Better Awareness of Plastic Shrinkage and Drying Shrinkage

#### Transportation Forum

Julie M. Vandenbossche, P.E., Ph.D. and Nicole Dufalla University of Pittsburgh

### National Calibration of PCC Performance Models in AASHTO ME Pavement Design

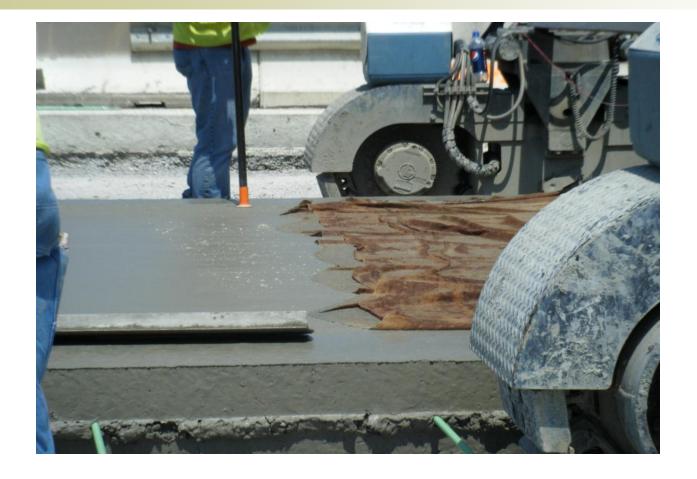
### Wet burlap drag micro texture

Excess surface water added

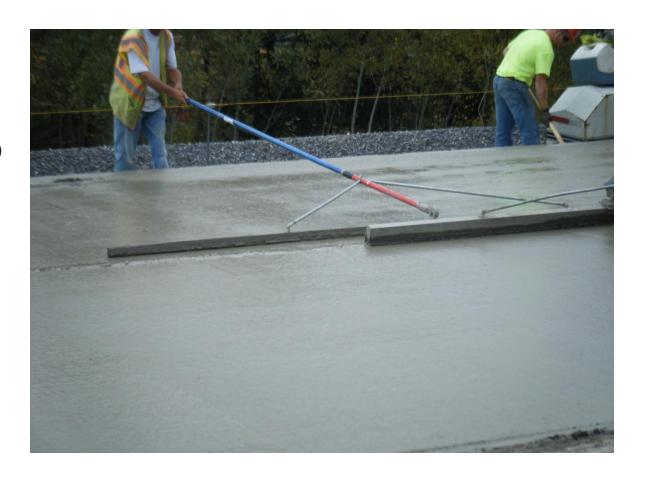
- Excess surface water worked into surface
- Micro texture removed by finishers

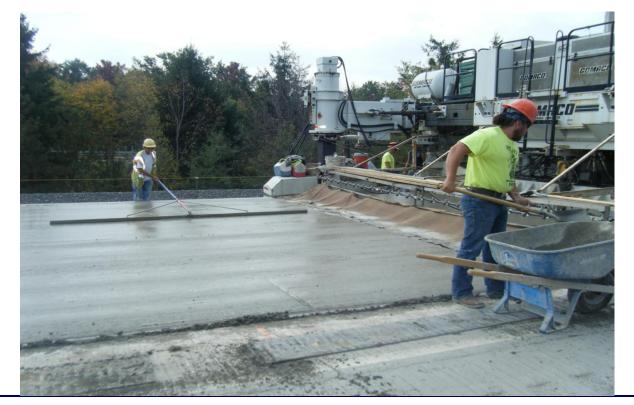
#### Excess surface water

Increases surface w/cm

Decreases durability of wearing surface Plastic shrinkage cracking

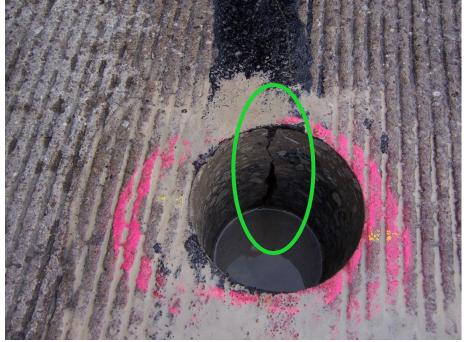
I-80 in Clinton County, PA

# Full depth cracking

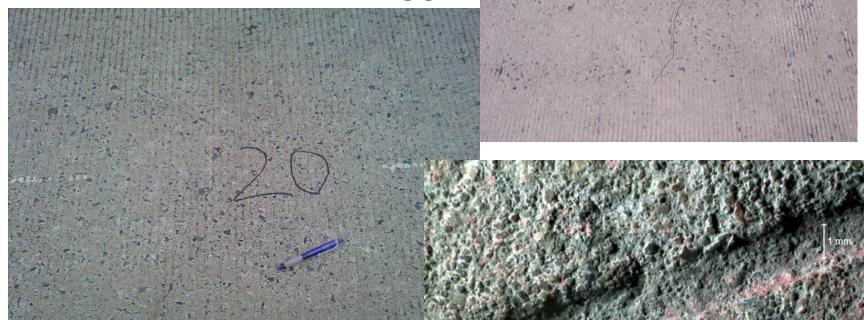
Vanport Limestone

# Polishing/erosion

**SR-22**

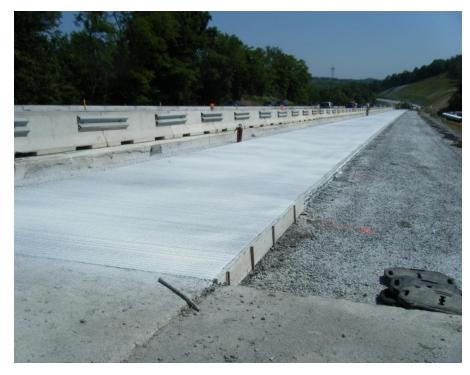
Application with hand wand

#### **Nonuniform**

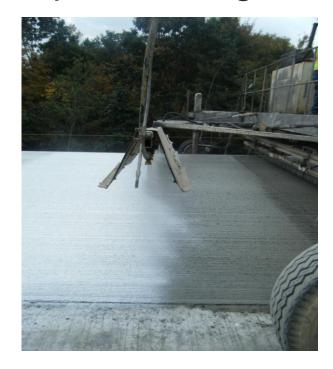
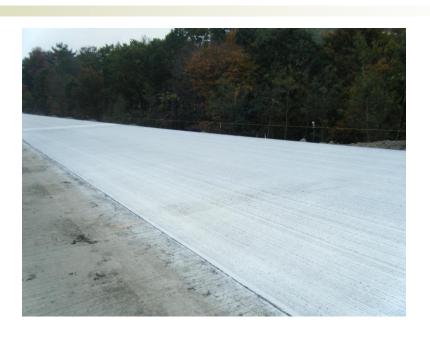
More uniform

PennDOT specification requires curing cart

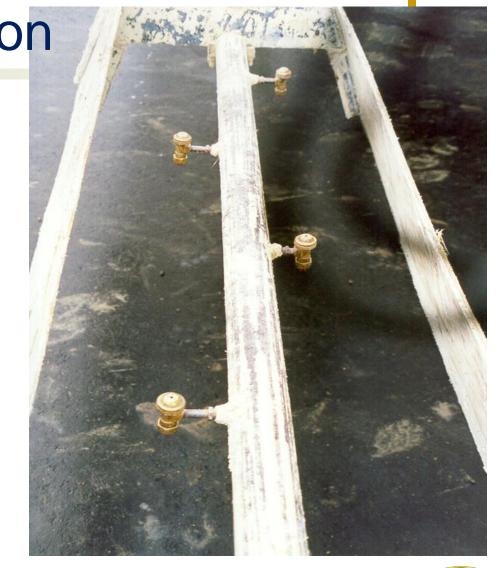
Nozzles must direct cure from 2 different lateral directions

or....

2 sets of nozzles along 2 traverse lines, each line capable of complete coverage

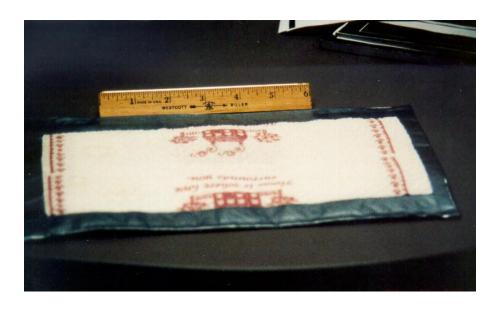
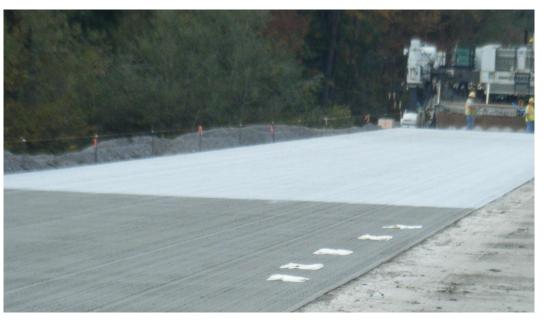
Measured: 220 sq ft/gallon

PA spec.: 150 sq ft/ gallon

Manufacturer's recommendations: 200 sq ft/ gallon

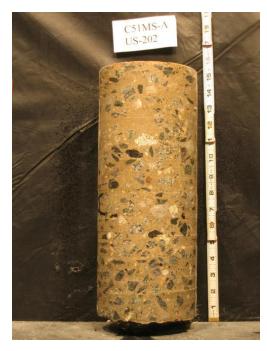
# Segregation

Observed frequently for WO12
