# Improving Bridge Assessment through integration on Visual Inspection and Non-destruction Evaluation Data

CENTER FOR IMPACTFUL RESILIENT  
INFRASTRUCTURE SCIENCE & ENGINEERING

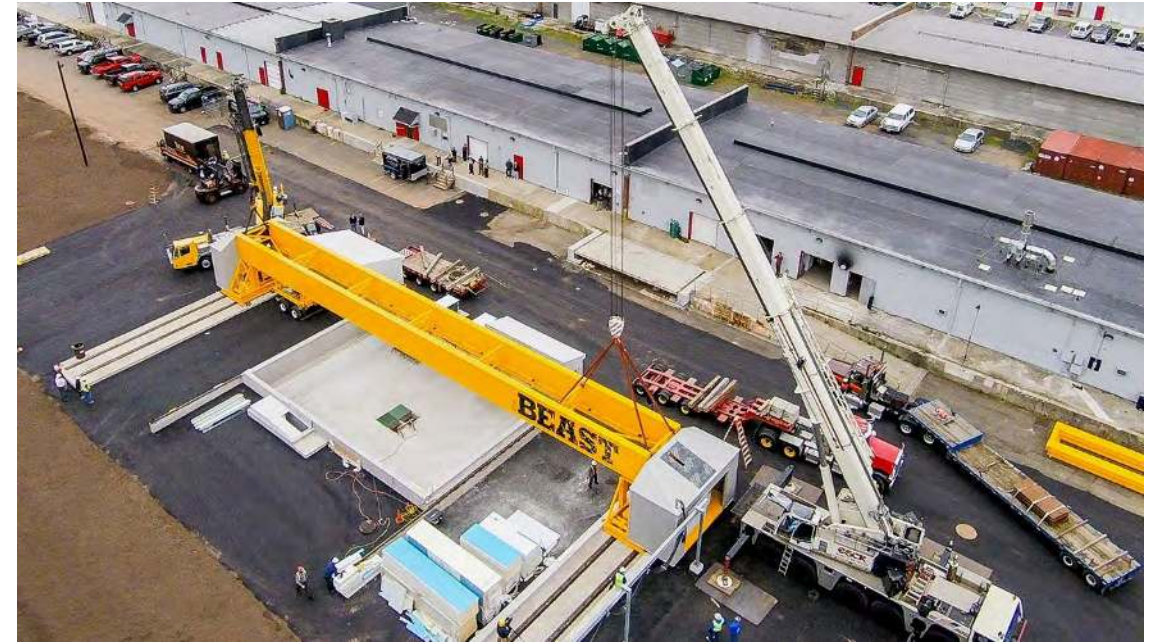
## Bridge Evaluation and Accelerated Structural Testing Lab (BEAST):

- Full-scale Bridge Systems
  - Accelerated Deterioration
  - Speed up 30 times
- NDE Data Collected from the BEAST:
- Electrical Resistance (ER)
  - Ultrasonic Surface Wave (USW)
  - Ground Penetrating Radar (GPR)
  - Half Cell Potential (HCP)

- UAV Data Collected from the BEAST:
- HD Images (UAV/Hand-held)
  - Infrared Images (UAV/Hand-held)

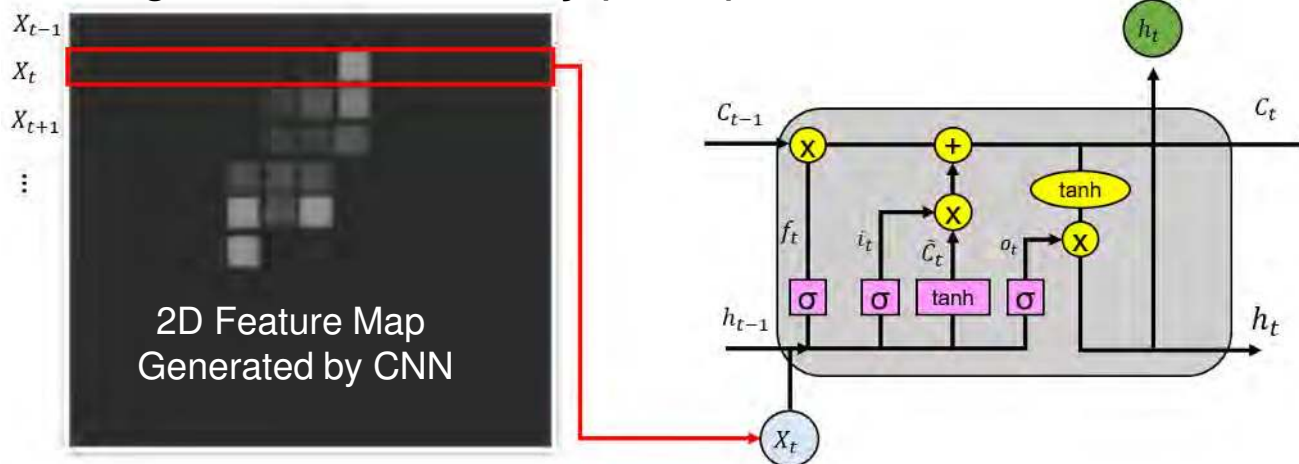
### Long Short-Term Memory (LSTM)

Higher-Level Feature Fusion

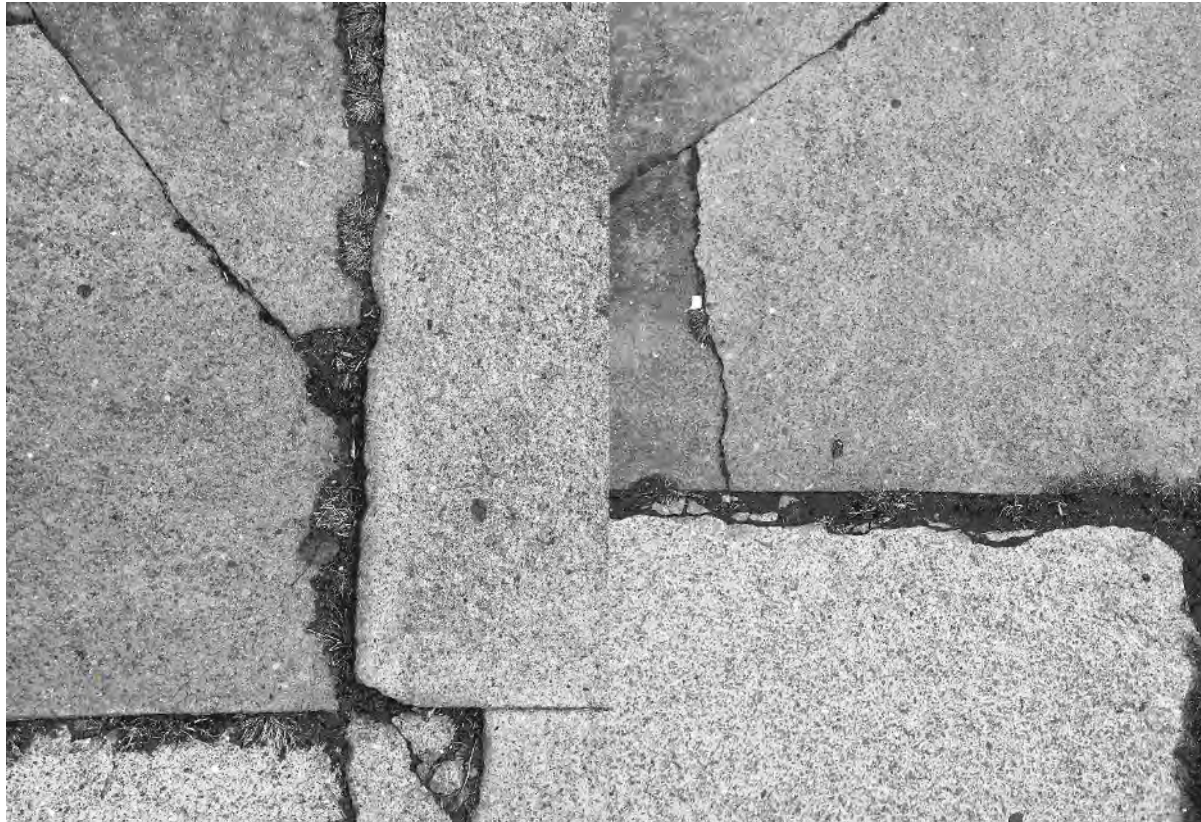
## Input

## Output

Crack — Crack Region

Spalling Region

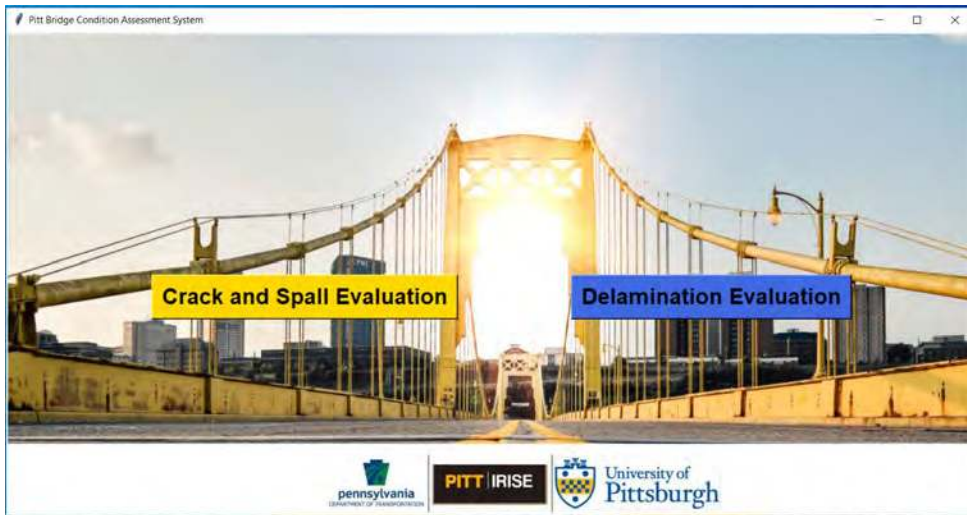
## Tool Development for Vision-based Evaluation

An **easy-to-use tool** is developed based on the presented methodologies for **surface and subsurface damage evaluation**

Defect detection speed is less than 3 sec/ft<sup>2</sup> of the deck

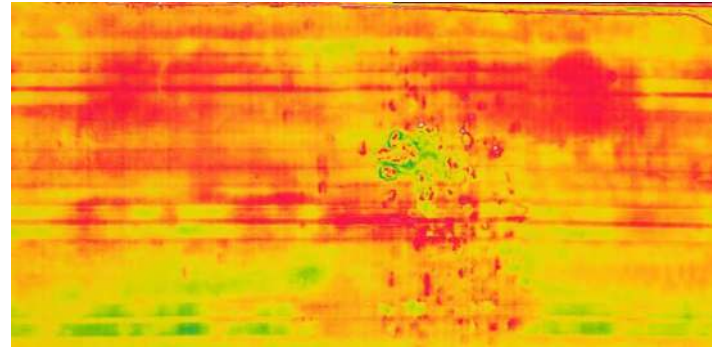
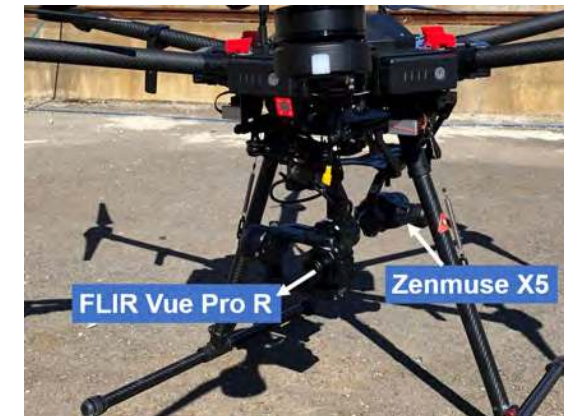
## Implementation and Validation on BEAST

Input

Output

Surface Defects

Potential  
Subsurface Defects

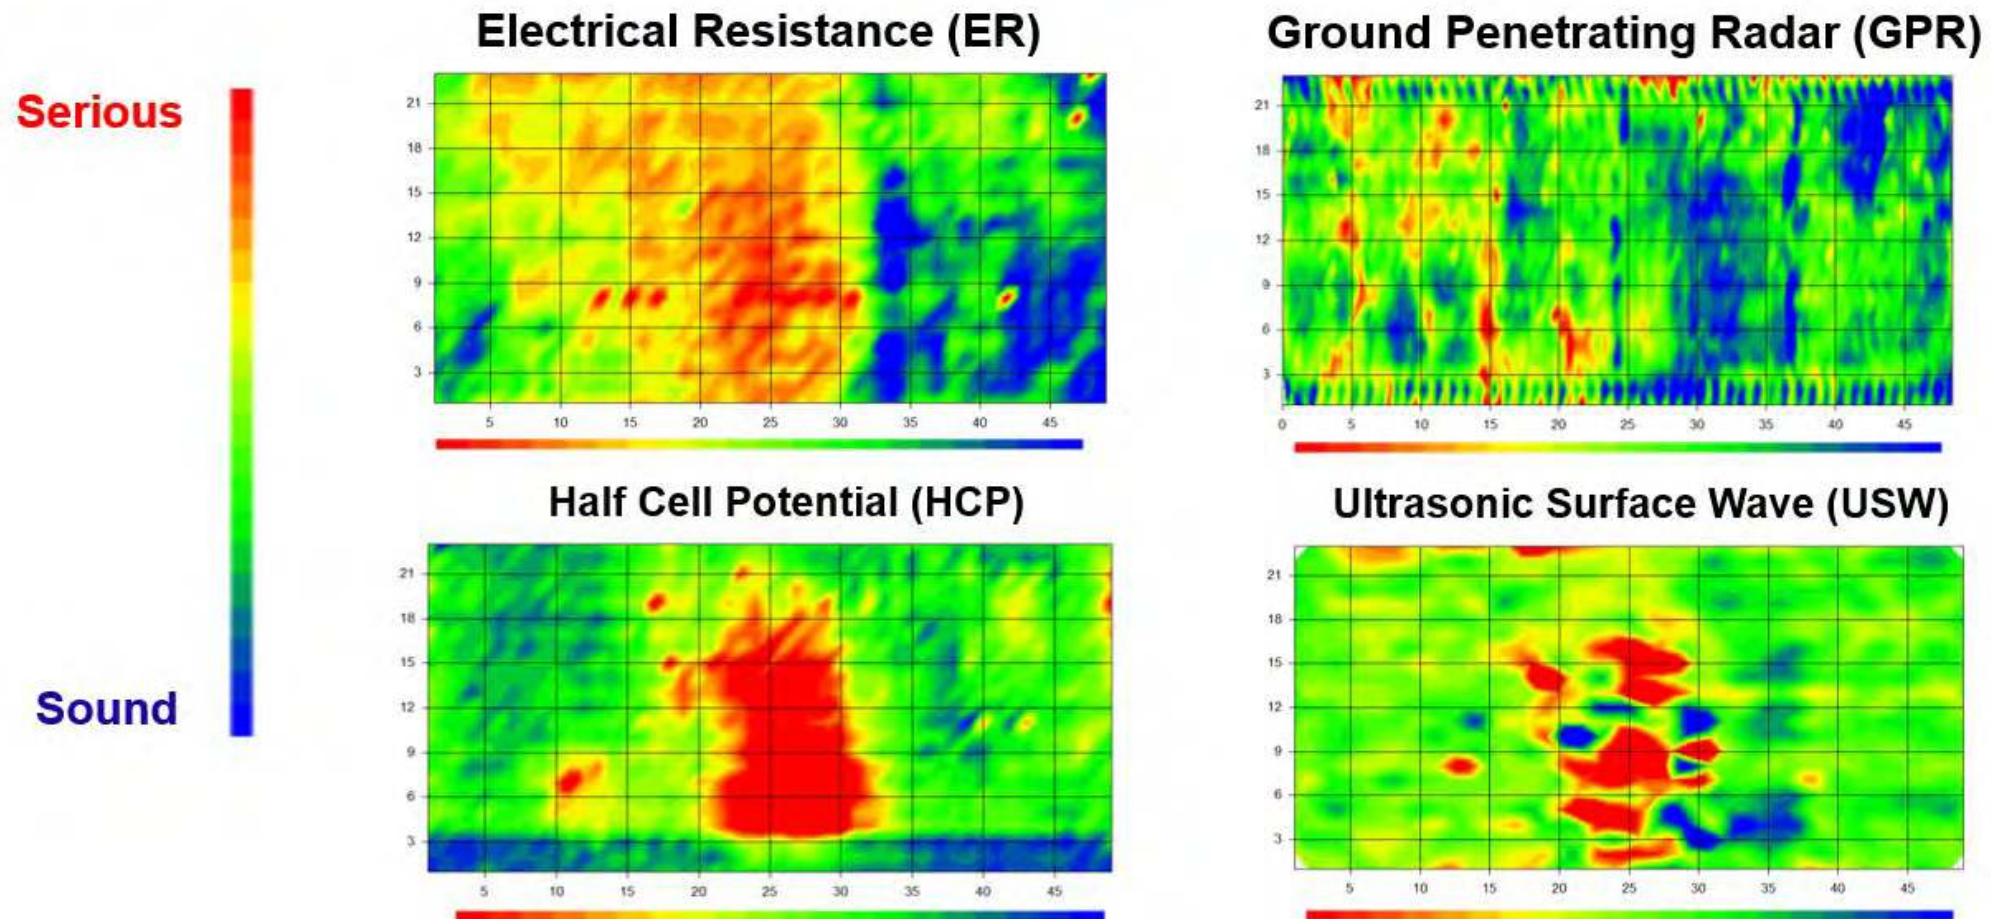
## Statistical Analysis for Individual NDE Data

Condition maps (April 2021)

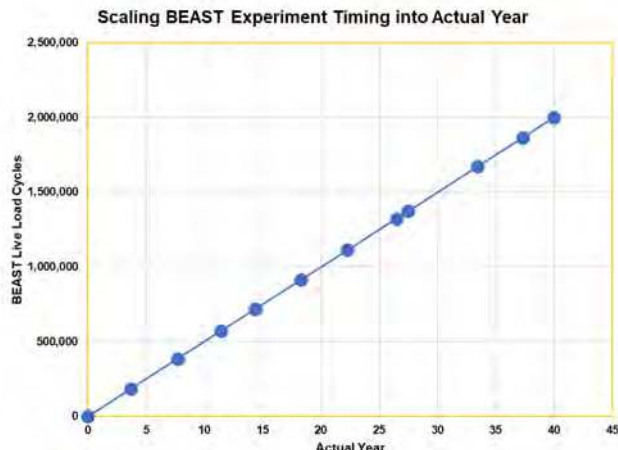
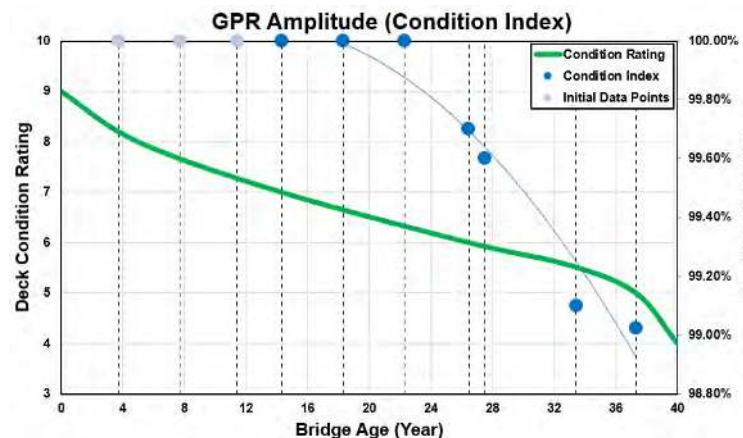
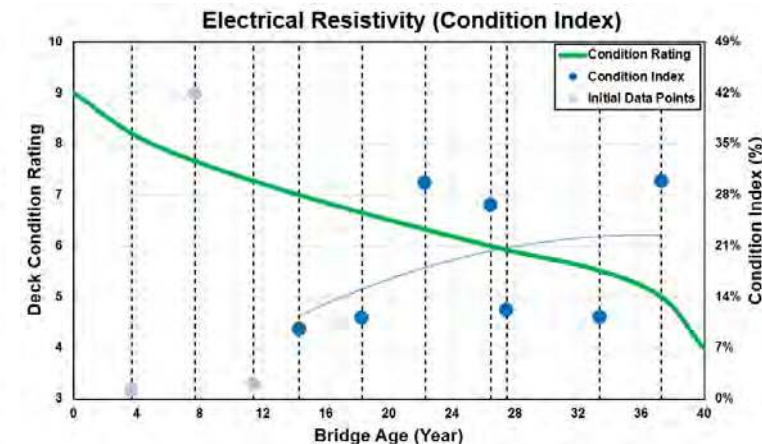
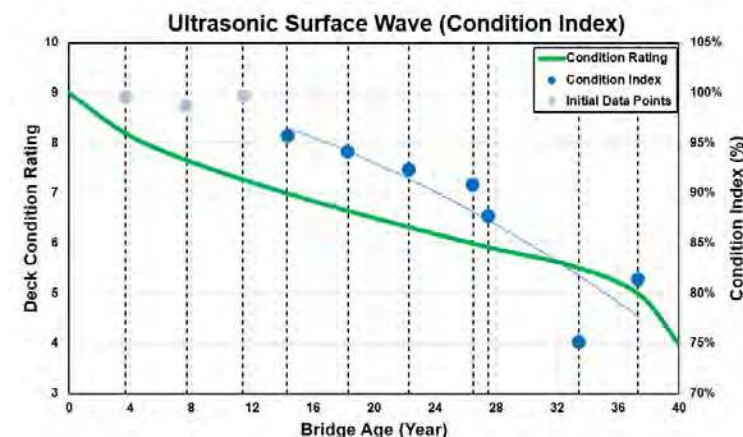
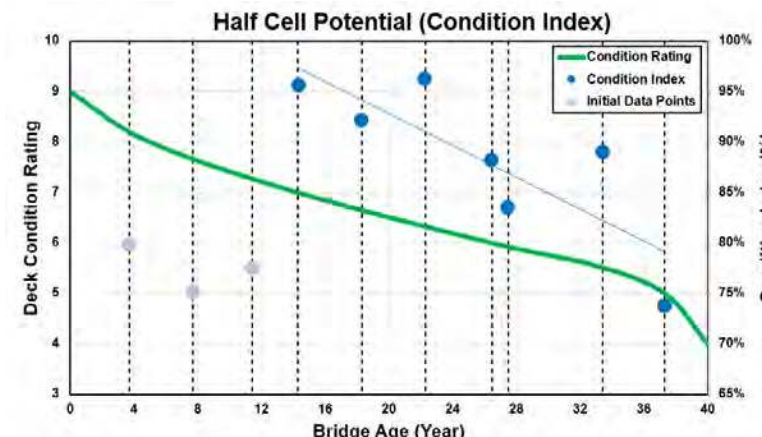
## Comparison Between Individual NDE Results and Fused Results

Conversion of BEAST live-load cycles into actual years

Individual NDE result does **NOT** match the trend well

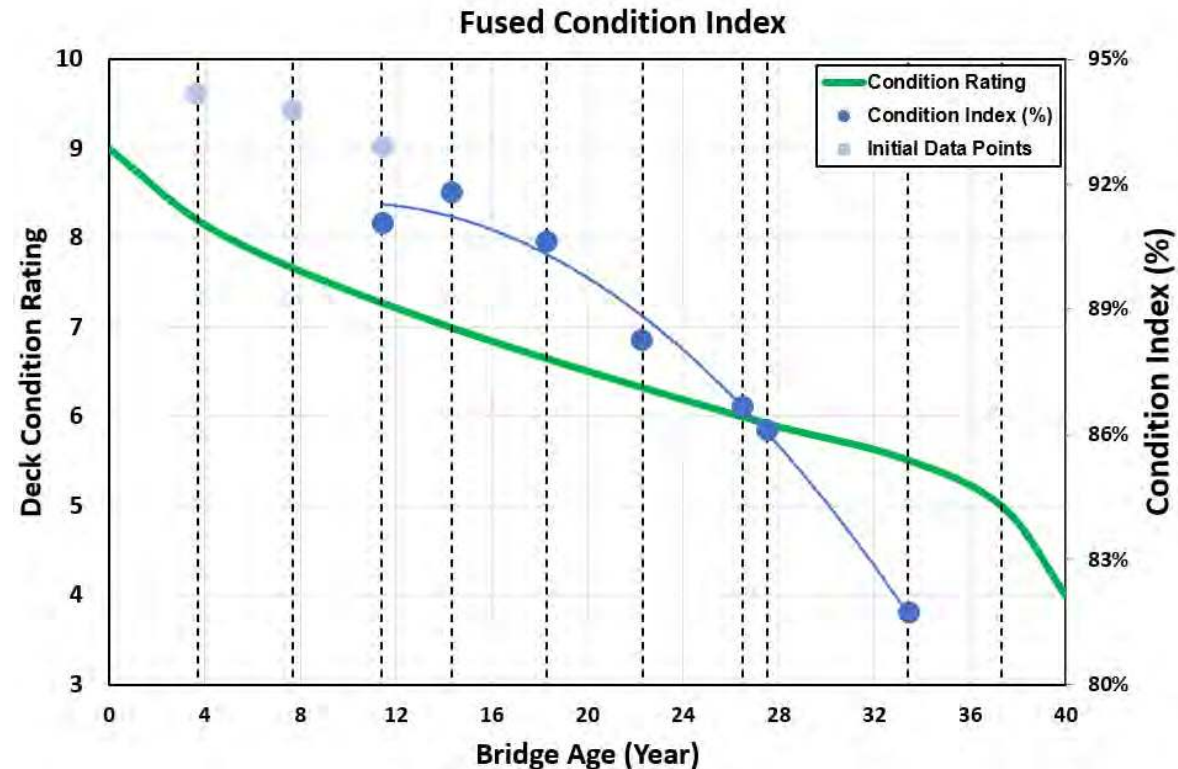
## Comparison Between Individual NDE Results and Fused Results

Individual NDE result does **match** the trend well

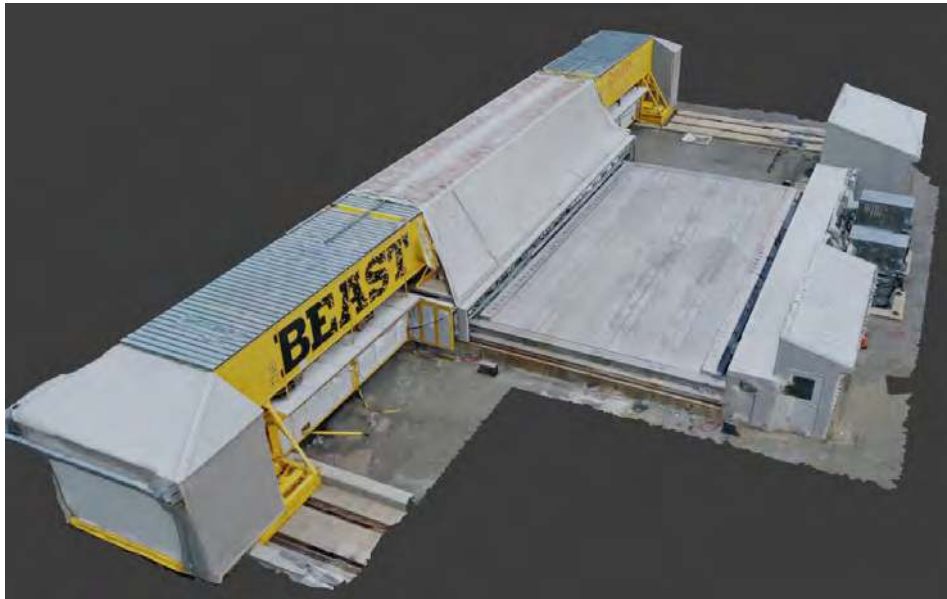
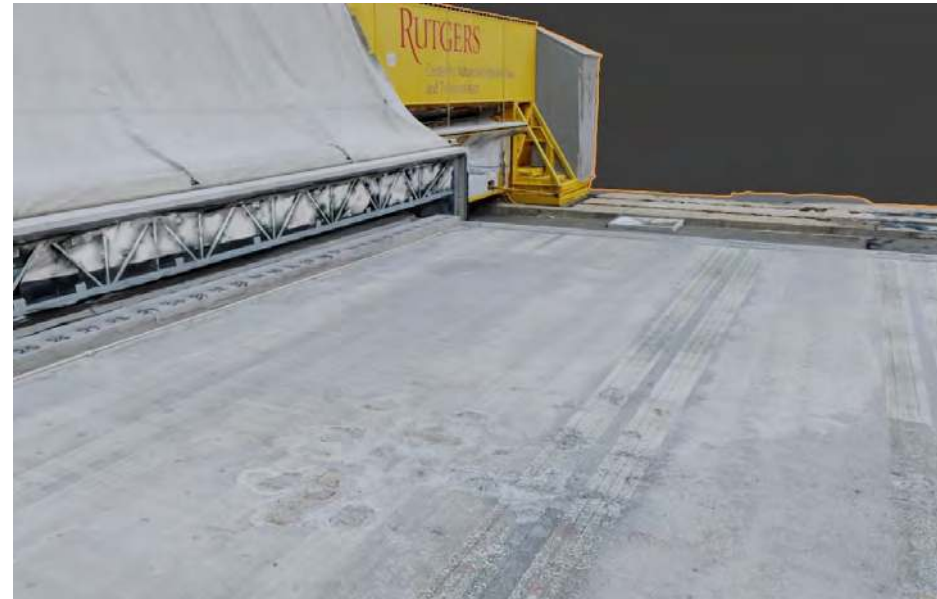
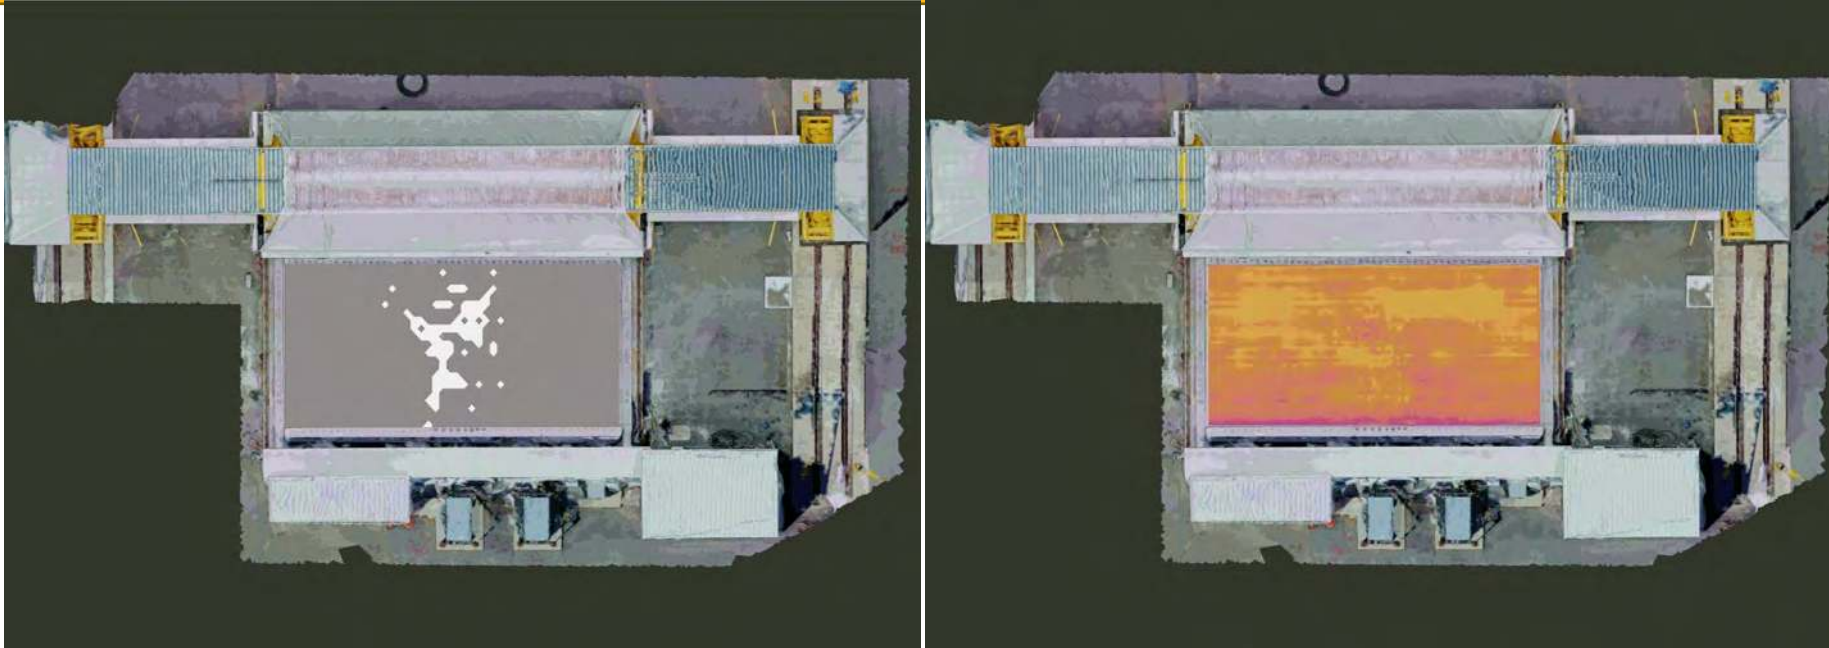
☐ To achieve better visualization, a 3D model of the BEAST has been developed as follows:

- ❑ Application:
  - ❑ Virtual bridge inspection
  - ❑ Bridge inspection training
  - ❑ Better post data interpretation and visualization
