Route 30 Emergency Landslide Repair, Use of Technology to Expedite Action

Brian F. Heinzl, P.E.

Geotechnical Project Manager, Gannett Fleming, Inc.

PennDOT District 11-0 and Golden Triangle Construction

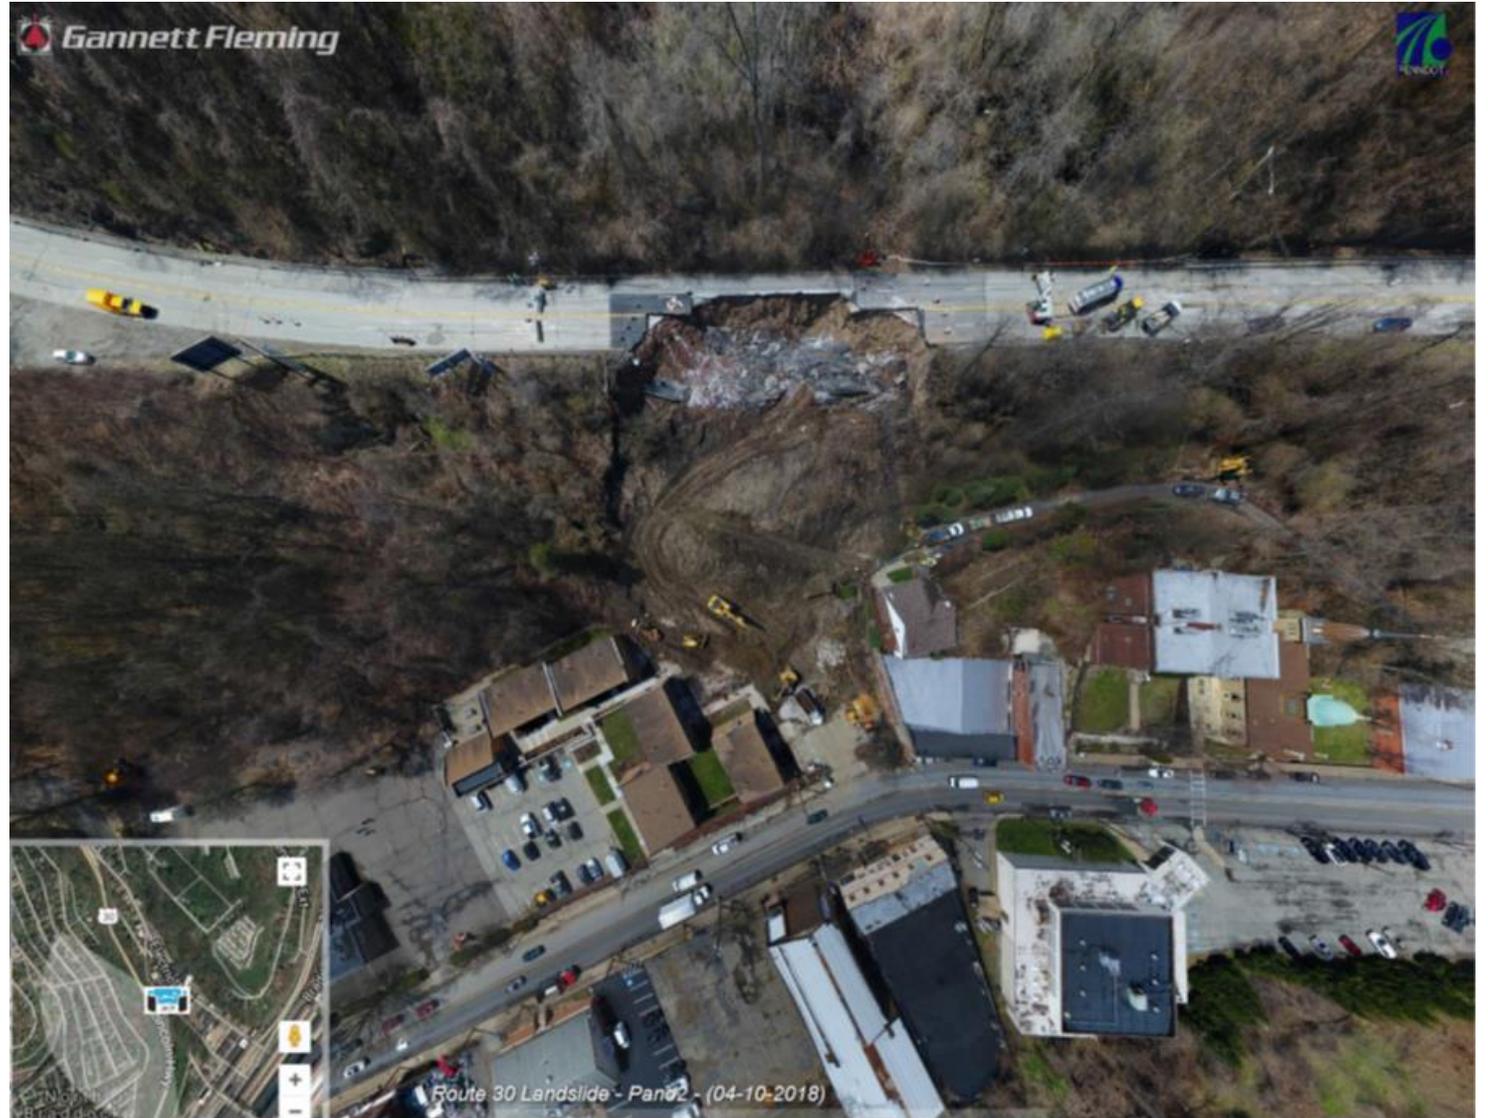
- April 4th – PennDOT and GF were investigating a progressing roadway displacement 'subsidence' feature.
- April 6th – identify retaining wall movement on slope between the roadway and community below – evacuate residents immediately
- April 6th - Close Route 30 and prepare to excavate material above wall
- April 7th – Major Landslide Occurs;

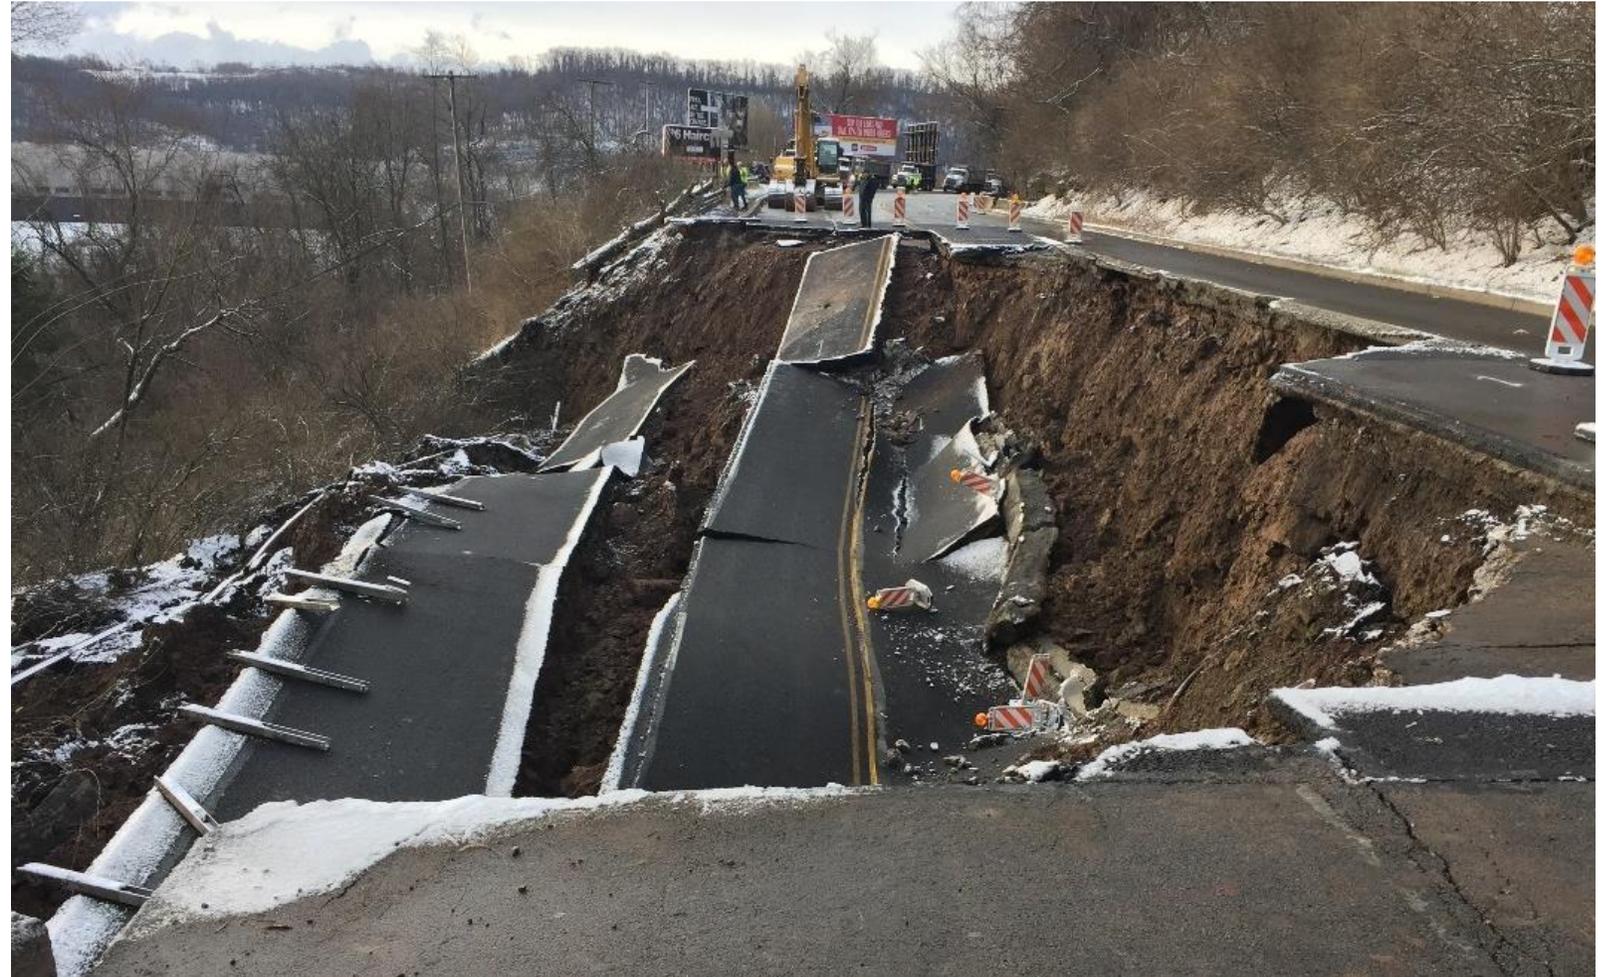
- 35,000 CY of material displaced down a 90 FT high slope over a length of 300 feet
- Directly impacting 2 Apartment Buildings and one residential home.
- A total of 34 residents were displaced, 10 permanently.

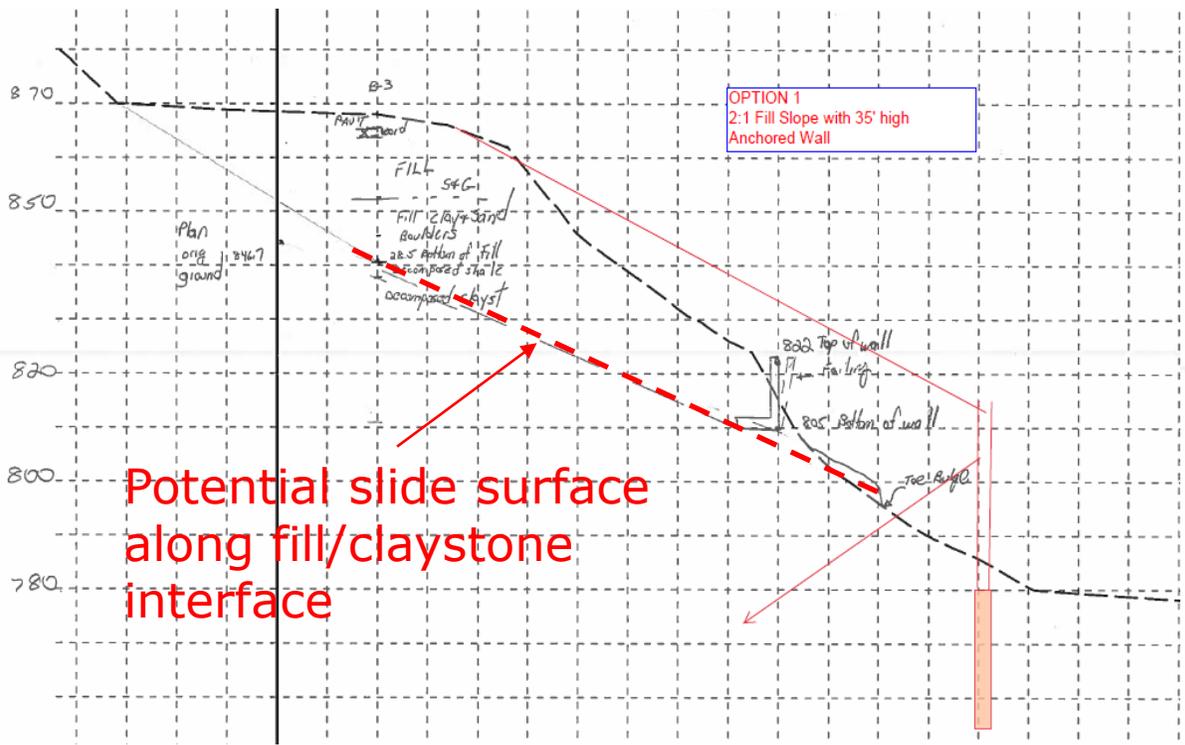
April 6th –Conceptual Option 1

LiDAR Cross Sections

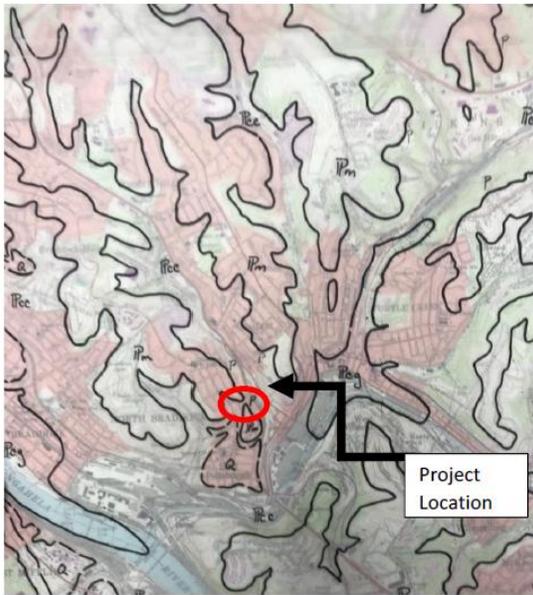
4.0 Approximate elevation of stratigraphic unit: (See Outcrop/Contacts Map in Geotech Unit)

Outcrop on the base/top of: Pittsburgh Coal

Project Location	Structure Contour Elevation	Surface Elevation	Elevation Difference	Stratigraphic Unit
Seg 230 Off 1700	1000'	870' Roadway	-130' Below	Morgantown Sandstone Massive
Seg 230 Off 1700	1000'	780' Toe	220' Below	Birmingham Sandstone and Shale

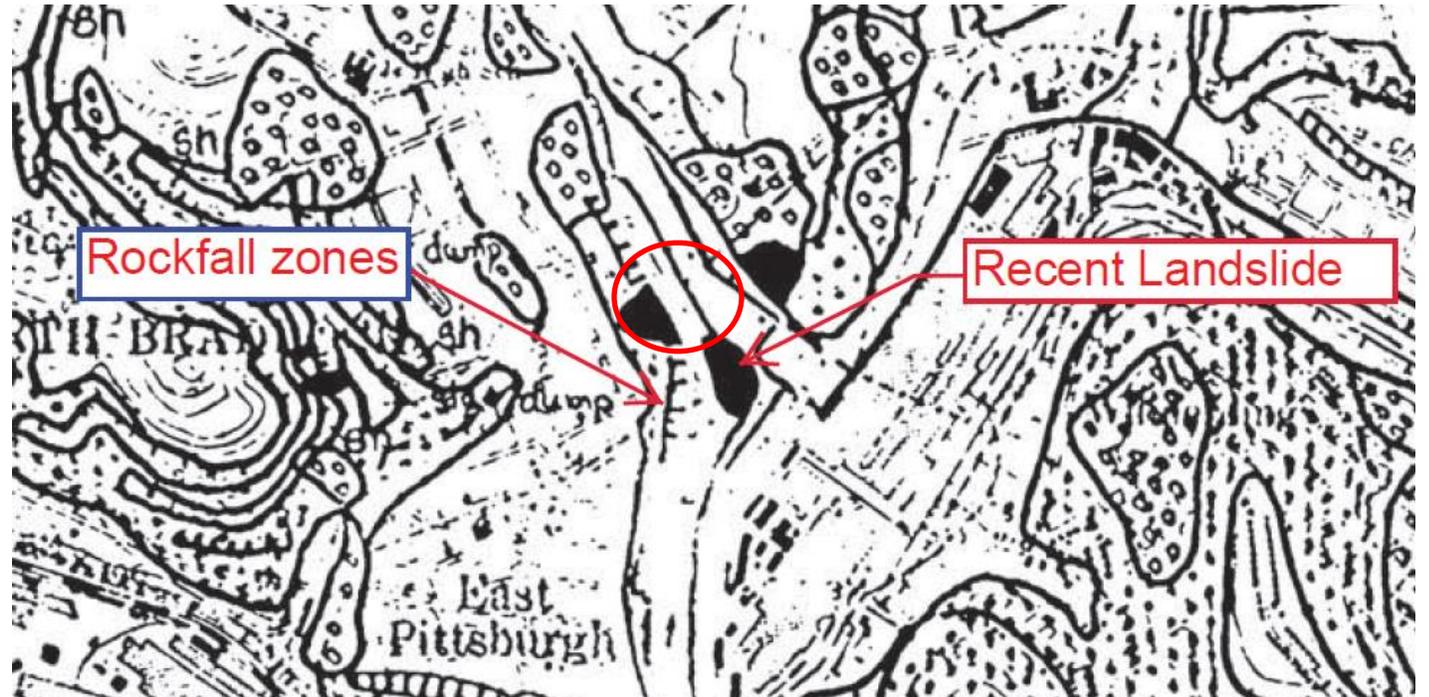
Geologic Contacts

Stratigraphic units

Landslide susceptibility

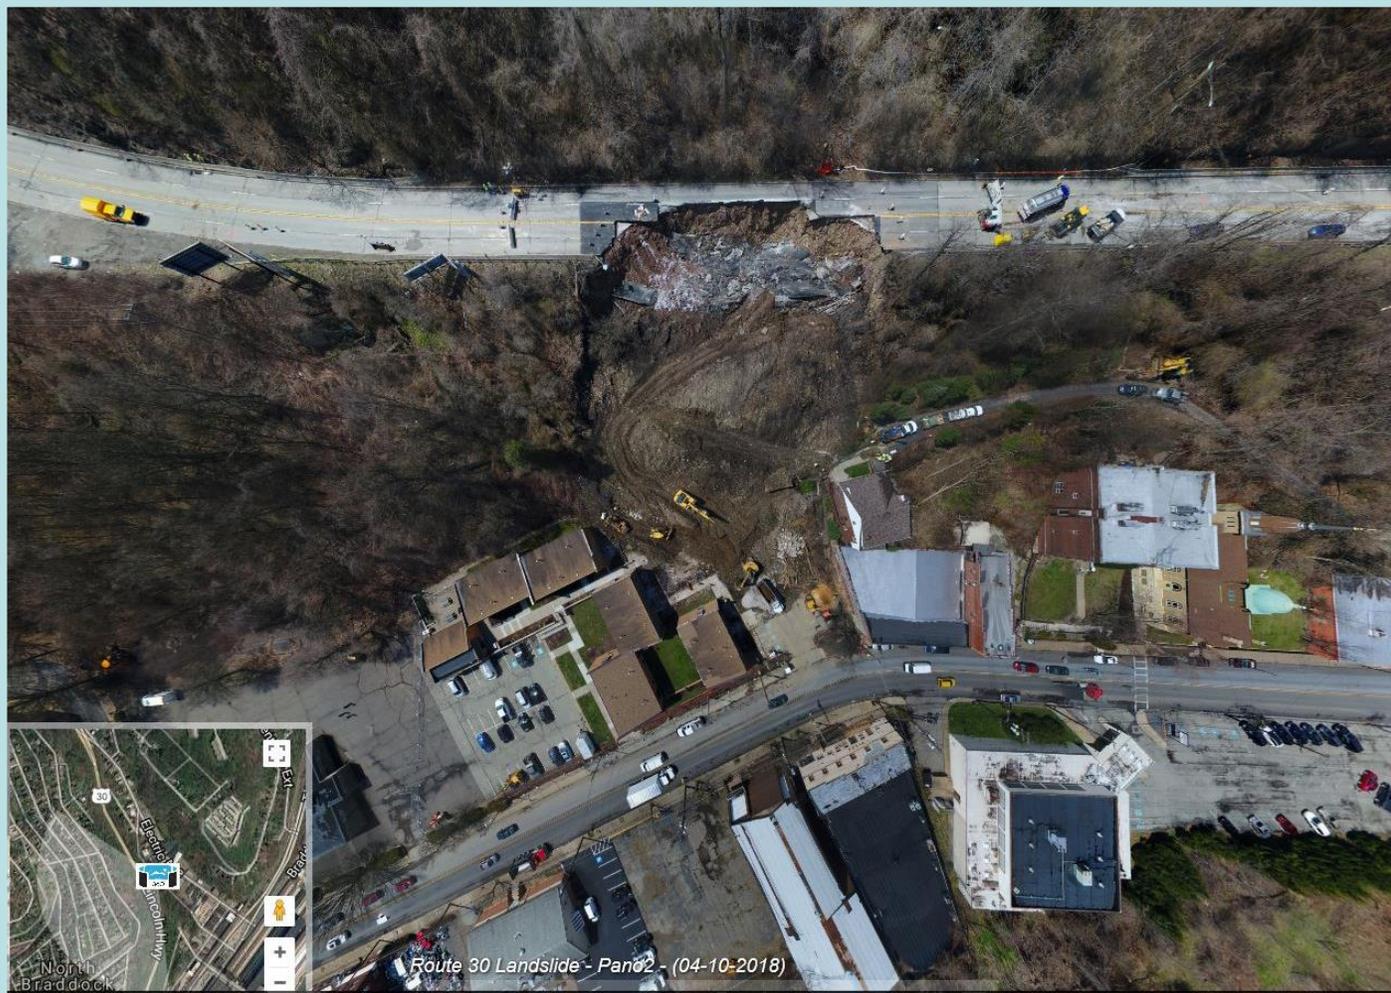
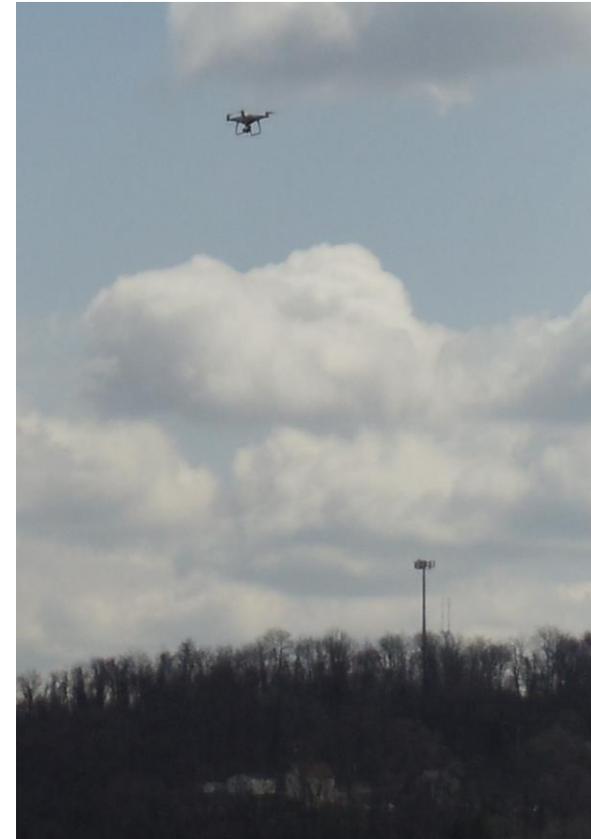
Within 3 days of the landslide, Gannett Fleming obtained an FAA approved flight plan and used an UAV (drone) to develop detailed mapping suitable for final design.

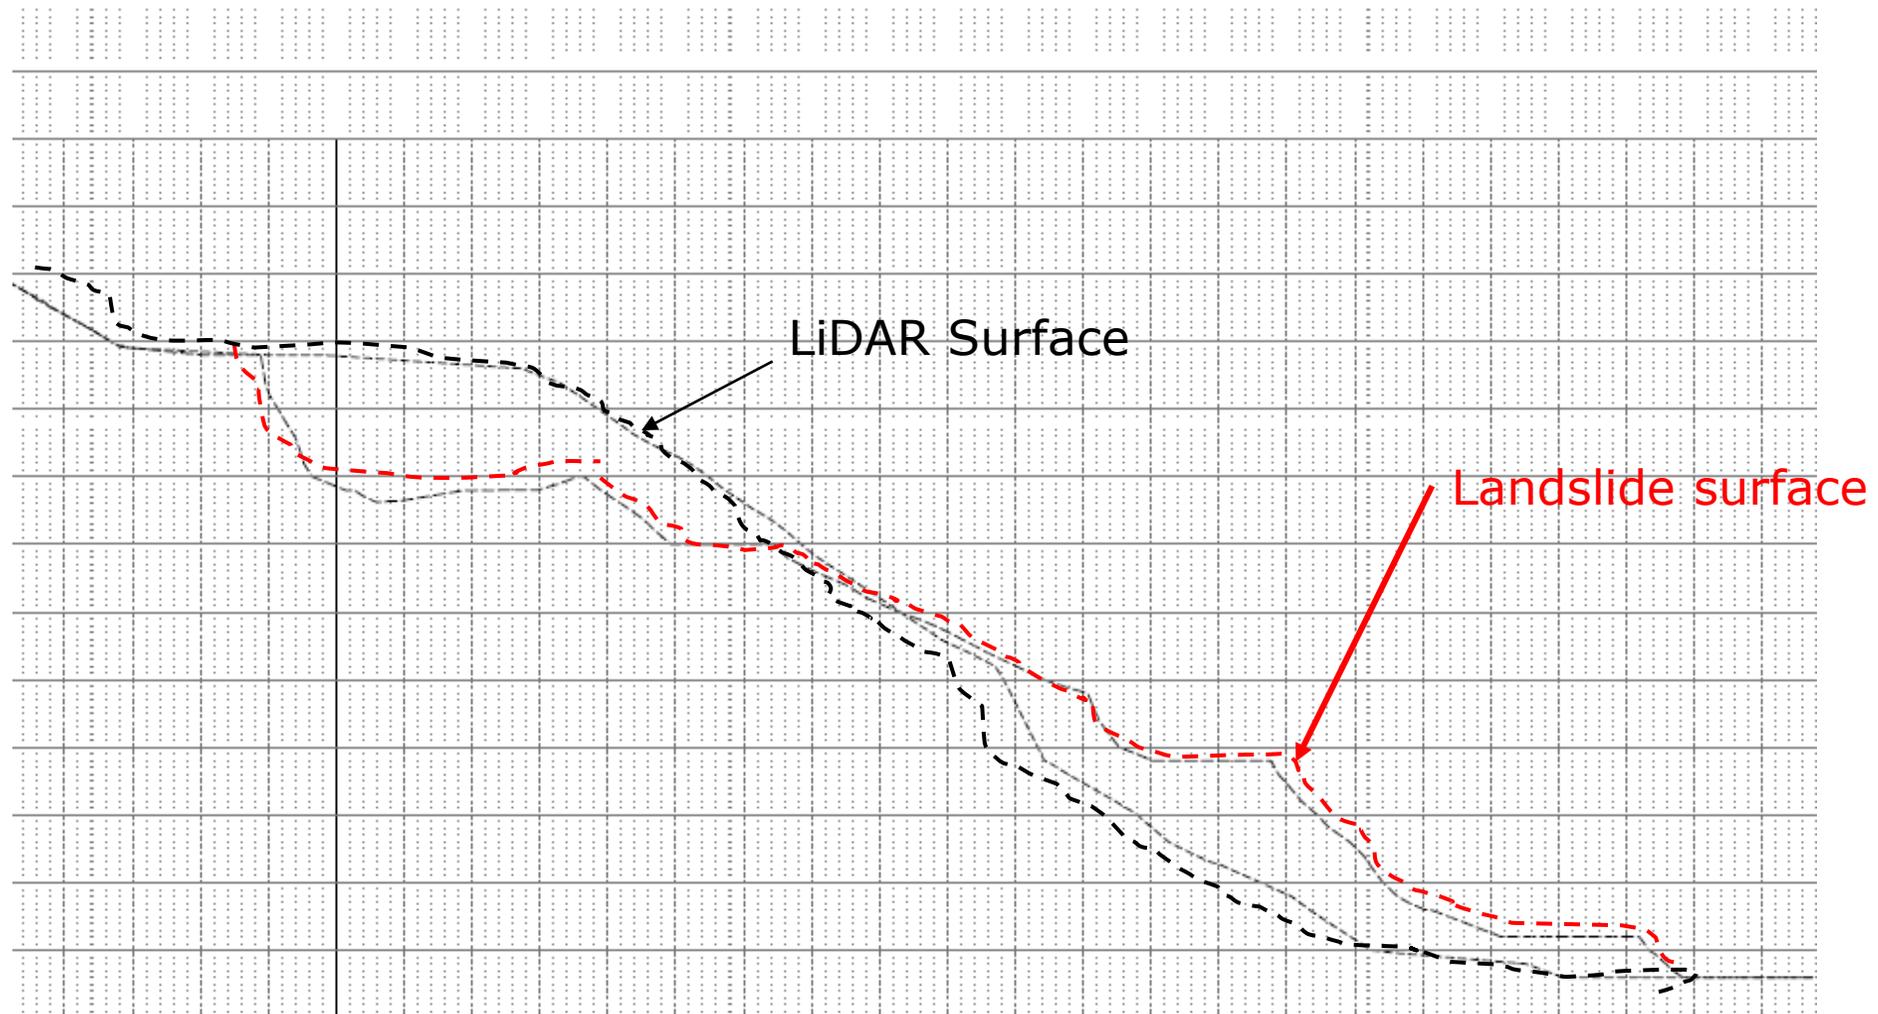
New Cross Sections vs 2006 LiDAR

April 11th - Updated Mapping comparison:

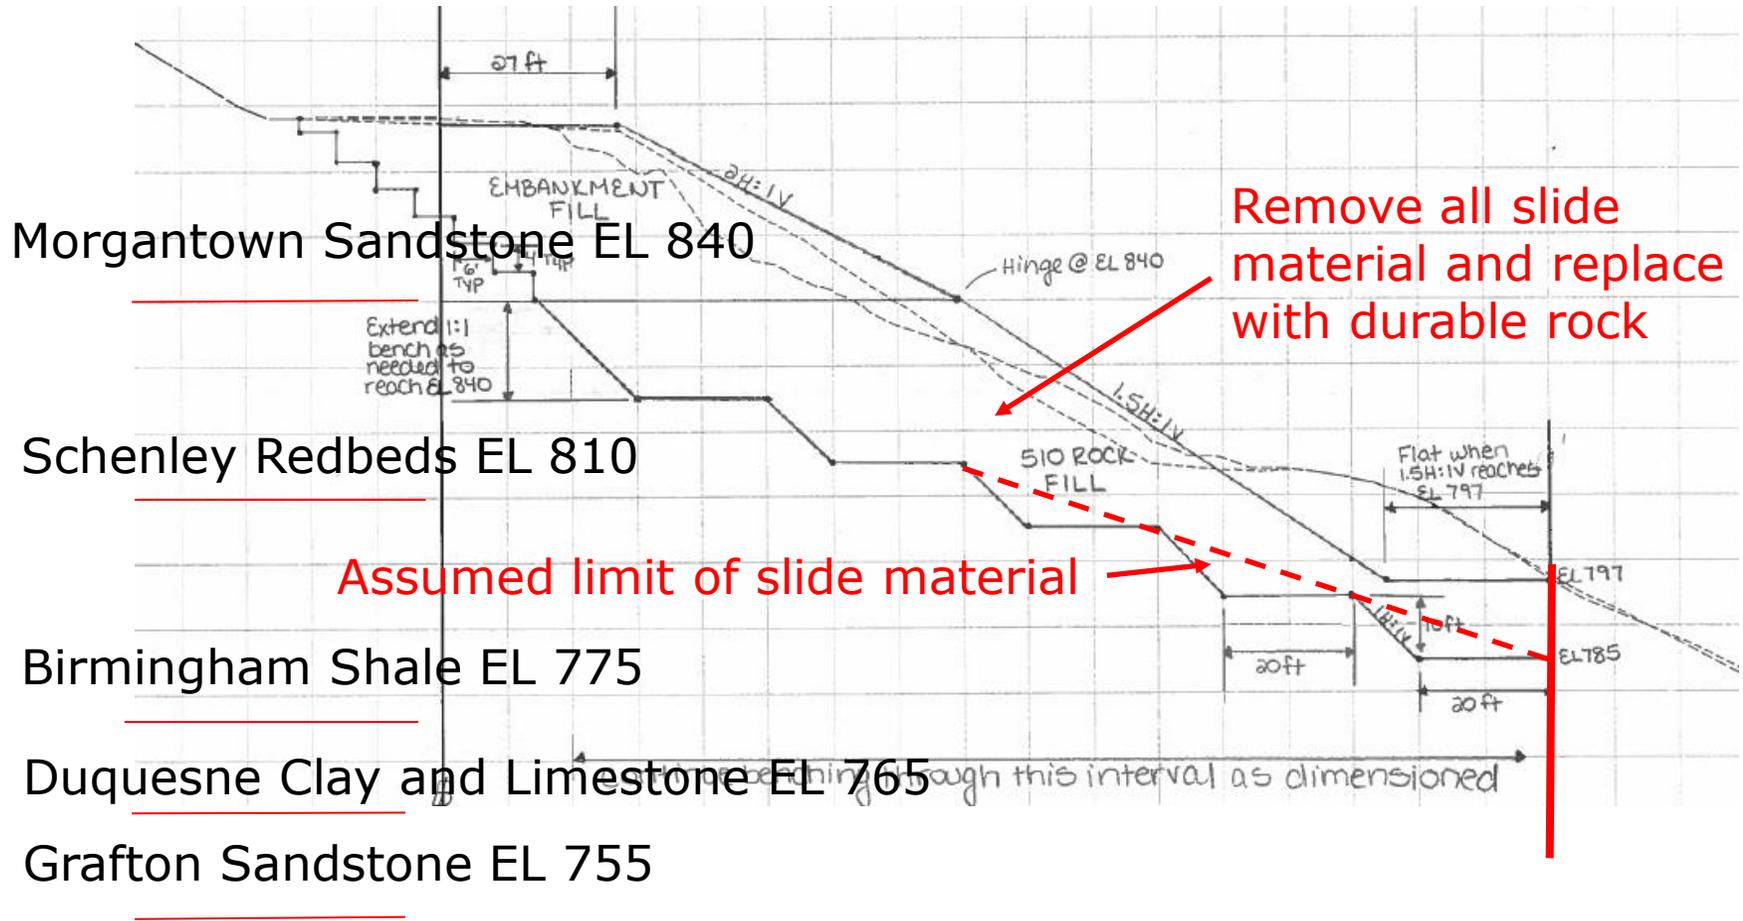
April 10th -12th : Stability Analysis

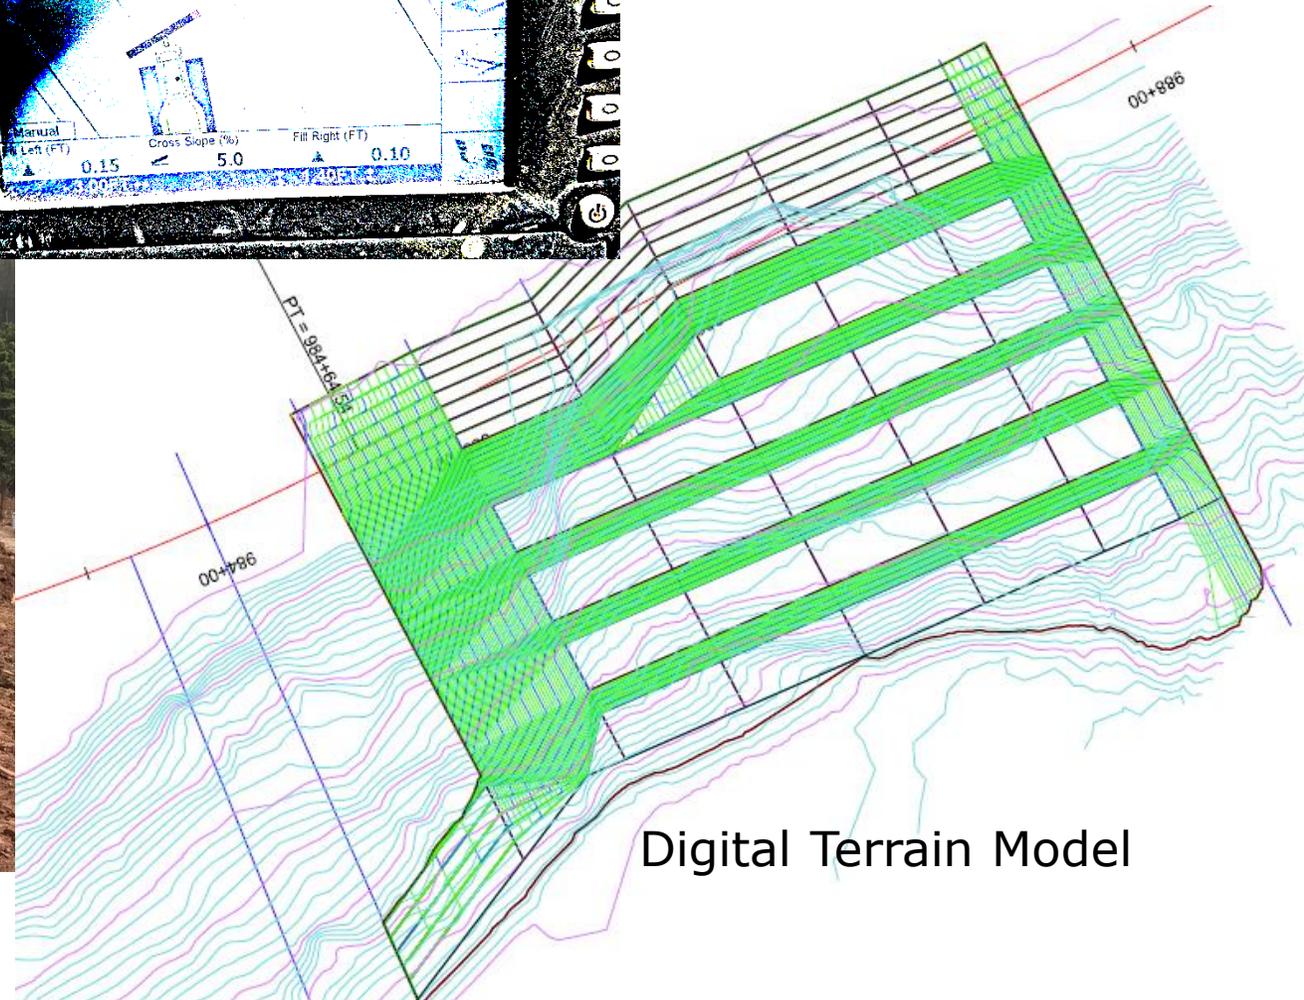
Machine Grading
Guidance System

Digital Terrain Model

- Real time checking of bench elevations

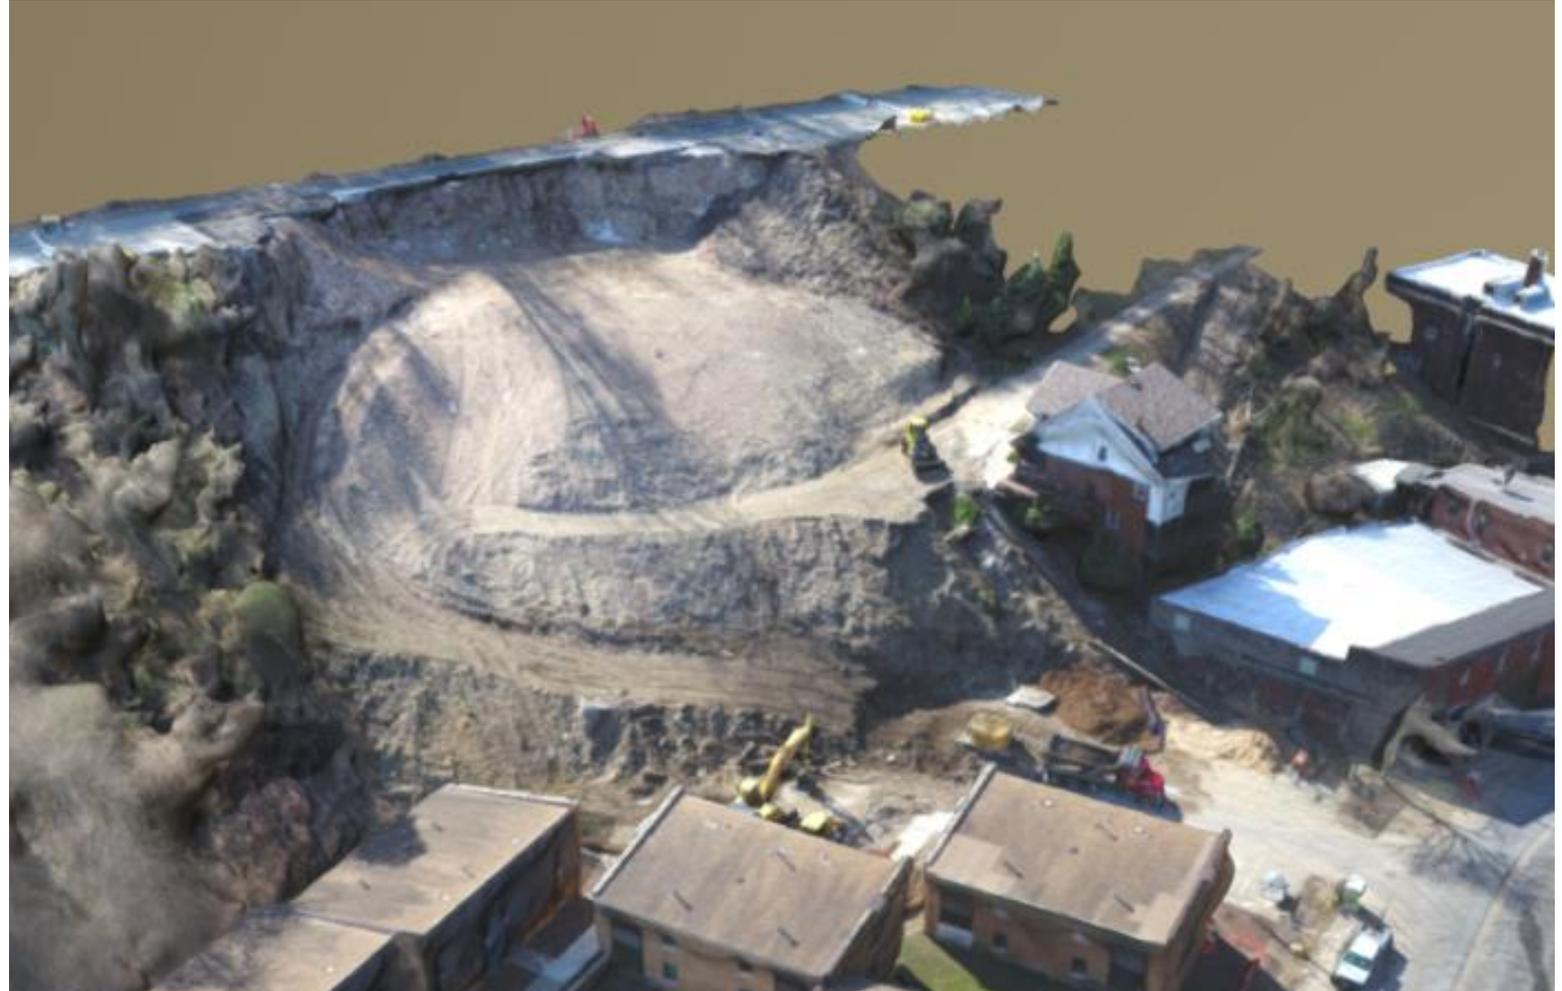
3D photo from 4/13/18 showing initial landslide removal operations

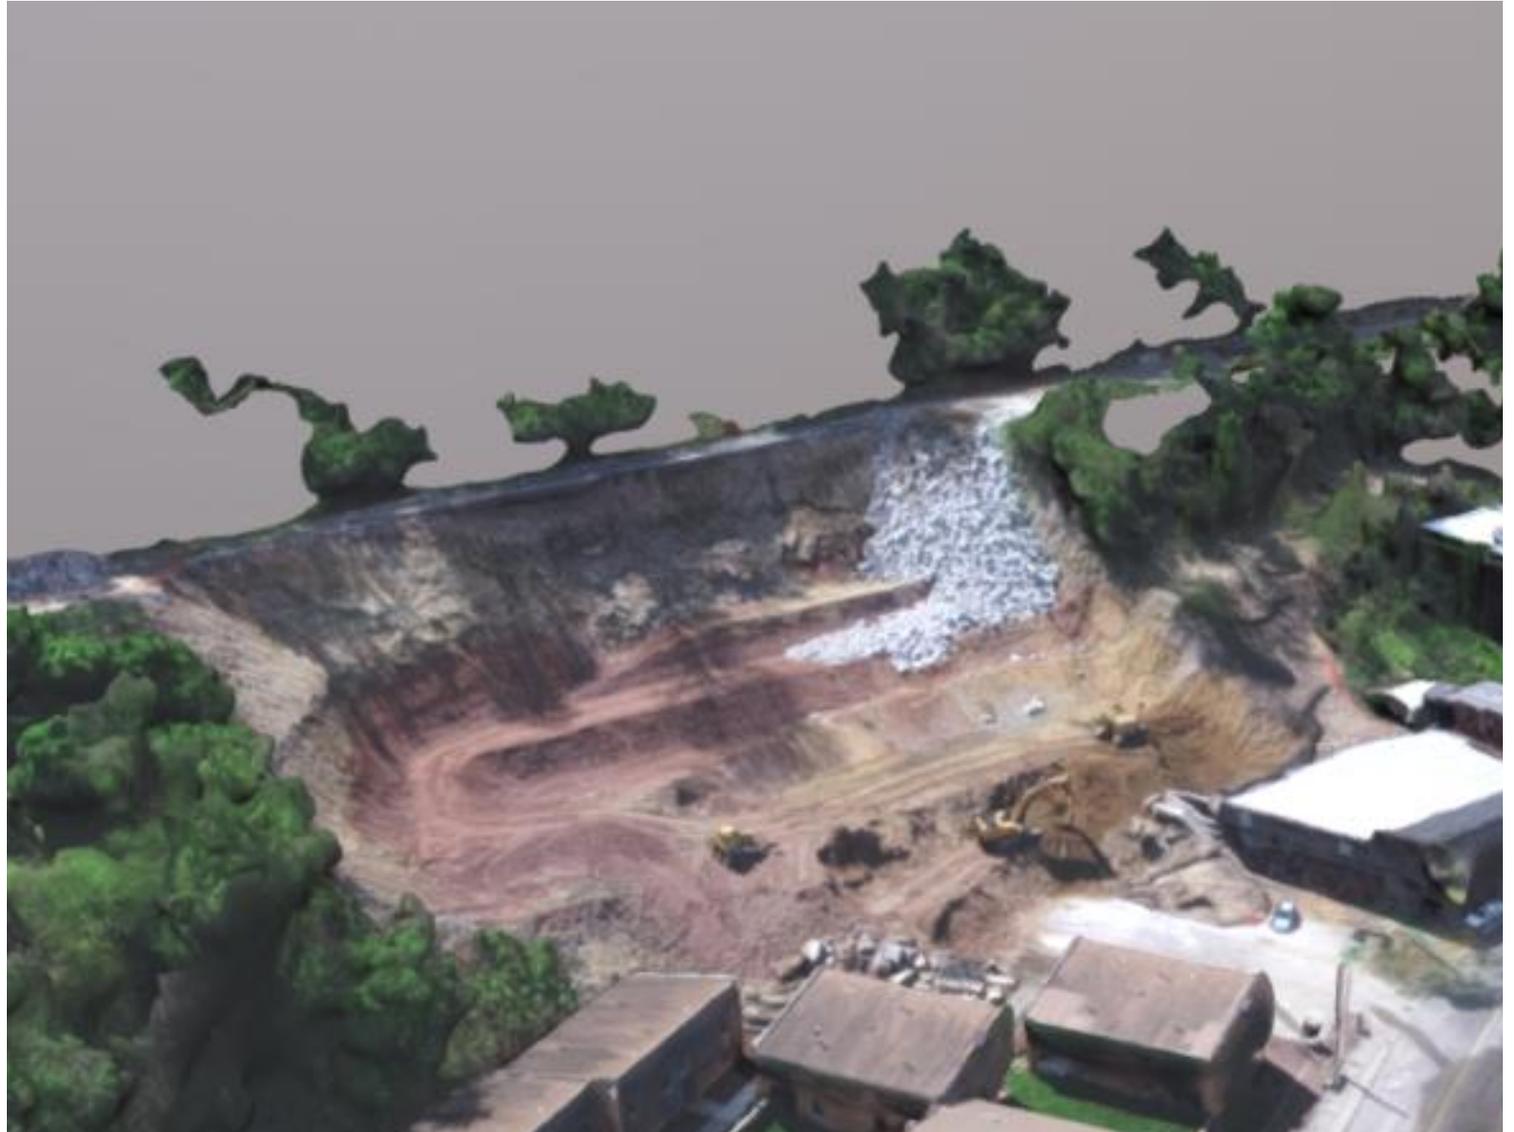
3D photo from 05/09/18
showing completion of bench
excavation and beginning of
rock embankment placement

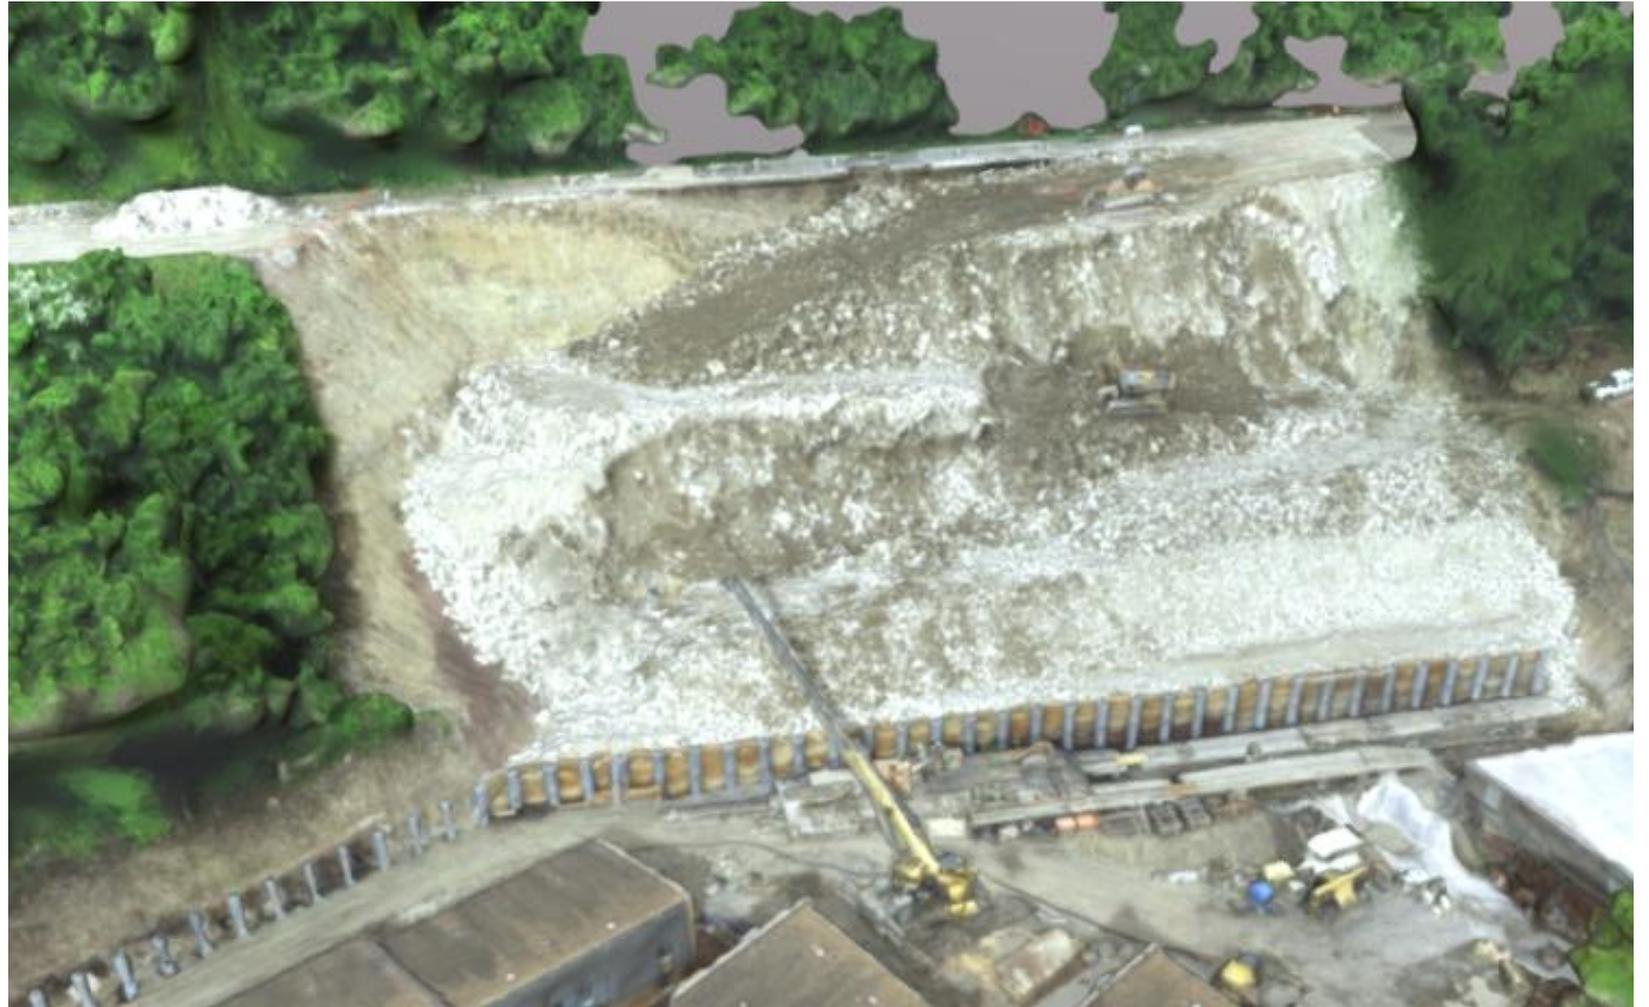
3D photo from 06/01/18 showing retaining wall construction and rock embankment placement.

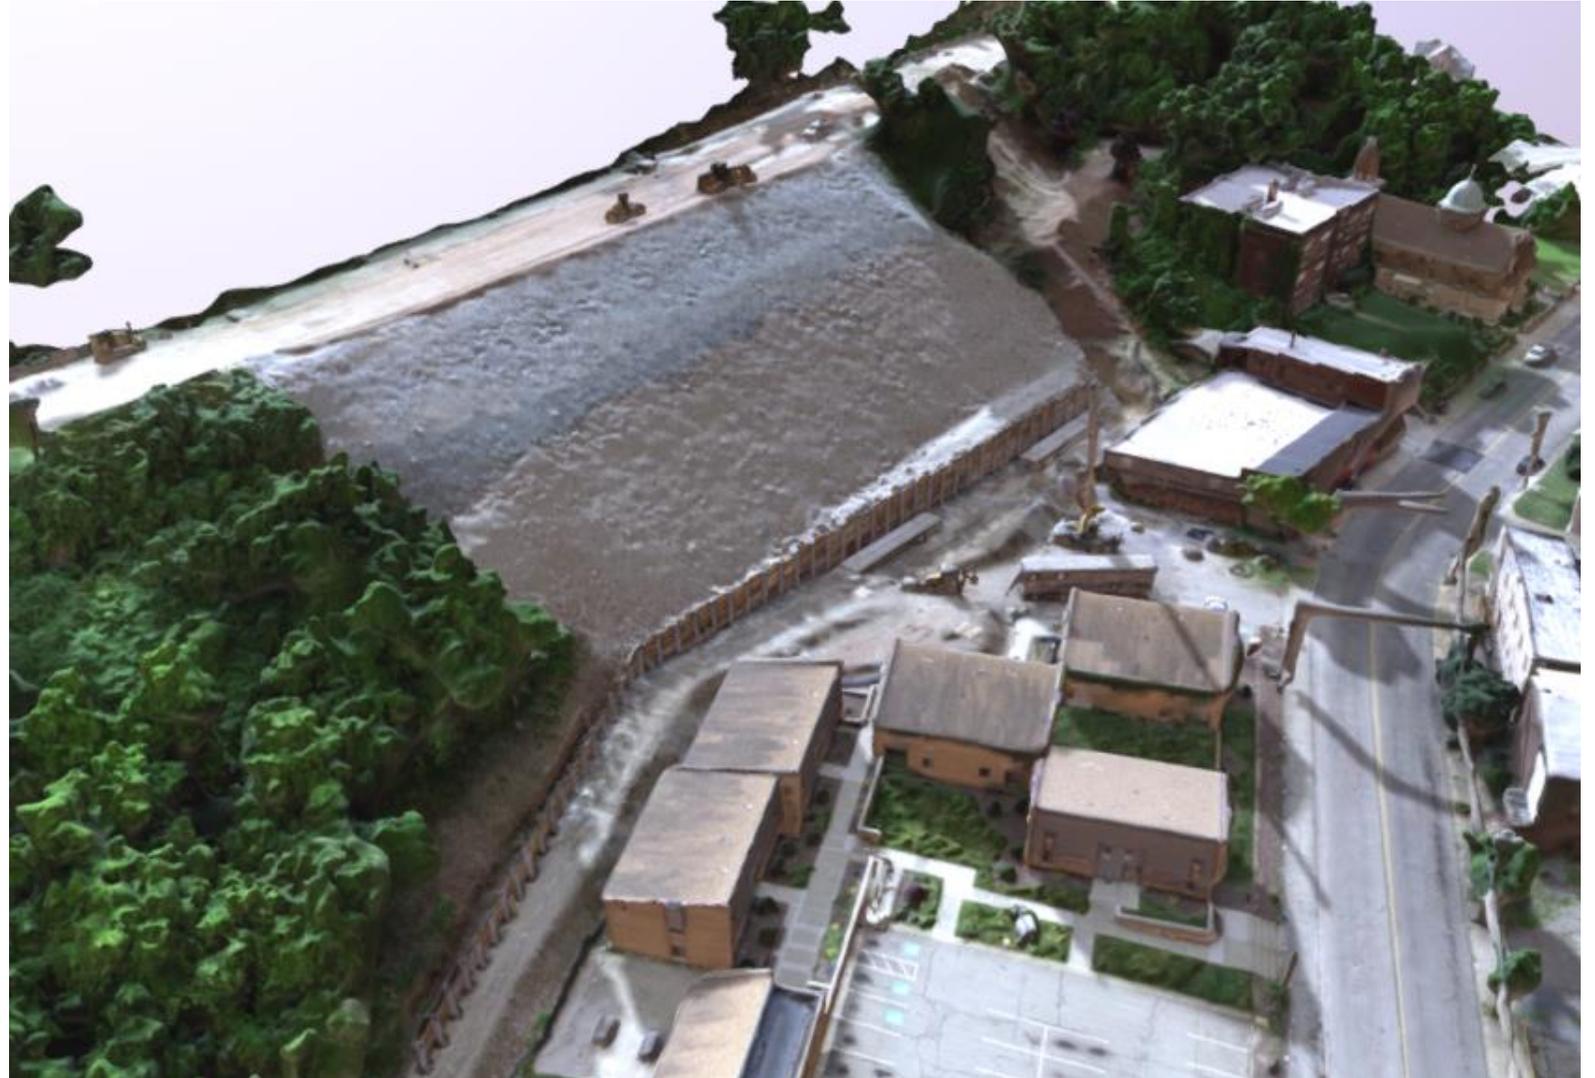
3D photo from 06/19/18 showing substantially complete retaining wall construction and rock embankment.

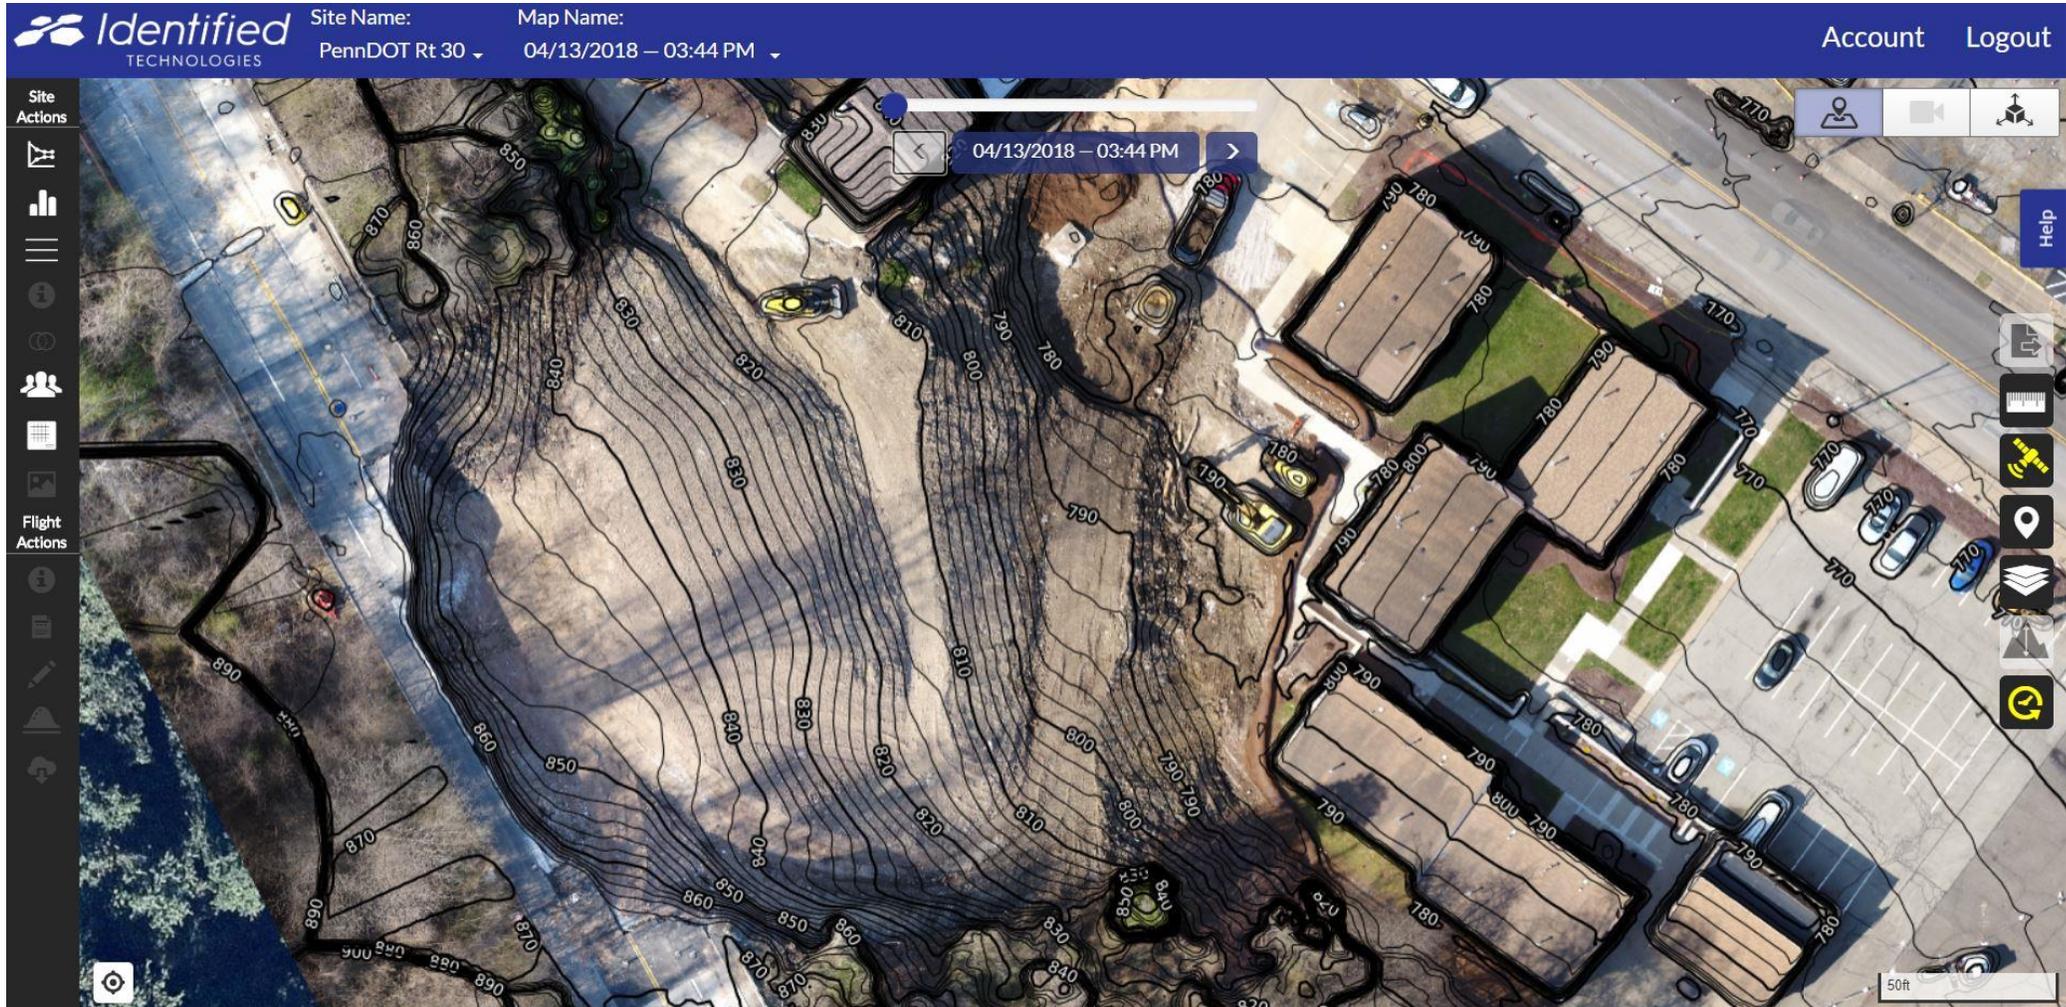
- Contours of excavation progress @ 4/13/18
