Route 30 Emergency Landslide Repair, Use of Technology to Expedite Action

Brian F. Heinzl, P.E.

Geotechnical Project Manager, Gannett Fleming, Inc.

PennDOT District 11-0 and Golden Triangle Construction

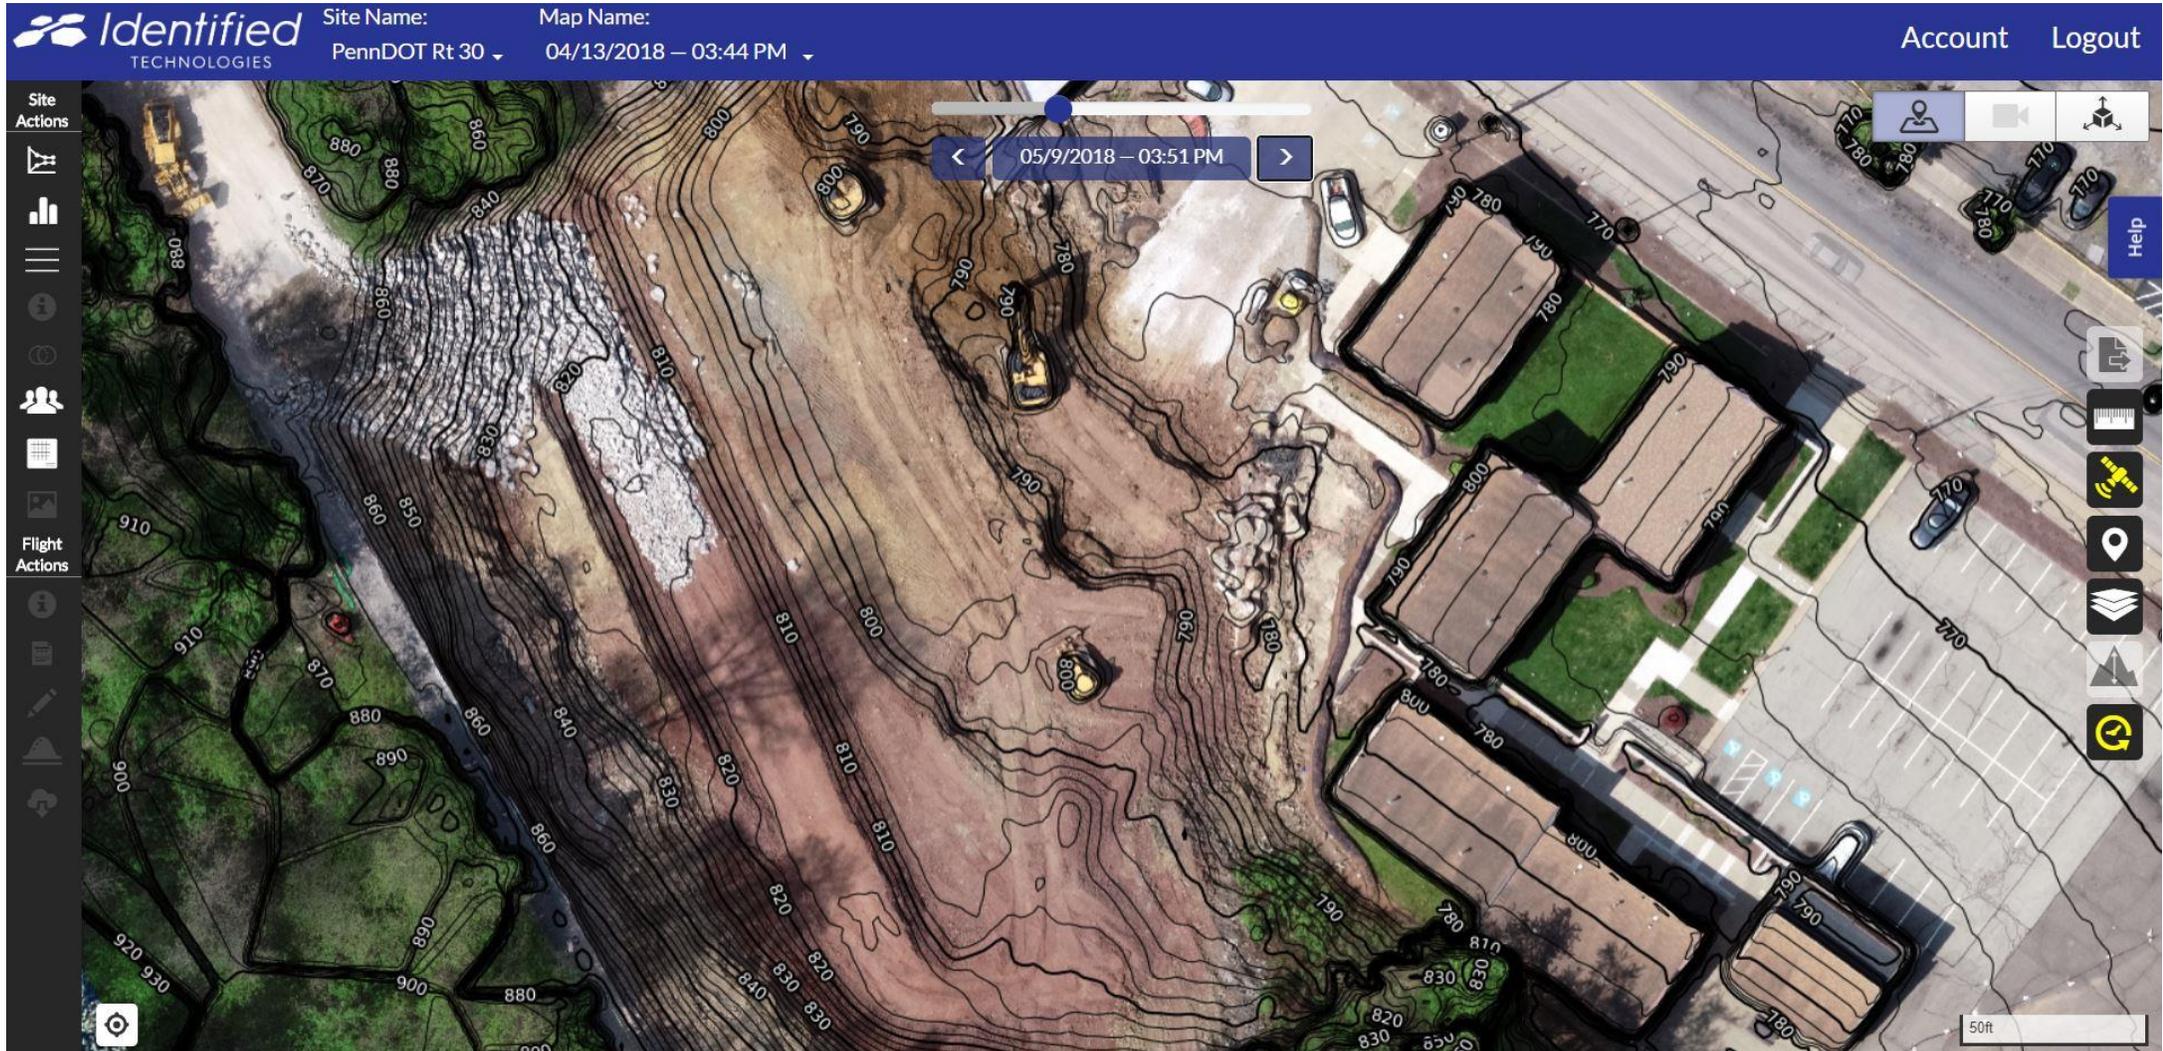
- Contours of completed excavation on 5/9/18

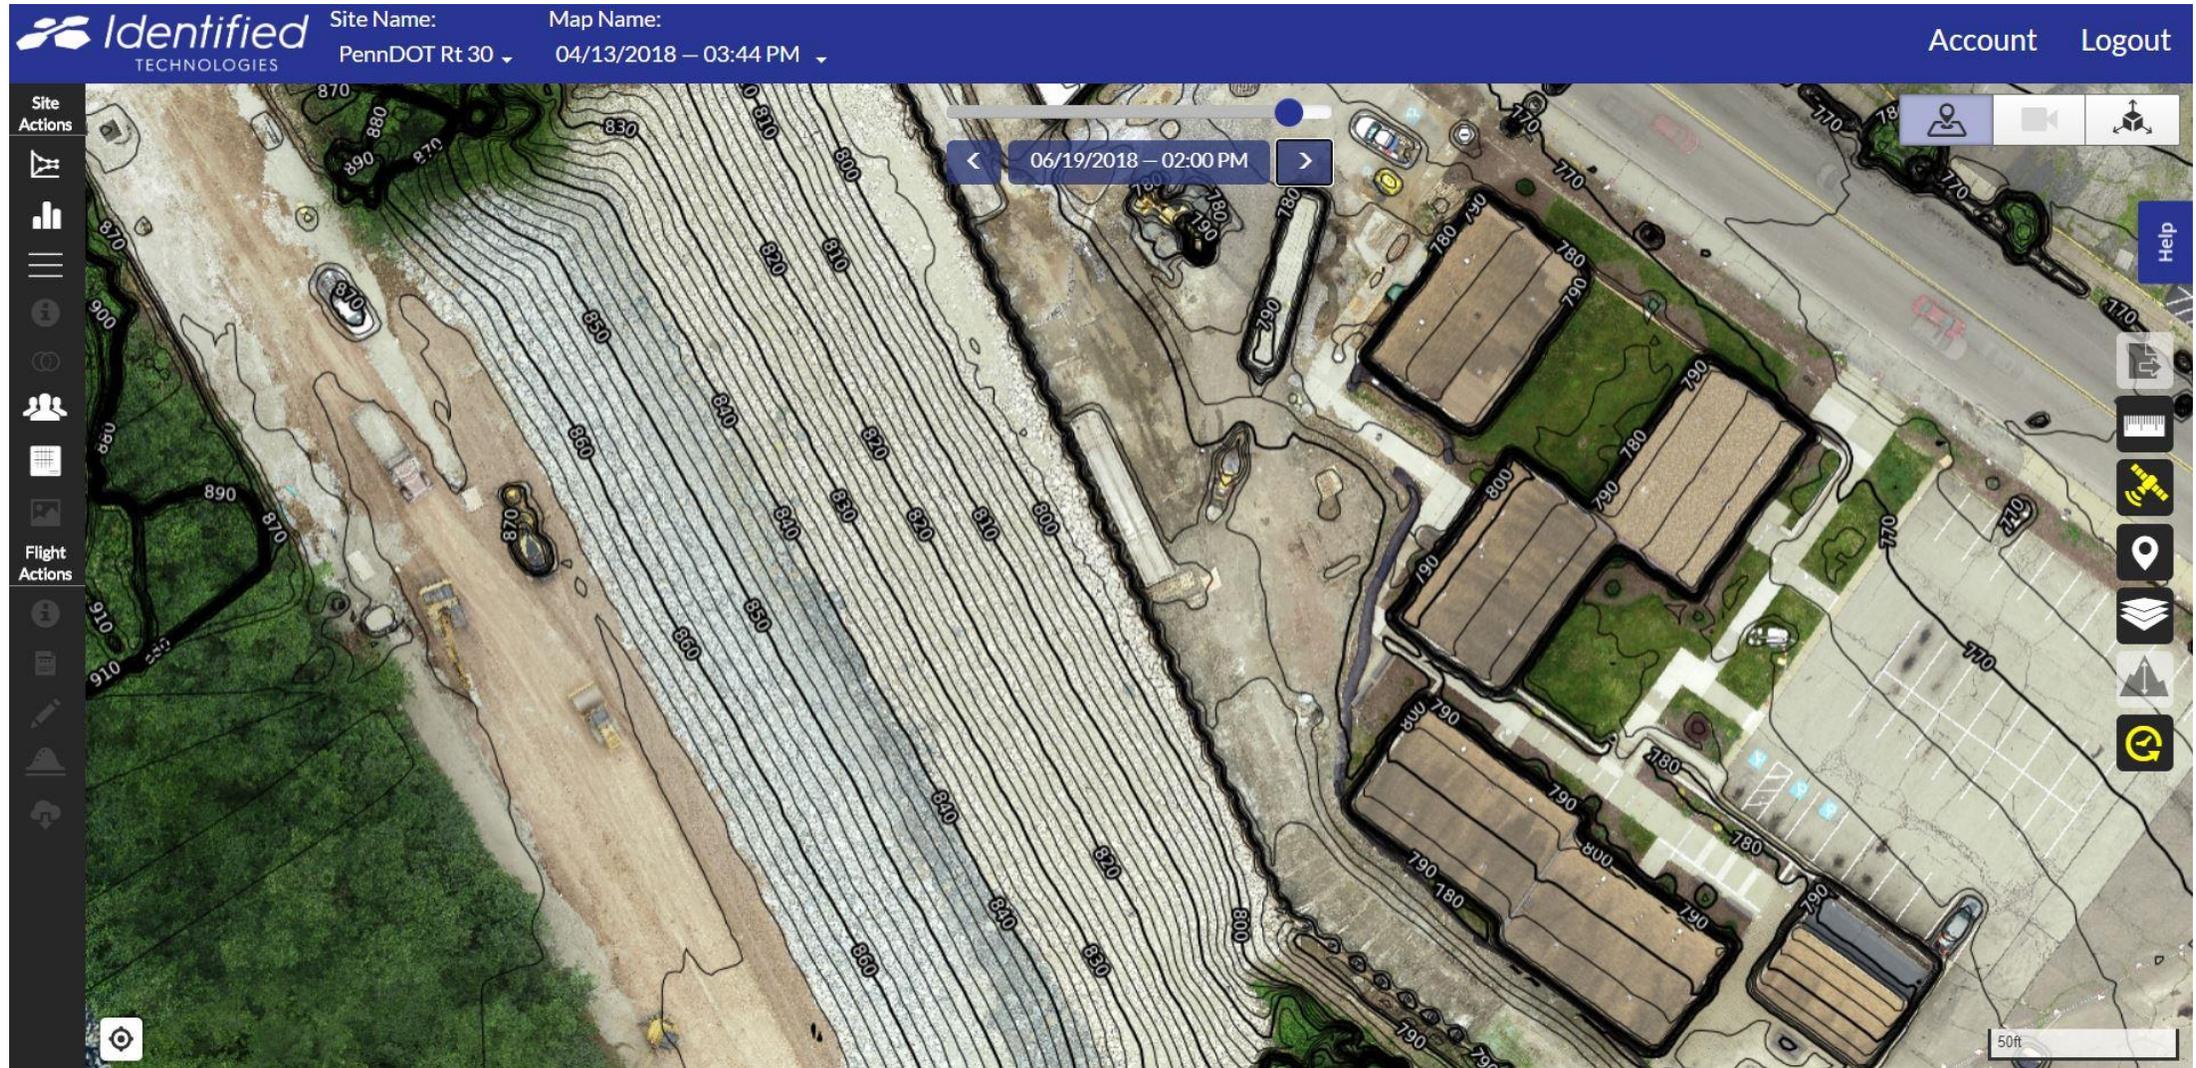
- Contours of completed earthwork on 6/19/18

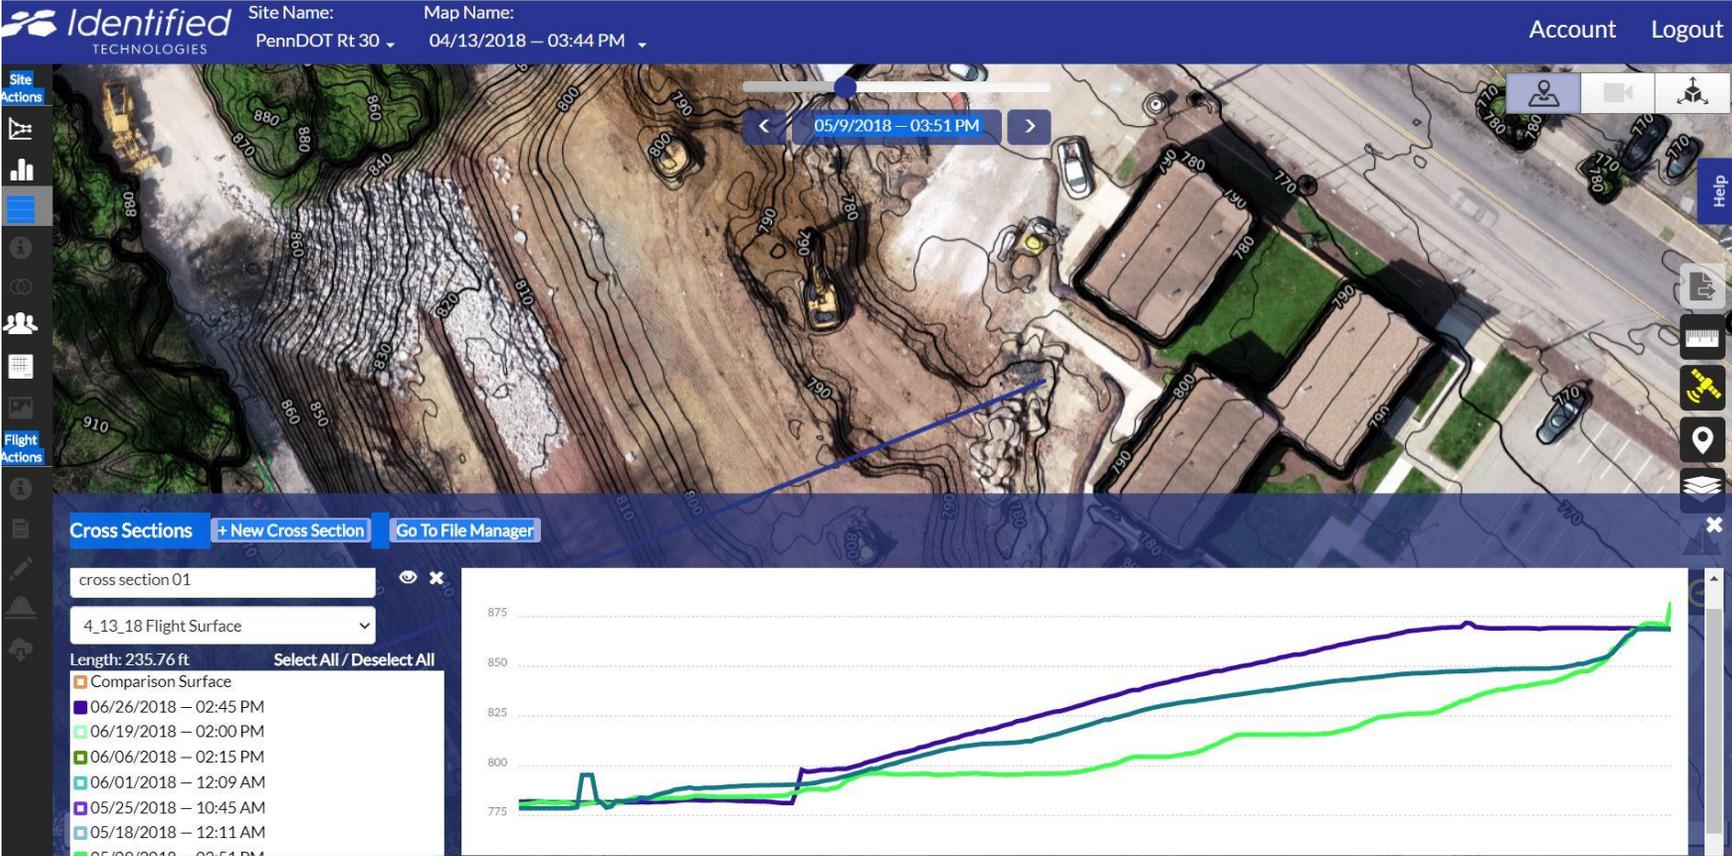
Software can be used to track:

- Excavation depth, area, volumes;
- Backfill depth, area volumes;
- Quantities;
- Production rates;

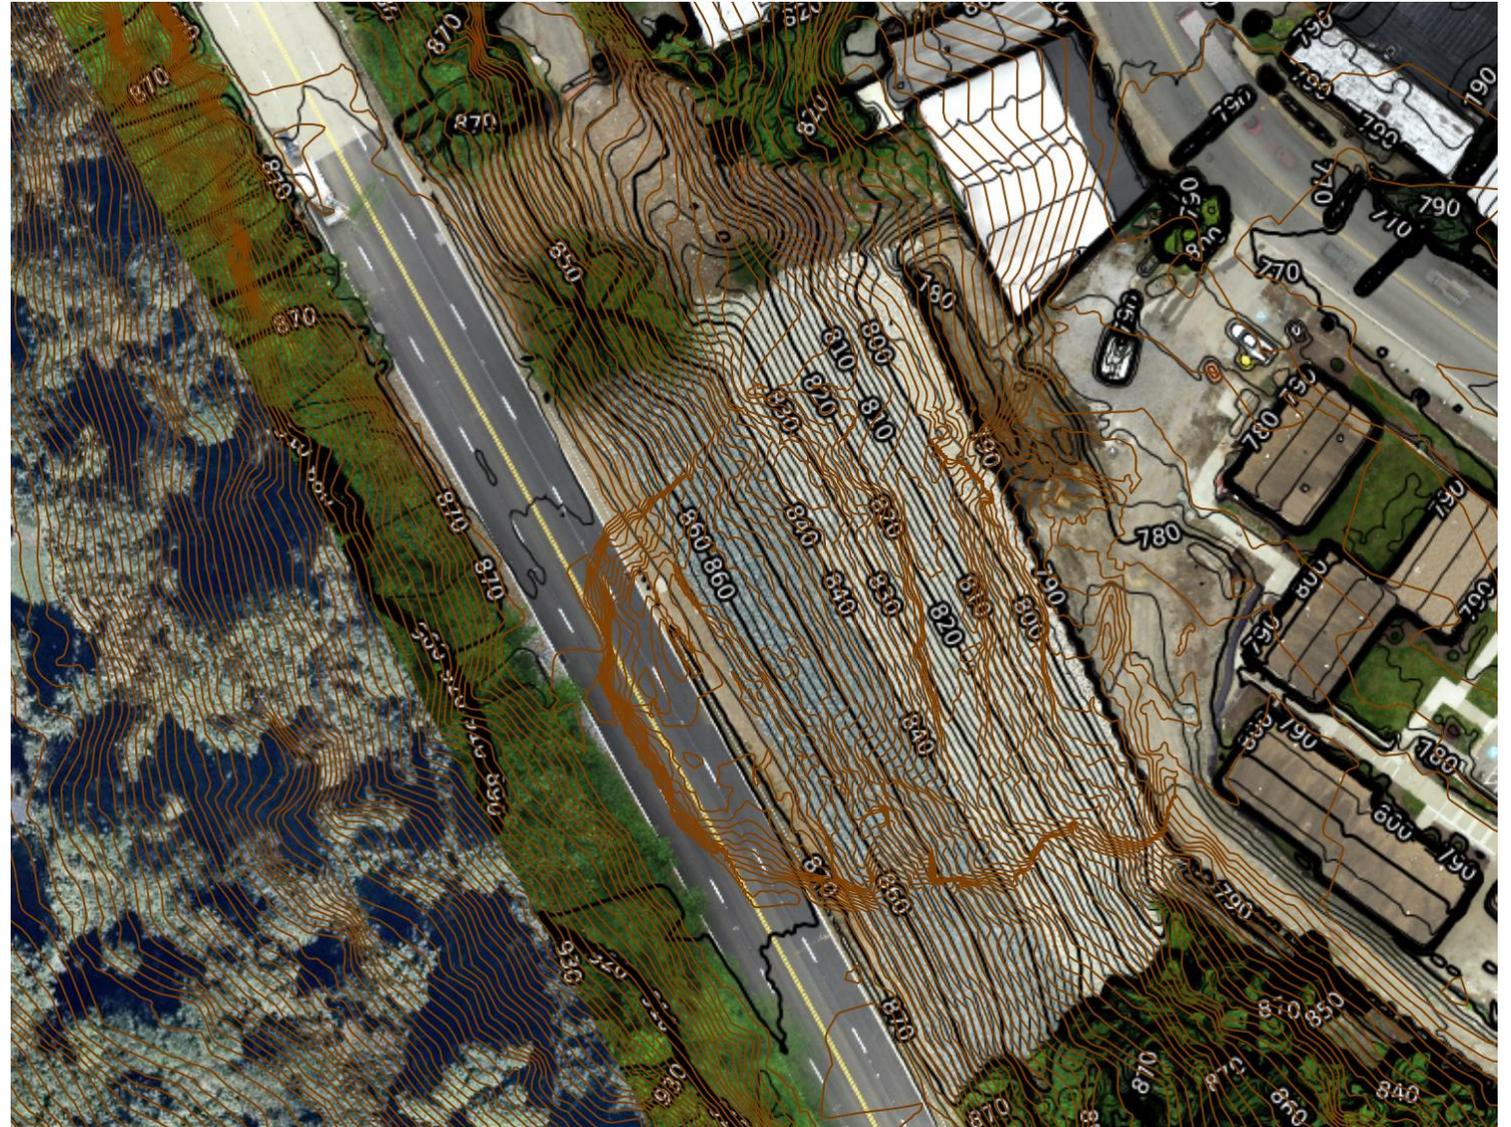
Contour plots of original grades
vs. final grade

or any interim 3D image
modeled by the UAV survey

presented to compare areas
change.
