FINAL REPORT

IRISE-22-P21-02-01 • SEPTEMBER 2022

**Preliminary Evaluation of  
Pavement Surface Distresses  
Related to Pavement Markings**

**PITT | IRISE**

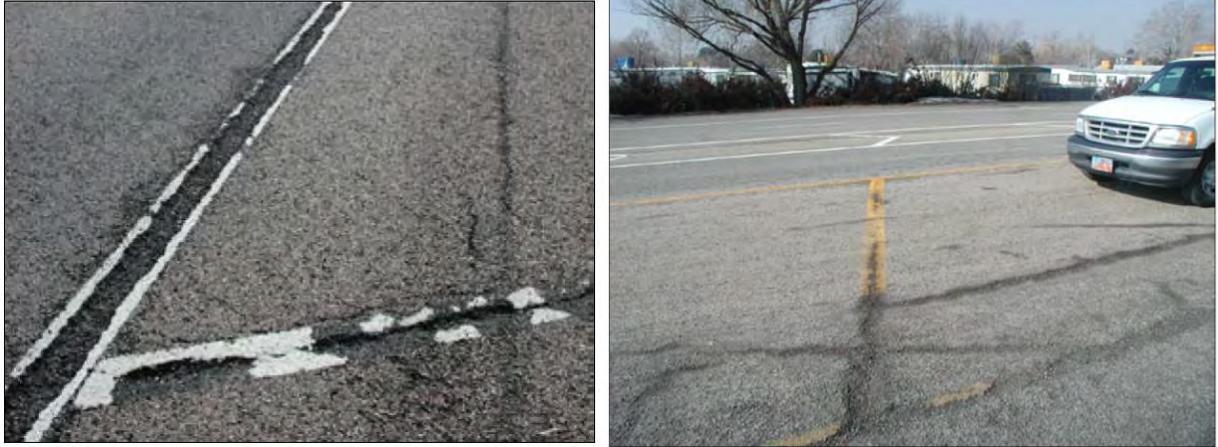
A study was done at the Utah Department of Transportation when they observed pavement distress underneath pavement markings [18]. They hypothesized that markings could contribute to the deterioration of the pavement and in some cases are the main source of the distress. This study observed pavement deterioration under both tape and water-based paint as shown in Figure 4 and Figure 5. This study was solely based on observations, but they had two hypotheses on the cause of the distress. First, that water vapor was trapped between the marking and the pavement surface. Asphalt mixtures with low binder content are more susceptible to moisture damage, raveling, and cracking. The state of Utah changed their asphalt gradation to increase the binder content in 2008 to address this issue. The second hypothesis was that there were differential strains in areas with pavement markings due to a difference in reflectivity. It was also noted that some issues began at construction joints where improper density could have been a concern.

Figure 4: Pavement distress focused in pavement markings taken in Spring 2009 near Salt Lake City, Utah when the pavement was 7 years old with tape markings [18].

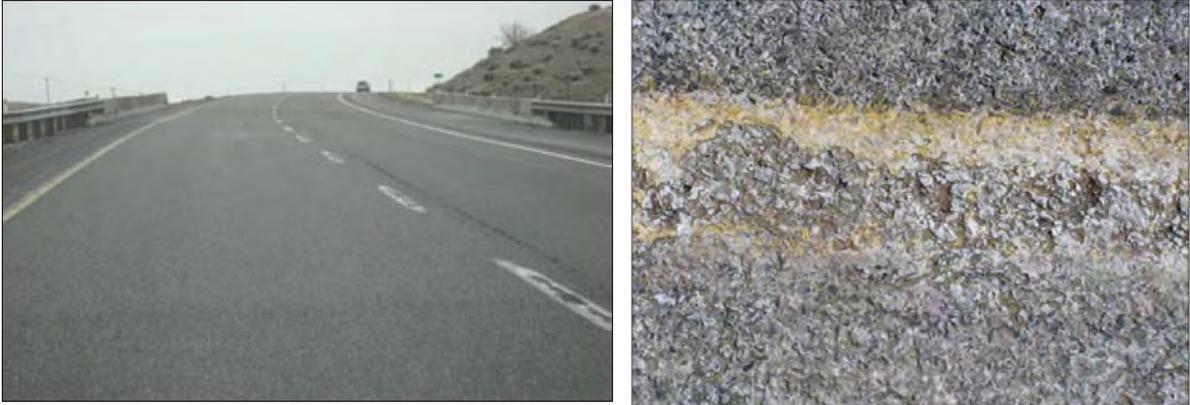
Figure 5: Pavement distress focused in pavement markings taken in Spring 2009 near Santaquin, Utah when the pavement was 6 years old with water based paint markings [18].

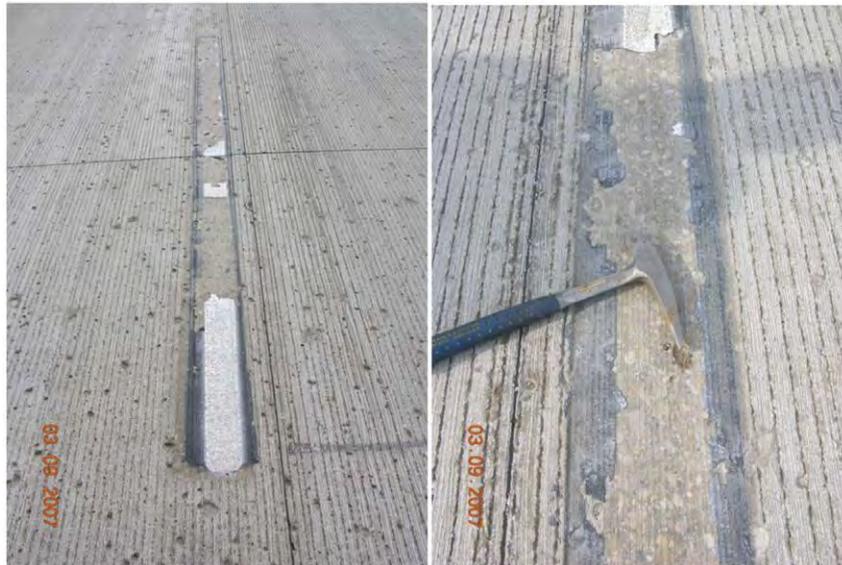
The Wisconsin Department of Transportation conducted a project that was originally proposed to investigate an alternative marking method involving milling or ground grooves on concrete pavements [19]. However, a second investigation began when early marking failure was observed on a specific section. Several markings were missing or de-bonded. An example of their observations is shown in Figure 6 [19]. The failed markings are what began the investigation; however, it was concluded that the primary cause of failure was expansive coarse aggregates. A high absorption value and soundness value that was just within the upper limit caused pop outs in several areas on the roadway including below missing markings. There were still observations of missing or de-bonded markings without the pavement distress underneath. They concluded that an adequate bond was not initially achieved, adding to the chance of marking failure. This was the only report with observations found on concrete pavements.

Figure 6: Missing or de-bonded pavement markings due to aggregate pop outs and poor bonding [19].

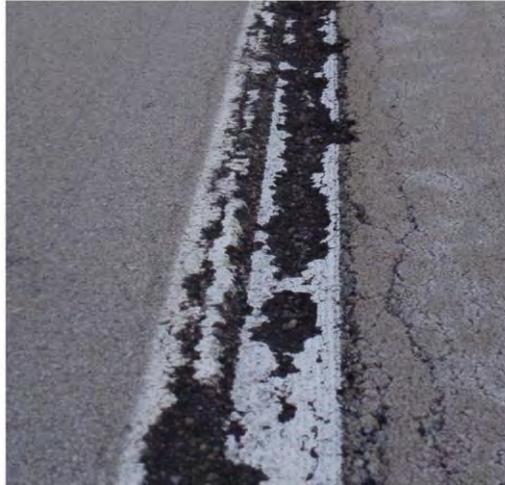
The Illinois Center for Transportation evaluated the performance of various pavement markings on both concrete and asphalt surfaces over four years with a focus on durability and visibility [13]. The data gathered in this study was ultimately used by the Applied Research Associates to create a pavement marking selection guide for Illinois. They focused on three factors that affect pavement marking performance: environmental condition (specifically snow and the subsequent removal), pavement surface type (determining the bond between marking and surface), and traffic volume. Based on their findings, they created a chart of material recommendations based on region, traffic, pavement type, and surface installation versus recessed. During this study, they observed some pavement distress beneath the pavement marking. As shown in Figure 7, one of their test sections had deterioration within the four years of the study. This pavement marking material was polyurea. However, distresses were not limited to the areas under the pavement marking and were observed in other locations on the pavement surface.

Figure 7: Pavement distress beneath polyurea pavement markings [13].

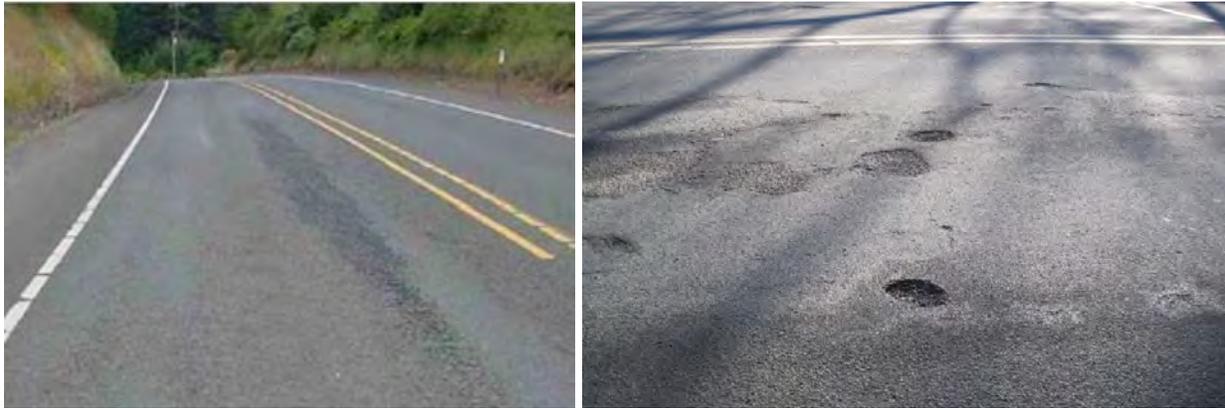
moisture tends to gather but if there is a reason for the water to gather at the surface the same loss of binder will occur, it is then called raveling. Stripping specifically causes pothole formation while raveling causes poor ride quality, increased noise, and loose aggregates on the pavement surface (Figure 8) [27], [28].

Figure 8: Raveling on asphalt pavement surface [27] and stripping between asphalt layers [28].

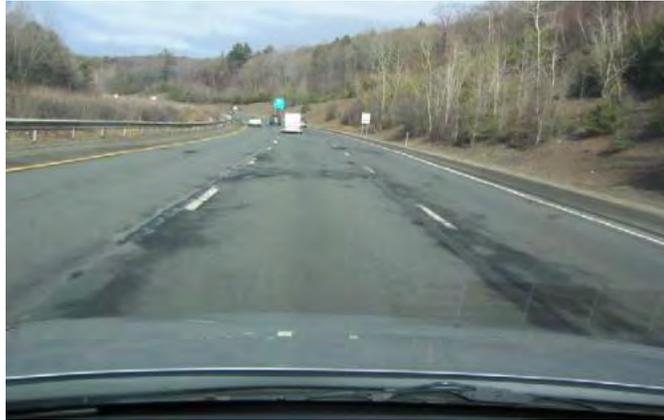
Joints on any pavement are launching points for a variety of pavement distresses due to the high potential of water infiltration (Figure 9); however, longitudinal joints are necessary in all pavements. Concrete pavements longitudinal joints can experience water-based distresses, such as longitudinal and durability cracking, and be the initial point of pavement failure. For asphalt pavements, poorly compacted joints allow water to penetrate easier causing debonding surface layers, stripping, and oxidizing [46]. When the first asphalt lane is paved, it will have an unconfined edge that will have a lower density compared to asphalt towards the center of the lane. The second lane will be confined by the first and will therefore have a relatively higher density [47]. The asphalt on either side on the joint will still have a higher air void percentage and lower density than the mainline pavement 12 inches away. This density gradient across the joint is a major source of pavement distresses including longitudinal and fatigue cracking, raveling, and crack widening [47]–[49].

Figure 9: Deteriorated longitudinal joints with water infiltration [50]

Due to the observed longitudinal joint problems in Pennsylvania, new procedures have been implemented in 2020 to improve pavement performance and lower maintenance costs. These improvements can be found outlined in the Pub 408 and the 2020 Asphalt Technician Field Program [8], [49]. Previous standard practices that were commonplace in most if not all asphalt roadways included significant handwork and luting at the edges of the pavement. This involved smoothing the edges and pushing fallen material back into the paved surface. This created inconsistent depths and densities along the joint. Updates have been implemented in Pennsylvania in recent years to improve density at longitudinal joints when using vertical joints, cut vertical joints, and notched wedge joints so that handwork is unnecessary when joint construction is performed correctly.

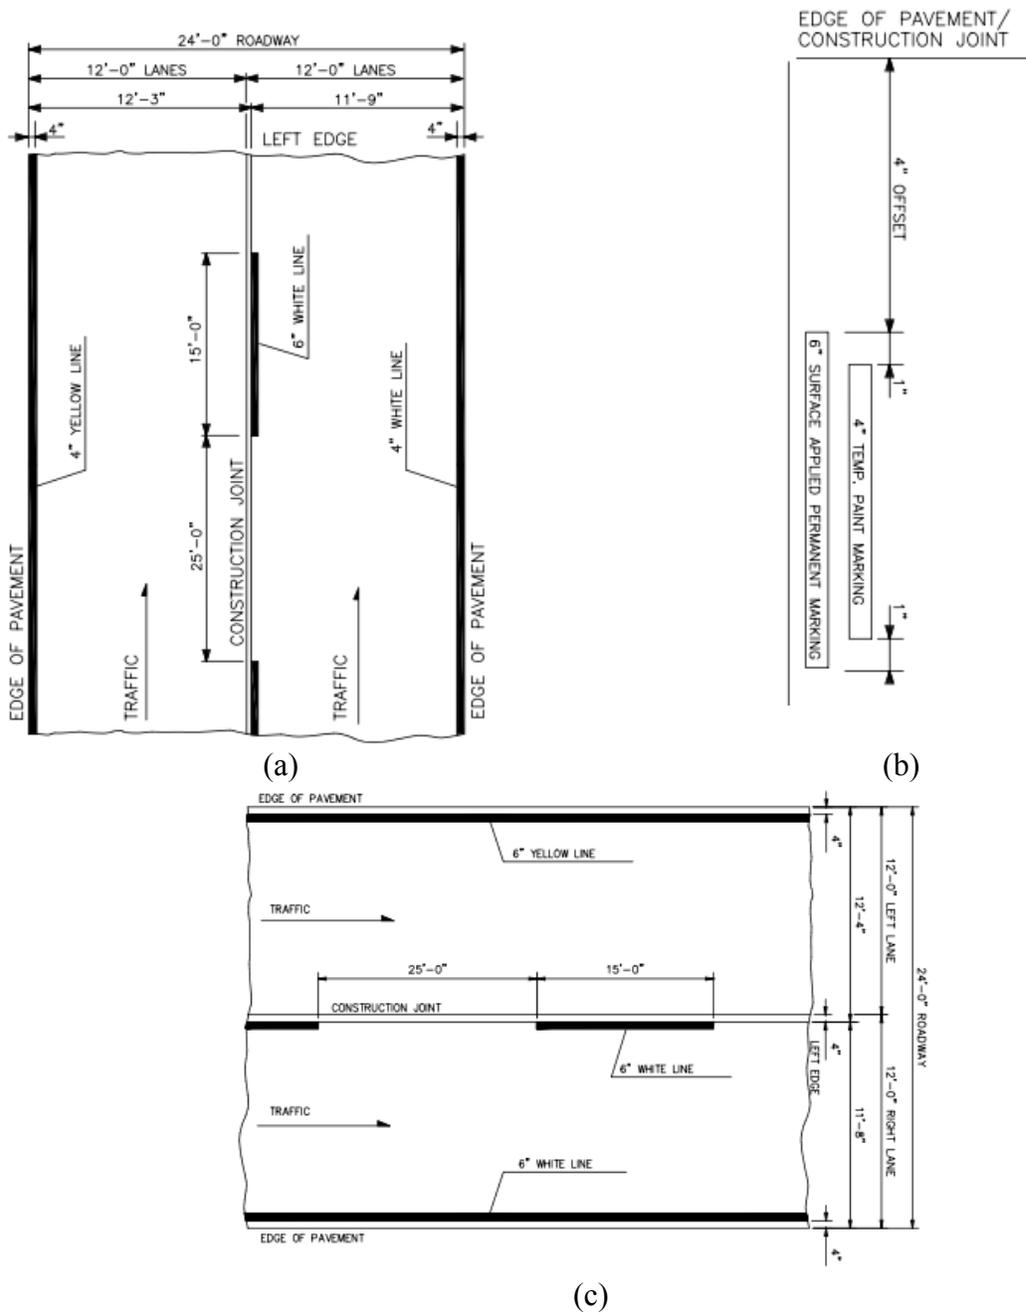
The Turnpike Commission initially reported anecdotal issues with distresses around pavement markings. However, upon further investigation, Turnpike informed that those issues were resolved by altering the standards concerning the location of the markings in relation to the longitudinal joint. Standards from 2011 (Figure 24a) show that there was not a recommended offset between the centerline (white marking) and the construction joint [54]. In 2012, an updated standard [55] shows a 4 in. offset for the marking placement (Figure 24b). The 2015 standard [56] which is used currently for permanent markings emphasizes this offset with an additional drawing. The Turnpike Commission informed that since the change in 2012 there were less issues with the durability of pavement markings and the pavement underneath it.

Figure 24: Turnpike Commission standards regarding offset of centerline marking placement from longitudinal joint in (a) 2011 [54], (b) 2012 [55], and (c) 2015 [56]

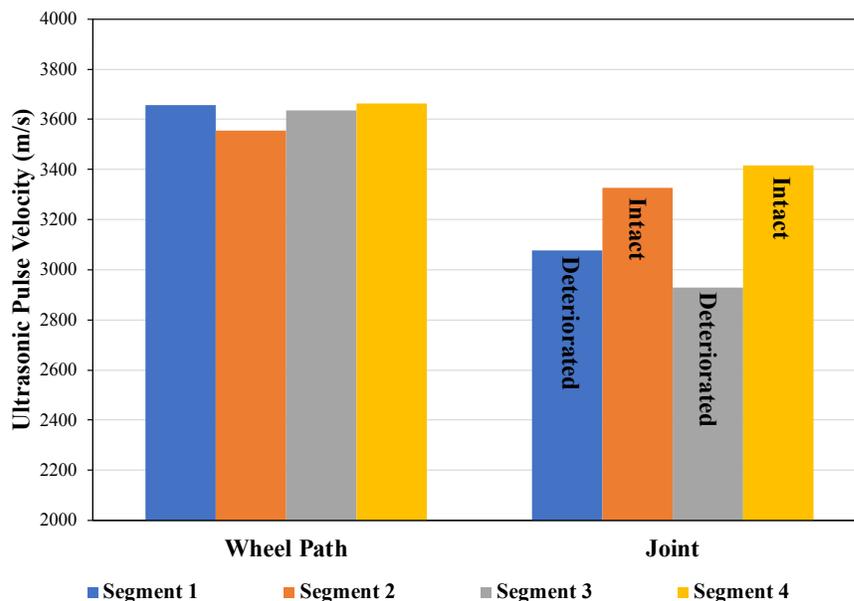
Section 1 (Figure 28) presents higher pulse velocity for the wheel path (average of 3628 m/s) than for the longitudinal joint (average of 3187 m/s). This indicates that the asphalt concrete density at the joint is lower than at the lane center (wheel path). Issues with achieving high levels of density at the longitudinal joint are common in asphalt paving [64] and are known to be the reason for several joint related distresses [65-67]. Results also show that joints without surface distresses (intact) also present higher pulse velocity than deteriorated joints confirming the greater presence of distresses in the latter.

Figure 28: Ultrasonic pulse velocity at wheel path and longitudinal joint in Section 1

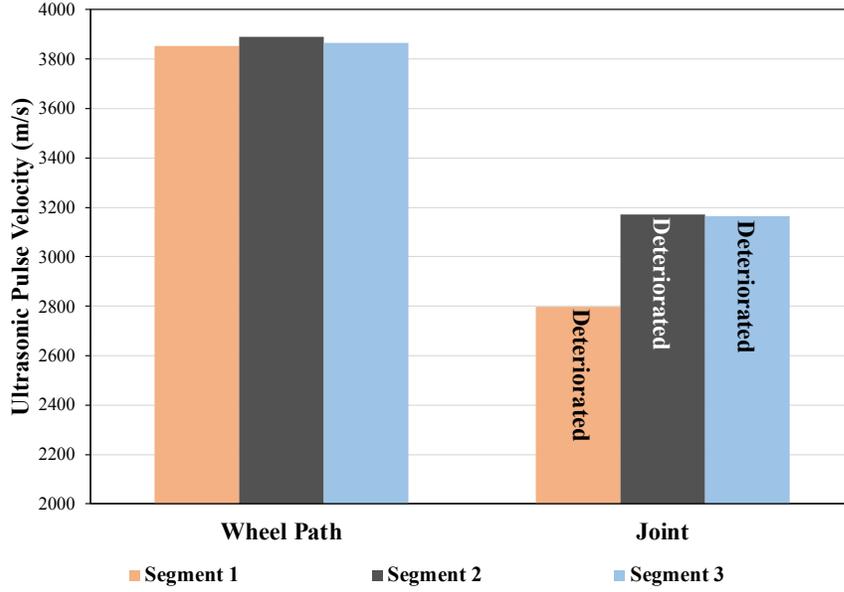
Similar results were obtained from Section 2 (Figure 29) where the wheel path presents high, uniform pulse velocity with an average of 3870 m/s. The longitudinal joint was so heavily deteriorated that no intact segments could be scanned for this section. This longitudinal joint showed a much lower pulse velocity than the lane center with an average of only 3044 m/s.

Figure 29: Ultrasonic pulse velocity at wheel path and longitudinal joint in Section 2

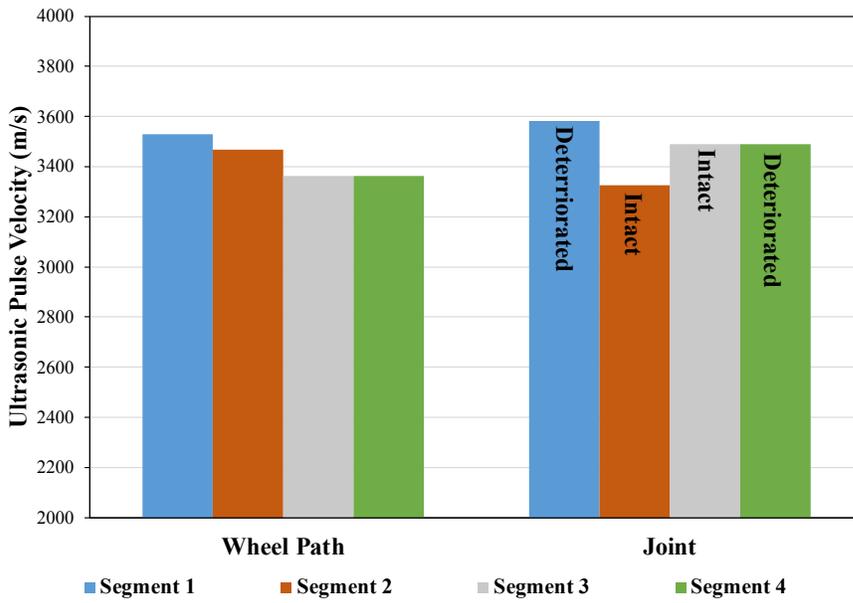
Section 3 differed from the previous sections by showing similar pulse velocity between the wheel path and the longitudinal joint with averages of 3479 and 3498 m/s, respectively. This can indicate that the construction of the longitudinal joint for this section was more successful in achieving similar density levels when compared to the center of the lane. However, from all the tested sections, Section 3 segments present significantly more deterioration at the wheel path (Figure 30) even when the longitudinal joint area seemed intact. The presence of distress in the wheel path, as seen in Figure 31 can also help explain the lower pulse velocity in comparison with the other Sections although comparison between sections can be misleading.

Figure 30: Ultrasonic pulse velocity at wheel path and longitudinal joint in Section 3

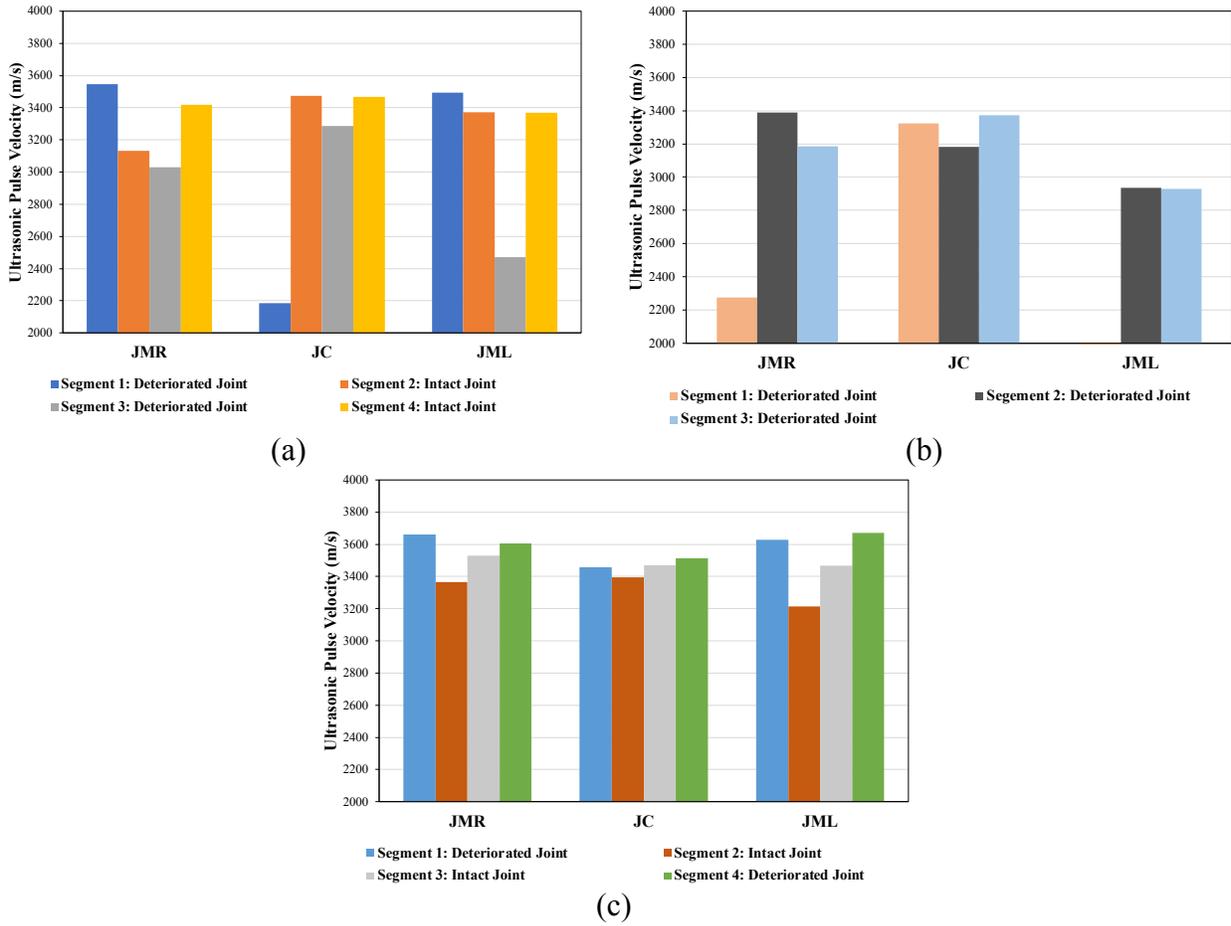
To evaluate the effect of markings on the ultrasonic pulse velocity, measurements at the longitudinal joint on top of the markings (joint marking right - JMR and joint marking left - JML) and between markings (joint center - JC) were analysed. Figure 32 presents the results for the three sections. As can be seen in the figures, results are inconclusive. There is no indication that measurements on top of the marking produces higher or lower pulse velocity.

Figure 32: Ultrasonic pulse velocity at the joint for (a) Section 1, (b) Section 2, and (c) Section 3

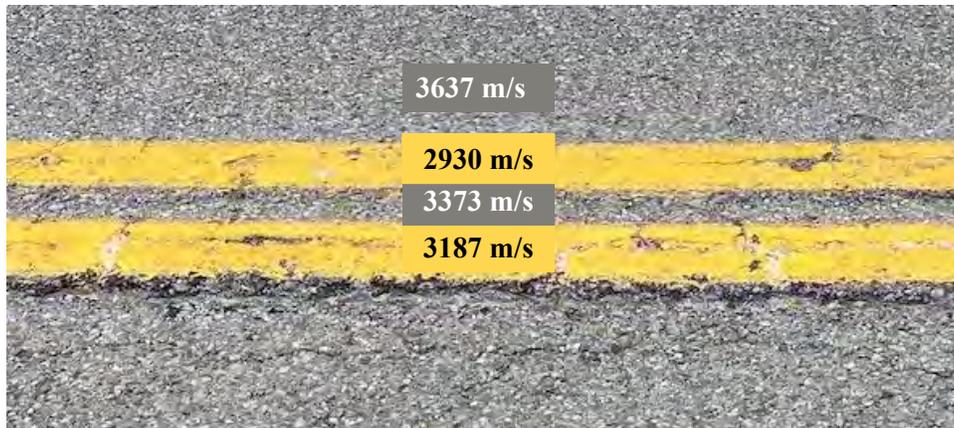
Overall results indicate that pulse velocity is more affected by the proximity to the longitudinal joint regardless of the presence of pavement markings. An extra set of measurements was performed in segment 3 of Section 2 in which the ultrasonic device was positioned with an offset of 10 cm from the outer centerline marking. Results (illustrated in Figure 33) show that pulse velocity and potentially asphalt concrete density increases significantly right outside of the joint. This could help explain the success in avoiding premature marking deterioration by the Turnpike Commission when changes in standards for marking placement in relation to longitudinal joints were put in place.

Figure 33: Ultrasonic pulse velocity at the longitudinal joint in different locations

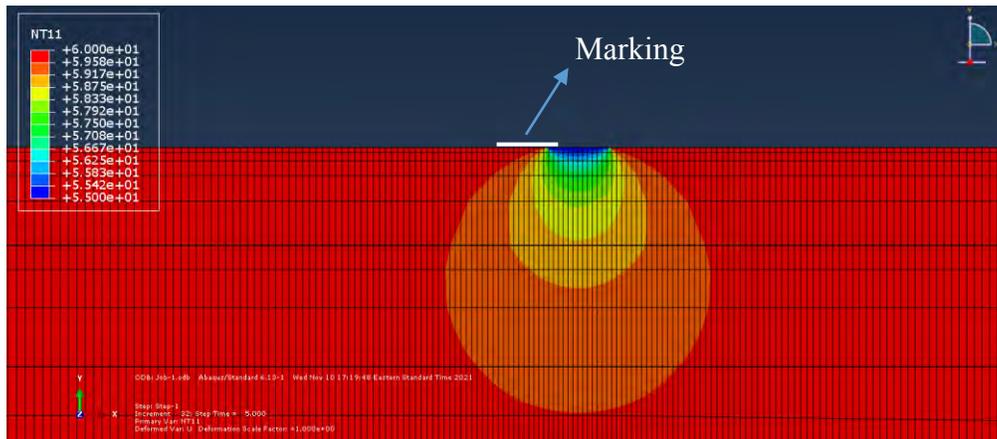
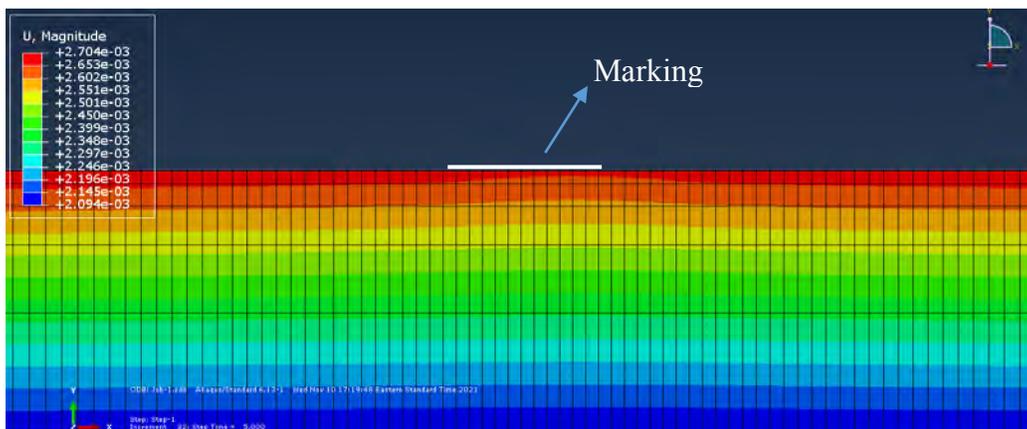
The temperature distribution, vertical displacement, stresses in transverse (x direction) and vertical (y direction) directions cause by the temperature differential are shown in Figure 36 and Figure 37. The temperature distribution in Figure 36a shows a decreasing gradient, with a lower temperature closer to the marking area. Figure 36b shows the surface temperature differential effect on deformation decreases with an increase of asphalt depth. These results are as expected based on previous hypotheses outlined in this report.

Figure 36: (a) Temperature distribution and (b) displacement in vertical direction

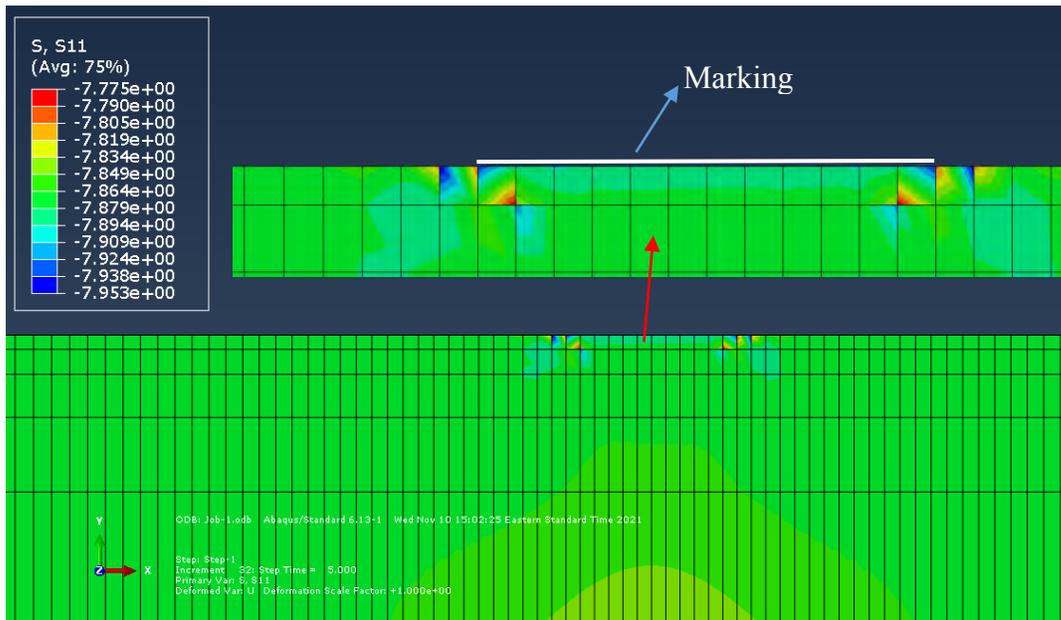
(a) stress in transverse direction (x-direction, MPa)

High-stress gradients in both horizontal and vertical directions are observed between marking and asphalt surfaces as shown in Figure 37. Since stresses are calculated assuming elastic behavior, very high values are observed between marking and asphalt surfaces (details can be seen in magnified plot in Figure 37). These high stresses are stress singularities that do not exist in practice. When stresses increase beyond the tensile strength of an asphalt layer, cracks would initiate and the stresses would be released. Since asphalt material has viscoelastic behavior and presents healing properties in the field, the results presented using this elastic model might not be representative. In any case, points with high stresses represent locations which can develop cracking exposing the effect of thermal differentials between pavement and marking surfaces.

Figure 37: Stresses in the (a) transverse and (b) vertical direction

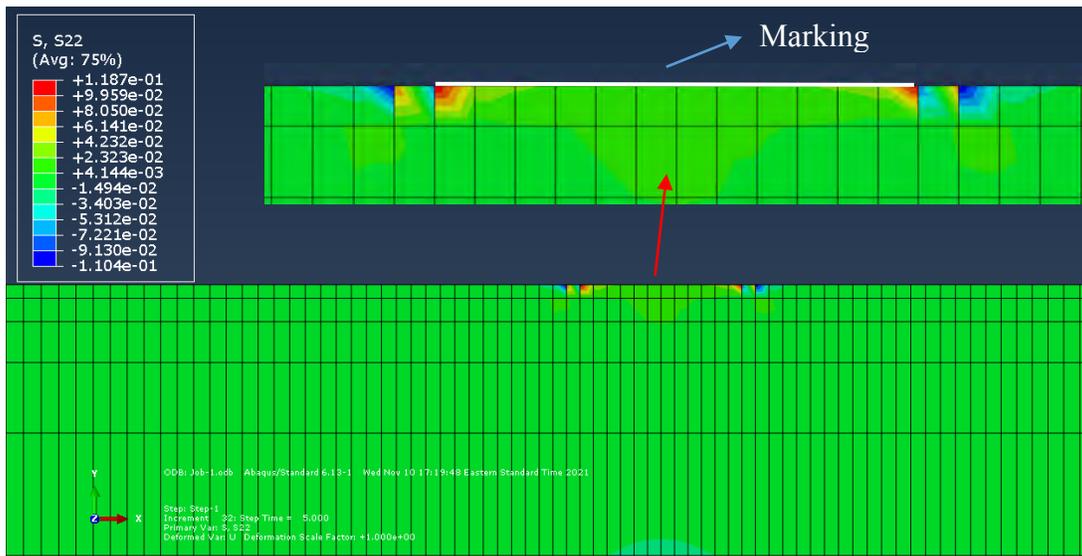
(b) stress in vertical direction (y-direction, MPa)

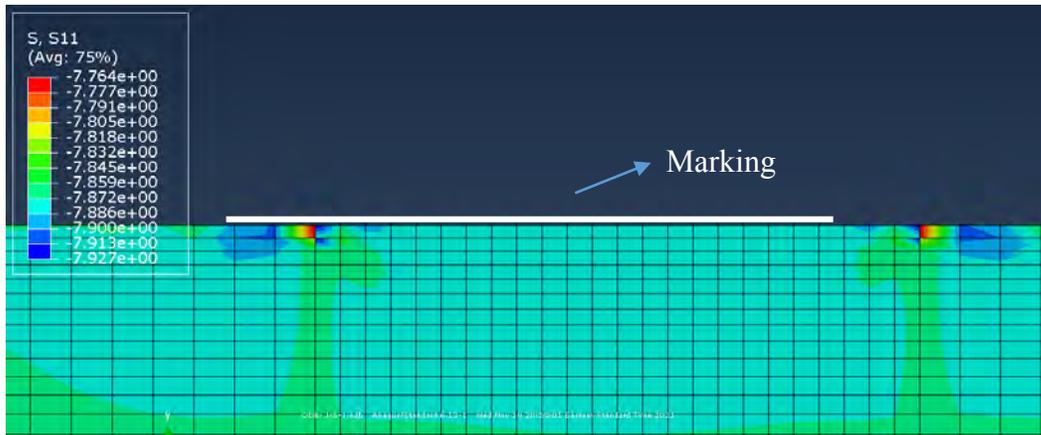
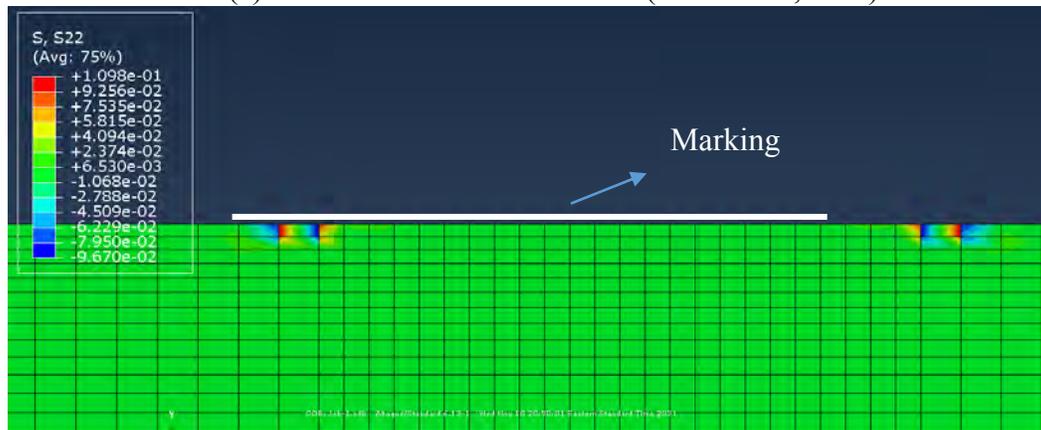
Figure 38: Simulation results using a finer mesh

directions are shown in Figure 38. Comparing Figure 37 with Figure 38 shows the effect of a smaller mesh size. Maximum stresses (in x and y direction) are still observed, which proves that the stresses are stress singularities or point stresses.

(a) stress in transverse direction (x direction, MPa)

(b) stress in vertical direction (y direction, MPa)

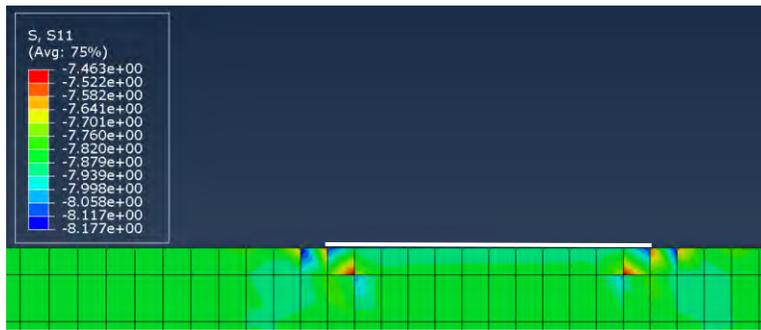
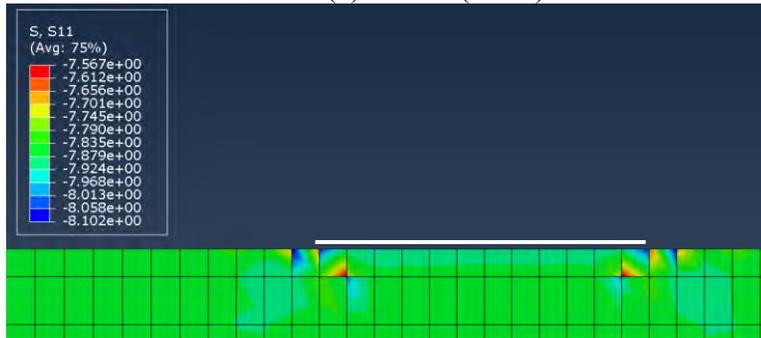
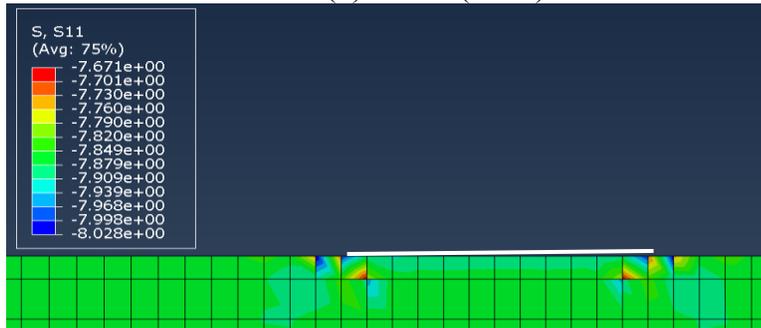
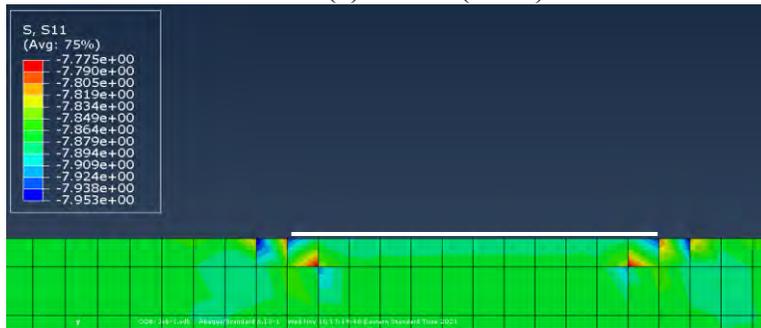
Figure 39: Transverse stress (MPa) variation with marking temperature

To further investigate the temperature differential effect on stress development, a sensitivity analysis was performed. The temperature of the marking was changed to 131°F (55°C), 122°F (50°C), 113°F (45°C), and 100°F (40°C), while the temperature of asphalt surface remained 140°F (60°C). Critical stresses in the transverse direction, which are responsible for cracking, are shown in Figure 39.

With the increase in temperature of the marking area, the temperature difference between asphalt surface and marking surface decreases and the magnitude of tensile stress singularities decrease as well. This further indicates the potential damaging effect of the temperature difference caused by the different absorptivity of the pavement and marking.
