Corrosion Repair Strategies for Steel Girder Ends Using High Performance and Traditional Materials

FINAL REPORT

By Kent A. Harries, PhD, PEng
University of Pittsburgh

CONTRACT # 4400018535 / 511801
WORK ORDER # PIT 002

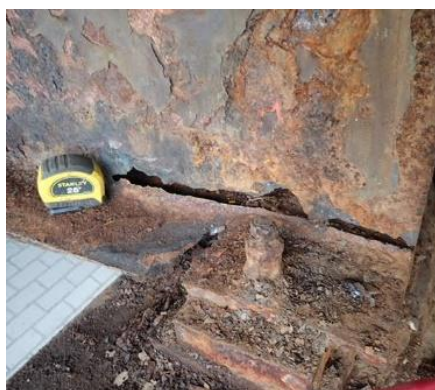
A few reports identified distortion of the corroded girders at the end bearings. Bridge B exhibits an extreme example of M1 damage – the complete loss of the web section above the bearing extending approximately one bearing length into the span (Figure 5a). This bearing region also has what appears to be a cut through the entire flange just inboard of the bearing (Figure 5b). The combination of the loss of web section, the absence of a bearing stiffener, and the now nonsymmetric section results in a lateral displacement of the web as seen in Figure 5c. It should be clear from Figure 5 that without a bearing stiffener, this girder end is presently carrying no appreciable load. Bridge B has only four girders and therefore a considerable incremental load has been redistributed to the remaining three girders at this pier support. Although not noted and not seen in Figure 5, one expects a distortion of the flange to accompany this damage.

a) Pattern M1 damage
(b = 17 in.; a = 1.5 in.)

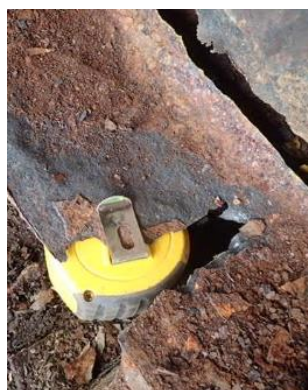
b) apparent cut through
bottom flange

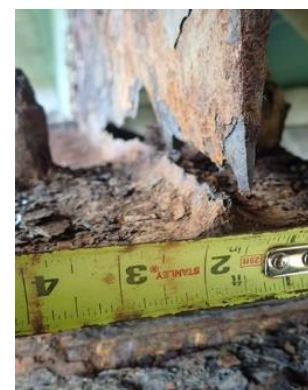
c) lateral distortion of web

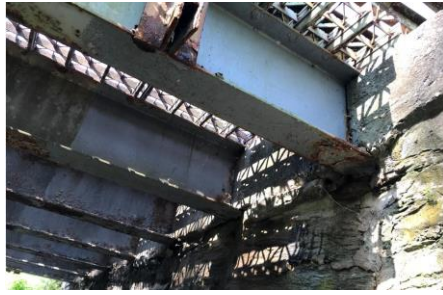
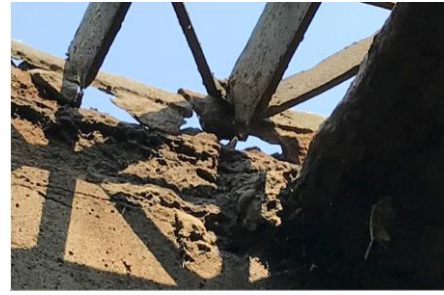
a) condition of far abutment prior to encasement (pre 2020)

note relatively little beam end corrosion compared to near abutment shown in Appendix A.

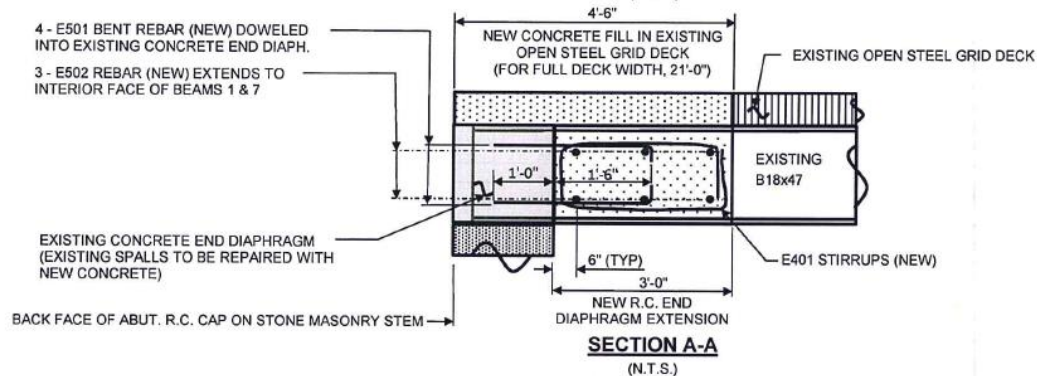
b) detail of steel-formed encasement

Finally, Bridge I has a steel-formed concrete encasement at the far abutment (Figure 9). This encasement, built in early 2020, was provided to address significant deterioration of the steel grid deck and top of the far abutment (PennDOT *personal correspondence* 2020); it was not provided to address beam end corrosion. The embedded girder ends at the near abutment show significant deterioration including instances of complete web loss and near total flange plate loss (see Appendix A). However, the 2018 inspection report does not identify a similar level of damage at the far abutment. The encasement is constructed of [stay-in-place] vertical and horizontal steel plate forms spanning between girder webs into which normal strength (Class AA) concrete is placed. The new concrete is made composite with existing abutment with four #5 dowels in each 42 in. bay. Six #5 bars are placed transversely along the new diaphragm through holes in the interior girders. To some extent, these will ensure that the beam is engaged in the concrete diaphragm (as shear studs would). It is unclear why steel stay-in-place forms were used as these are not shown in the detail (Figure 9b).

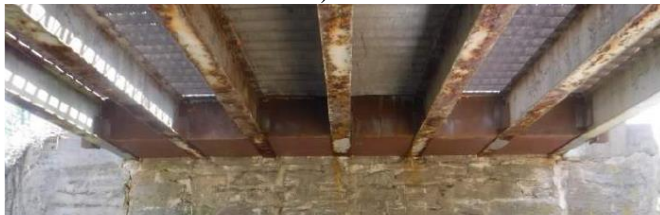
c) steel-formed concrete encasement at far abutment (post 2020)

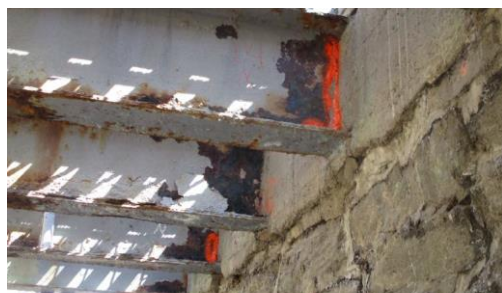
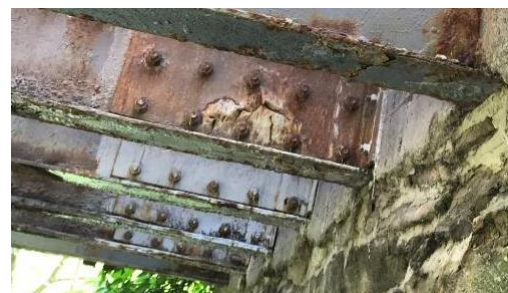
During the review of Bridge I repairs, an additional apparent repair of girder end corrosion at the near end abutment was identified; this is shown in Figure 10. The repair appears to be a bolted steel web plate anchored to the abutment with a bolted and anchored clip angle. It is unclear whether this repair is one or two sided; no details of this repair are available to the research team.

a) beams 4 to 7 reported April 2018

b) beams 3 to 6 reported June 2019

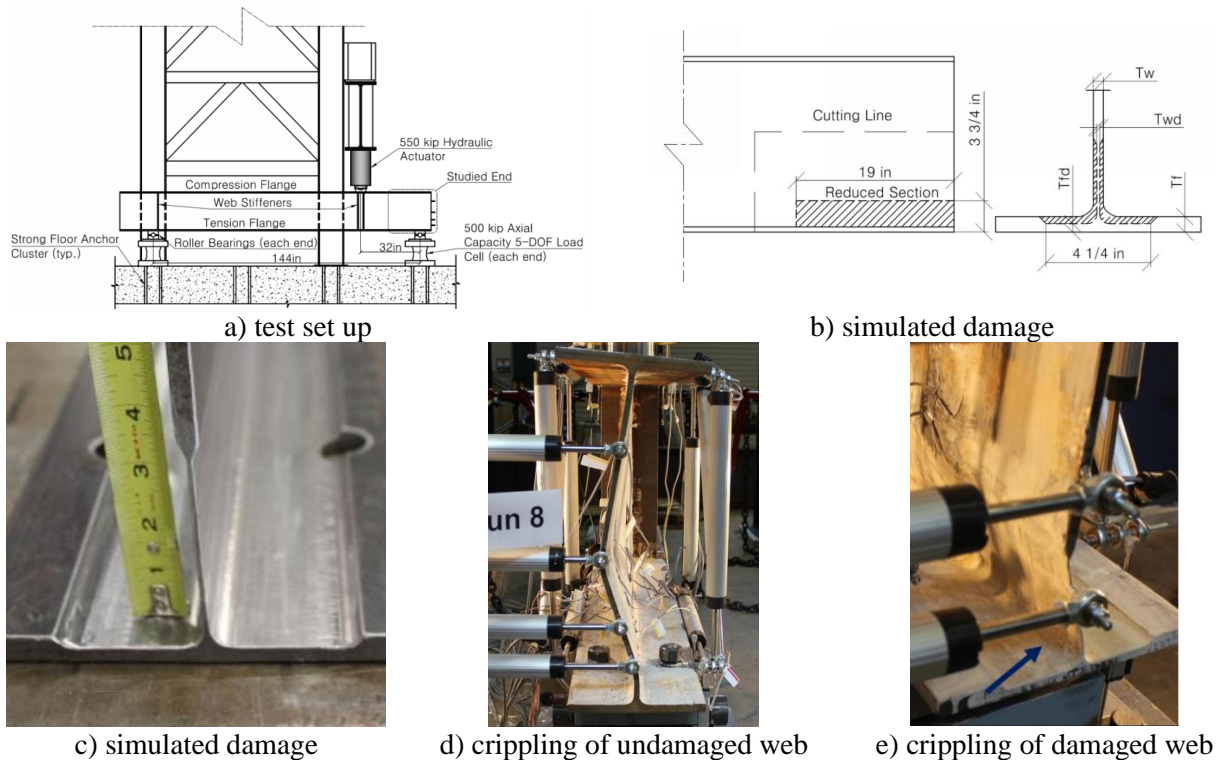
An undamaged control specimen and two specimens having artificial corrosion damage (Figures 13b and c) – produced by thinning the web using a milling machine – were tested. The rectangular damaged region extended 19 in. along the girder and extended 3.75 in. up the web (i.e., Pattern W1 with $C_L = 19$ in. and $C_H = 3.75$ in.). A portion of the flange was also removed as seen in Figures 13b and c. The resulting plate thickness of each damaged girder is given in Table 8. The nominal residual capacity of this damaged girder based on web crippling capacity (Eq. 6) is only 18.4 kips (the other capacities will not fall as dramatically). A quirk of this study is that in order to produce the damage, a tee-section was cut from the original girder, the damaged simulated on this, and then the tee was replaced into the girder using full-penetration groove welds. The cut-line is shown in Figure 13b and only the tee is shown in the left image in Figure 13b. A second concern that must be noted is that the

The undamaged girder behaved largely as expected, exhibiting a web crippling failure (Figure 13d) at an applied bearing load of 180 kips, demonstrating considerable reserve capacity. The damaged girder exhibited a web crippling failure at an applied bearing load of 43.4 kips. This failure is characterized by a ‘kink in the web at the top of the damaged region (i.e, at the change in section) as seen in Figure 13e. The damaged girder exhibited considerably greater residual capacity than predicted although it only achieved about 35% of its nominal capacity exhibiting about 66% web material loss.

Figure 13 Test set-up and damaged girders reported by Zmerta (2015)

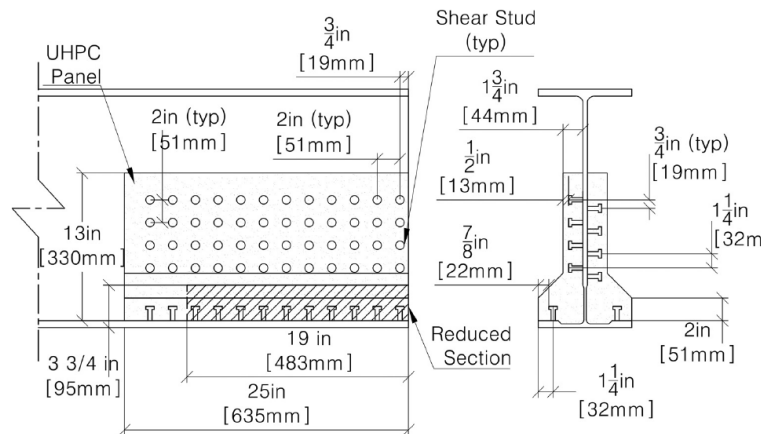
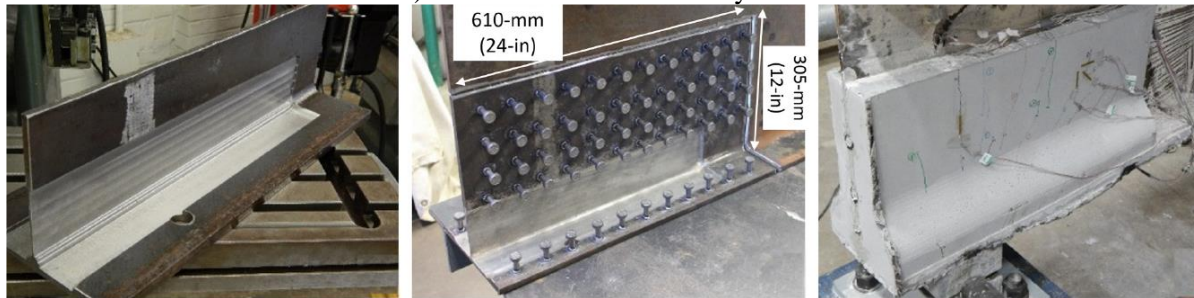
a) headed stud and UHPC layout

b) progression of repair [note that left image shows only damaged tee region prior to being rewelded into girder]

The second damaged specimen was repaired using UHPC. The repair, shown in Figure 14, consisted of 1.75 in. thick UHPC panels on both sides of the web extending 25 in. along the beam and 13 in. (about two-thirds) up the web. Forty-eight 3/8 in. diameter by 1.25 in. long headed shear studs were applied to both sides of the undamaged region of the girder web (96 studs in all). Twelve additional studs were applied to each bottom flange outstand (24 in all). All studs were applied on a 2 in. pattern

as shown in Figure 14a. The stud patterns were offset 1 in. on either side of the web. ‘Bulb-shaped’ UHPC panels were installed as shown in Figure 14b; the single-use forms were reportedly milled from 2 in. foam insulation boards.

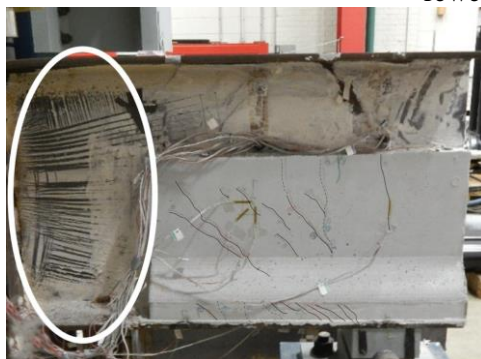
As reported in Table 8, the UHPC-repaired girder exhibited the first cracks in the UHPC at a bearing load of 35 kips. Shear cracks appeared at 69 kips and the girder exhibited evidence of web yielding (circled regions in Figures 14c and d) at an applied bearing load of 176 kips when the test was stopped. The observed cracking of the UHPC was relatively well distributed and minor (Figures 14c and d). The inclination of the cracks suggest a compressive strut developed in the UHPC resisting the bearing force. The UHPC prevented the web from buckling and/or crippling.

c) cracking of near side of UHPC panel
(end of girder at right)

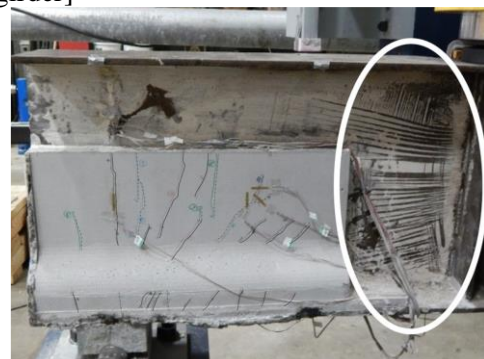
d) cracking of far side of UHPC panel
(end of girder at left)

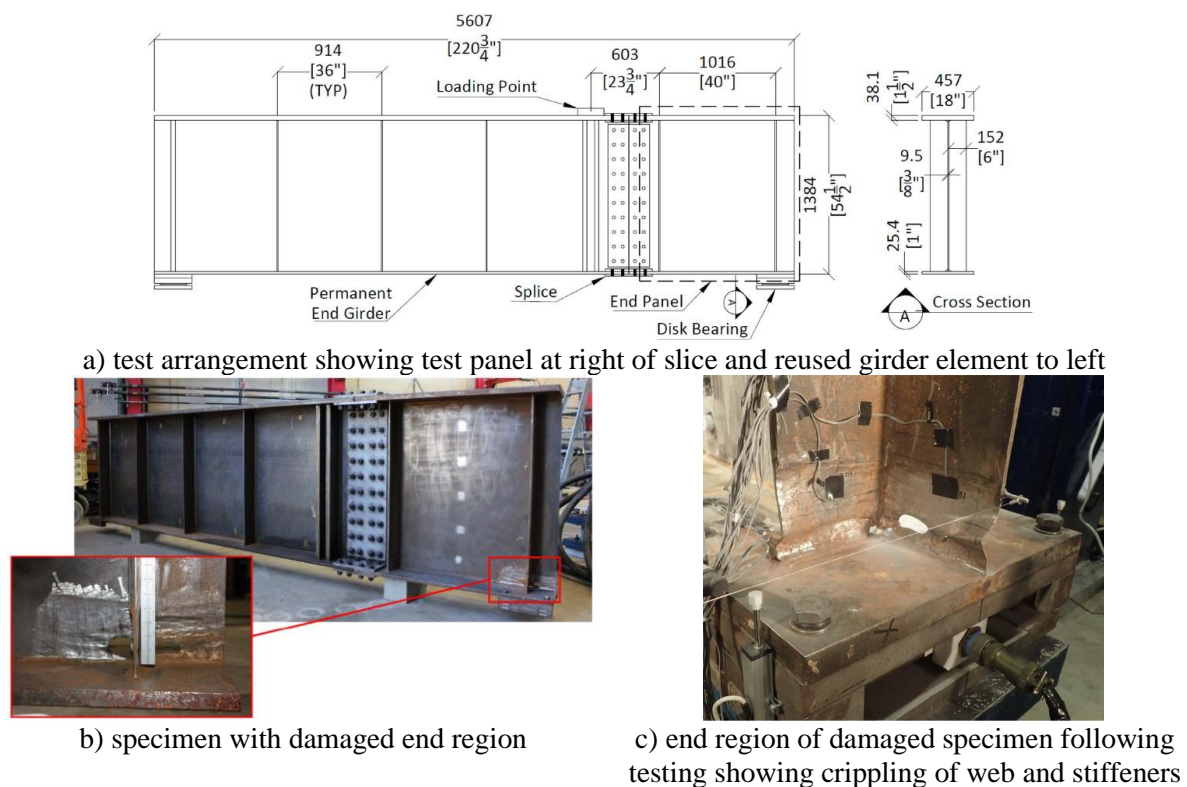
Corrosion was simulated by a combination of grinding and sandblasting resulting in the localized damage shown in Figure 16b. Simulated damage was targeted at 66% of web and stiffener plate loss and 50% of flange plate loss concentrated in a region at the end of the girder. The damage pattern was W1 with $C_L = 8$ in. and $C_H = 5$ in. As seen in Figure 16b, small regions of 100% section loss were simulated immediately above the bearing (Pattern M1: $a \approx 2$ in.; $b \approx 4$ in.). The bearing capacity of the damaged girder was 95.3 kips (Table 10) controlled by crippling of the reduced web and stiffener as seen in Figure 16c. Another important observation made by McMullen is that the failure of the specimen having more realistic, non-uniform damage exhibited more gradual reduction of stiffness than observed for the very uniform artificial damage reported by Zmerta (2015) and Kim et al. (2013).

Figure 16 Test set up and damage reported by McMullen and Zaghi (2020)

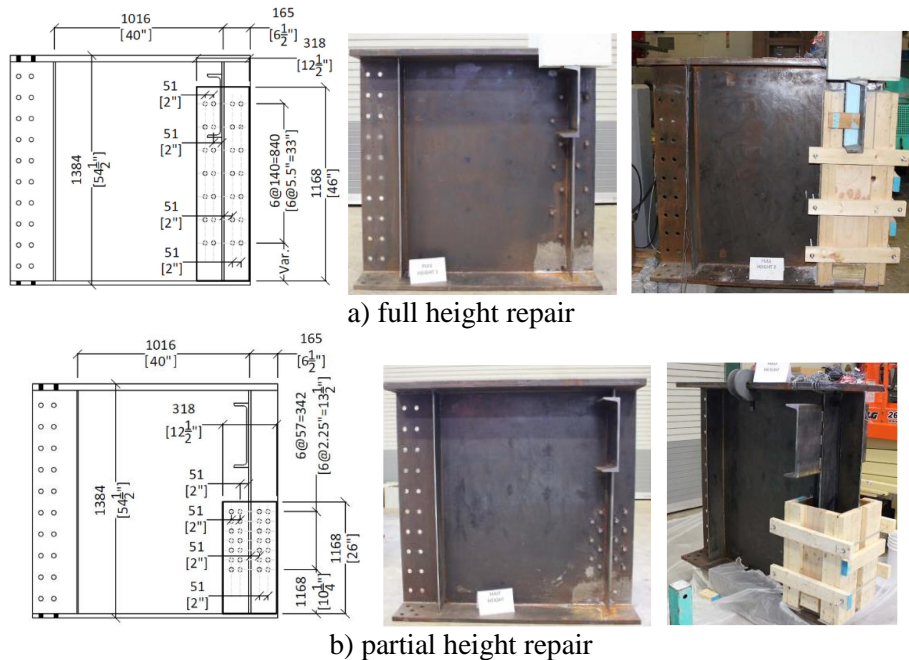
Figure 17 UHPC repairs reported by McMullen and Zaghi (2020)

UHPC encasement, shown in Figure 17, was limited to a 'stub column' immediately above the bearing, encasing the bearing stiffener region only. Two repairs extended the full height of the 52 in. web while the third extended 26 in. Two commercially available UHPC mixes having strengths exceeding 20 ksi were used (see Table 10). Ductal® JS1212 is a high early-strength mix (intended to

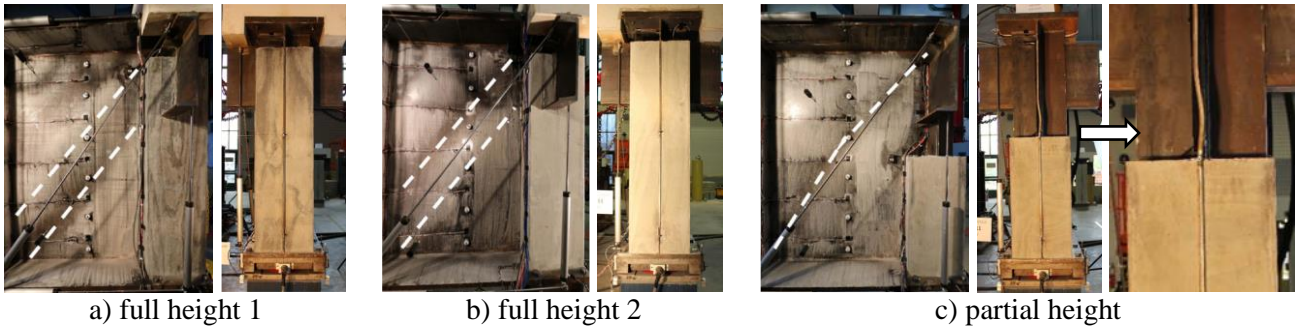
Test results of the UHPC repaired girders are provided in Table 10. Both full-height repairs behaved similarly, achieving the nominal capacity of the undamaged girder (495 kip bearing capacity) and exhibiting a tension field buckling failure in the web panel immediate adjacent the repair. The failures are shown in Figure 18. The partial height repair exhibited some tension field behavior but ultimately, the web crippled immediately at the top of the UHPC (Figure 18c). Because tension field behavior was engaged, all repaired girders exhibited post-peak residual capacity exceeding 85% through displacements exceeding twice those at the ultimate capacity.

Figure 18 Failure modes of UHPC encased girders reported by McMullen and Zaghi (2020)

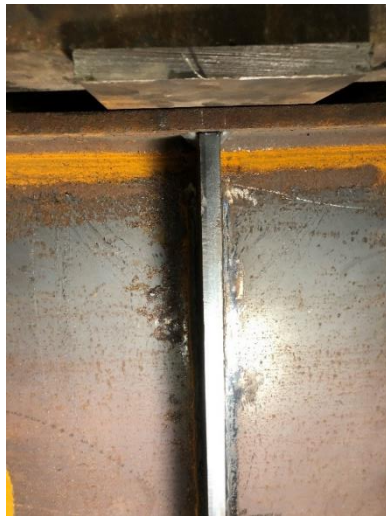
Figure 49 Girder 1A following testing.

Undamaged control Girder 1A behaved essentially as predicted, achieving a maximum shear capacity $V = 213$ kips ($v = 27.7$ ksi). This capacity corresponded to web yield beneath the applied load (260 kips applied over a 5 in. length of flange); this is shown in Figure 49. The predicted capacity based on this limit state was an applied load of 256 kips or shear of 210 kips. Nonetheless, strain data (Figure 48) indicated that web buckling had also just initiated at this capacity.

a) yield lines expressed in mill scale under point of application of load

b) distortion of top flange associated with web yield under point of application of load

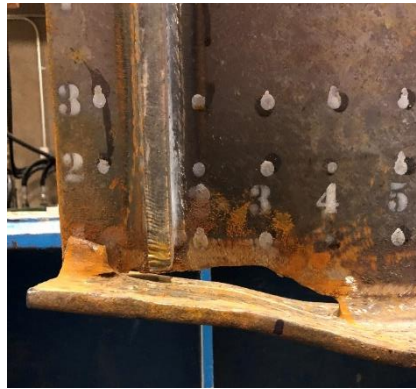
Figure 50 Girder 2A during and after testing.

Unrepaired corroded Girder 2A exhibited little capacity, achieving a shear resistance of barely 7% of 1A: $V = 15.1$ kips ($v = 2.0$ ksi). In this girder, shown in Figure 50, the bearing capacity was provided almost entirely by the bottom flange bending about its weak axis. The web collapsed and some residual capacity was observed at displacements exceeding 0.75 in. (Figure 47) as the hole in the web physically closed and began to bear again on the flange.

b) residual distortion of bearing region after testing

c) complete collapse of the web

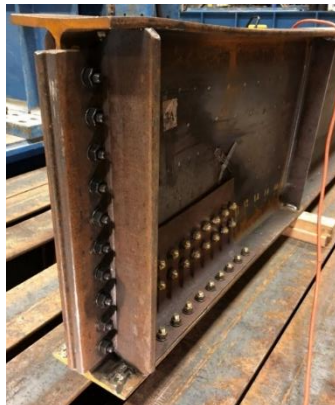
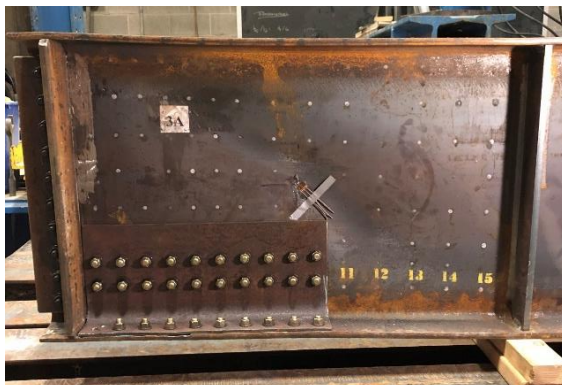
Figure 51 Girder 3A following testing.

Girder 3A demonstrated a conventional bolted steel repair. The girder capacity was effectively restored to approximately that of 1A: $V = 197$ kips ($v = 27.3$ ksi). 3A exhibited very clear web buckling in the unstrengthened region of shear span as shown in Figure 51. Following testing, the bolted stiffeners were removed (Figure 51d); no web distortion or collapse was observed although a few of the bolt holes appear to show evidence of bolt-bearing distortion ('ploughing').

a) bearing region following testing

b) web distortion following testing and removal of stiffeners

c) web buckling

d) bearing region following testing and removal of stiffeners

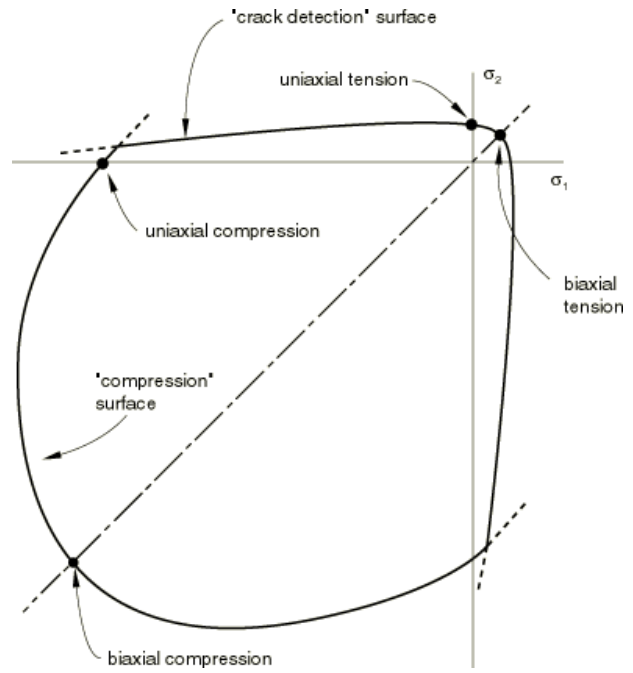
c) concrete failure surface

The plane stress smeared crack concrete failure surface adopted in ABAQUS is that described by Kupfer and Gerstle (1973) and is shown in Figure 65c. Four failure ratios are required:

Figure 65 ABAQUS smeared crack concrete model.

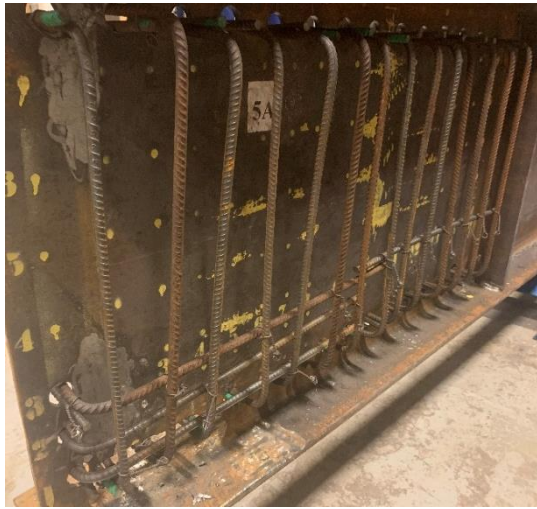
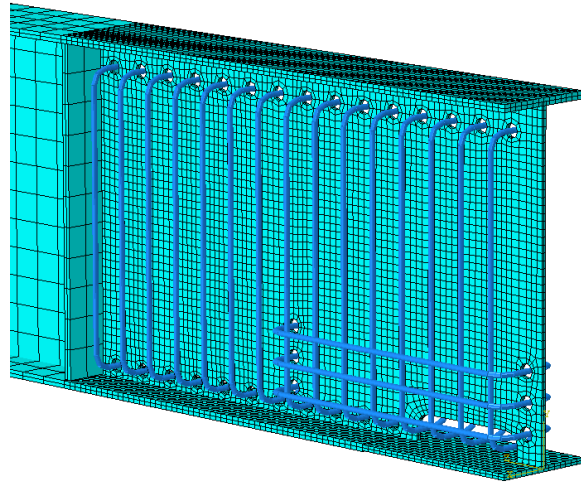
Figure 66 Modeling internal reinforcing steel of Girder 5A.

ABAQUS supports the discrete modeling of internal reinforcing steel. T3D2, two node linear displacement truss, elements are used to model conventional 60 ksi steel reinforcement (Figure 66). The reinforcement is embedded in the concrete using an embedment constraint. Initially this constraint is rigid, implying 'perfect bond' although it can be calibrated for experimentally

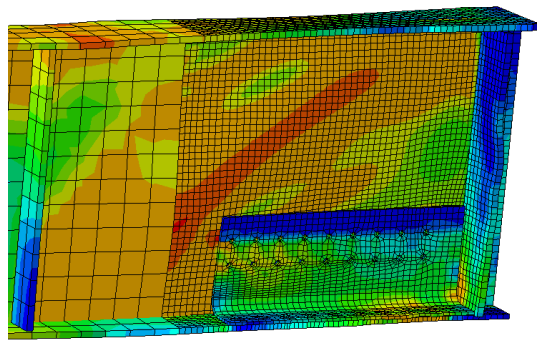
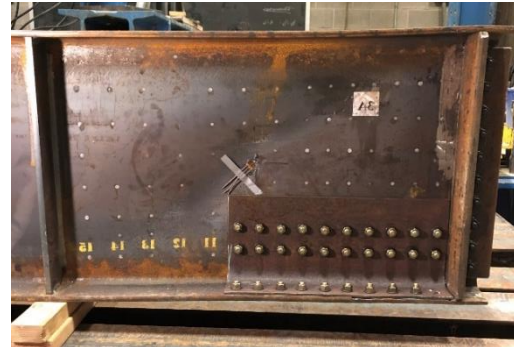
Figure 71 Bolted steel repair.

Bolted steel repairs are modeled in the same manner as the substrate steel using actual geometry, S4R elements, and the same isotropic material model. Mesh size matches the substrate steel and bolts are modelled using tie constraints. Bolts holes were included in the model that matched the pattern of the test specimen. Normal compression is transferred through 'hard contact'. The FE-predicted shear capacity was 200 kips as compared to an experimental capacity of 197 kips. As seen in Figure 71, tension field behavior was predicted.

a) girder end view with tension field action evident

b) observed behavior following testing (image mirrored)

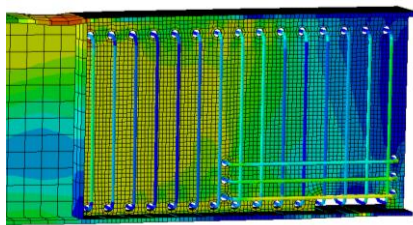
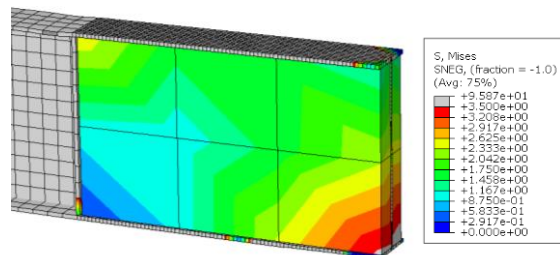
Figure 73 NSC encasement repair.

Girder 5A was modeled as tested. The FE-predicted shear capacity was 200 kips and the tested capacity was 199 kips. The specimen failed by concrete crushing (Figure 73). The steel web and internal reinforcing bars remained elastic.

a) bearing region shown with concrete elements hidden

b) concrete crushing ($f_c' = 3,161$ psi) stress over 3,500 psi grayed out

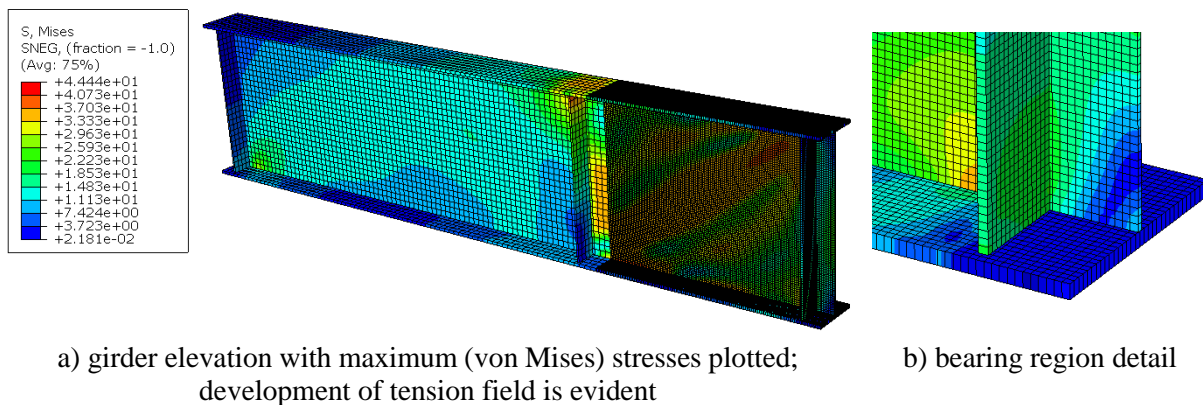
Figure 74 Undamaged girder predicted behavior at failure.

The undamaged plate girder was modeled with the load applied $1.5D = 81$ in. from the centerline of the bearing ($a/d = 1.5$). The FE-predicted shear capacity was 183 kips in shear (measured as the reaction at the bearing). As seen in Figure 74, local web yield is evident at the bearing although the bearing stiffener remains mostly elastic. The predicted failure is web shear of the panel. The AASHTO-predicted capacity of this section is 186 kips.

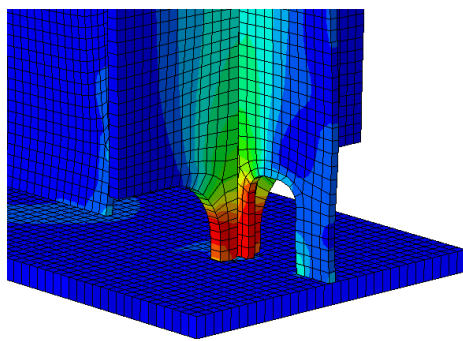
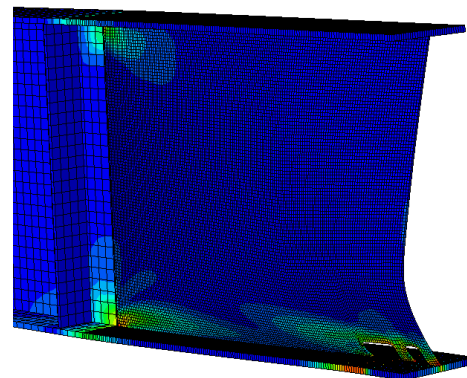
Figure 75 Bearing region failure of Case I archetypical damage
(stress plots on deformed model)

The damaged plate girder was modeled based on the archetypal damage described in Figure 29. The FE-predicted capacity was 100 kips and failure, shown in Figure 75a was characterized as web yield, followed by crippling. Without the bearing stiffener present, the AASHTO-predicted web yield capacity for this case is 99 kips.

Repeating this analysis without the bearing stiffener, the FE-predicted capacity falls to 45 kips and web instability is clearly evident (Figure 75b). For this case, without a stiffener, the AASHTO-predicted web crippling capacity is 37 kips, the web yield capacity is 99 kips while the web shear capacity is approximately 80 kips.

- i. Verify capacity of the unstiffened web prior to removal of bearing stiffeners (see Figure 75b) and provide temporary support as required.
- ii. Replacement bearing stiffeners shall be applied to both sides of the girder web.
- iii. Bolted replacement stiffeners shall be steel angles whose out-stand leg dimensions are at least those of the bearing stiffener being replaced or required based on AASHTO LRFD requirements.
- iv. The leg bolted to the web shall be sufficient to accommodate a single vertical row of bolts.

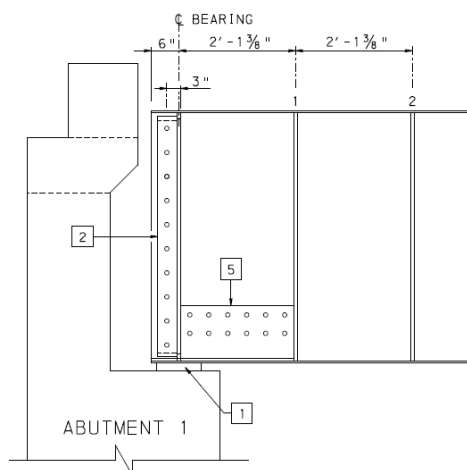
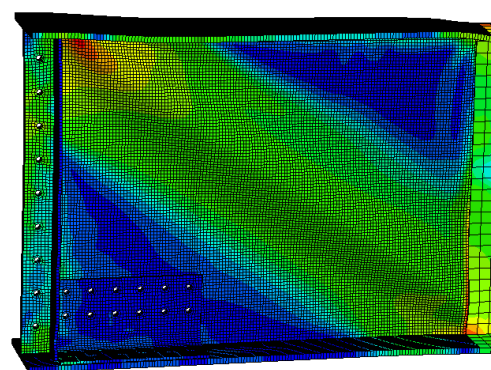
Figure 76 Bolted steel repair.

Not surprisingly, considering the significant stiffening effect of the repair, the FE-predicted capacity increased to 297 kips. At 297 kips, a tension field has clearly developed in the shear panel as can be seen in Figure 76b. The conservatively designed repair plates have mitigated web yield and crippling.

a) Bridge D repair (intermediate stiffeners are not modeled)

b) stresses at girder end (tension field is evident)

Bolted steel repairs are modeled in the same manner as described in Section 4.3.3. The repair details, shown in Figure 76a are those used to repair Bridge D in the field³³. The 7 x 5/8 in. bearing stiffeners are replaced with considerably stiffer L9.5x5x3/4 SLBB angles. Section loss to the lower region of the 3/8 in. web is repaired with 0.5 in. bent plates, extending 12 in. up the web and across the full width of the flange, on both sides of the web.

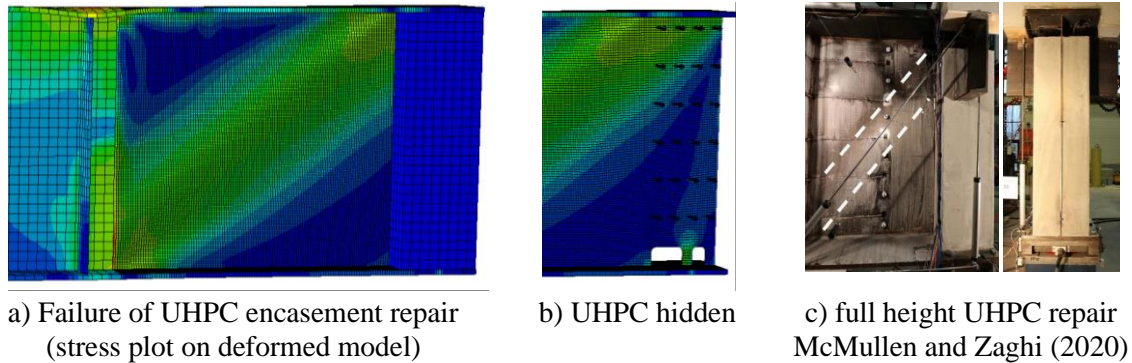
Figure 77 UHPC encasement repair.

The UHPC encasement modeled is similar to the full height repairs proposed and tested by McMullen and Zaghi (2020) and shown in Figure 77c. In this model, 19 ksi UHPC was modeled. The UHPC columns extend the full height of the web, the full breadth of the flanges, and 16 in. along the length of the beam. Four vertical rows of bolted studs are used in the undamaged region of the web (Figure 77b). The stud spacing is 8 inches vertically and 4 inches horizontally.

The FE-predicted capacity was 244 kips, exceeding the 183 kip capacity of the undamaged girder. As reported in McMullen and Zaghi, the model shows evidence that tension field action was being developed over the shorter shear panel bounded by the UHPC and bearing stiffener at the load point (Figure 77a).

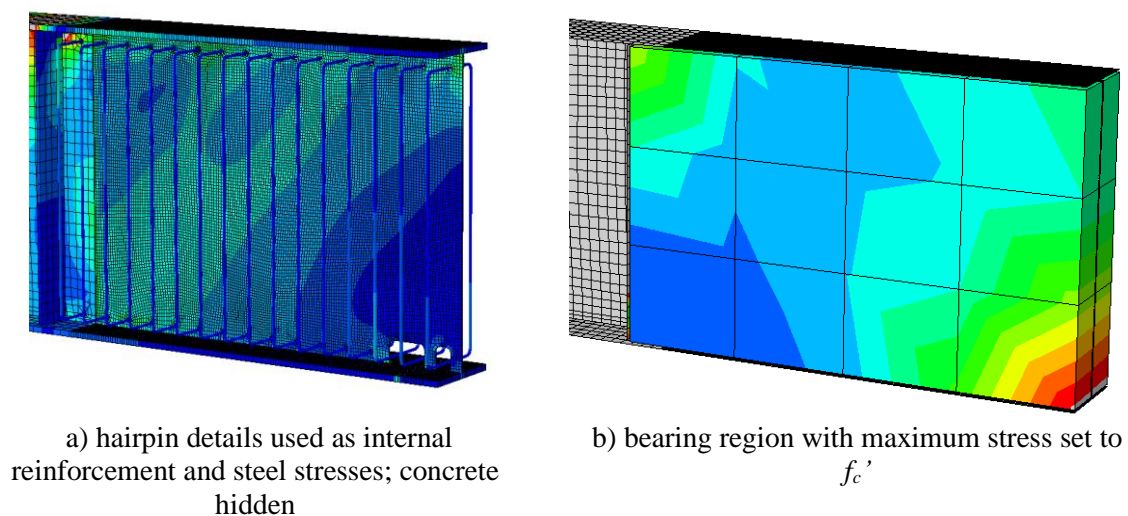
Figure 78 NSC encasement repair.

In this model, shown in Figure 78, the loaded girder end region was encased in 5 ksi normal strength concrete. The reinforcement detail includes conventional 60 ksi hairpins passing through the web. This detail provides reinforcement development, continuity through the web, and eliminates the need for shear studs.

The FE-predicted capacity was 250 kips. The concrete encasement provided adequate lateral support to the damaged web. The web remained stable over its entire depth. Figure 78a shows the stress in the embedded reinforcement and indicates that this steel remained elastic ($f_s < 34.8$ ksi).

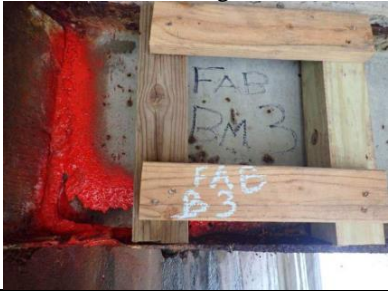
E-M4: b = 1; a = 1 E-W3: C _{L3} = 24; C _{L1} = 5; C _{H1} = 2; C _{H2} = H ₀ ; t _{w min} = 0.125 (28%) >50% loss of flange over 17 in.

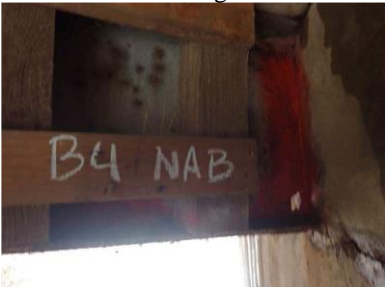
4	E-M4: b = 3; a = 1.5 E-W3: C _{L3} = 17; C _{L1} = 2; C _{H1} = 3.5; C _{H2} = H ₀ ; t _{w min} = 0.125 (28%) (away from M4) 100% loss of flange over 4 in.

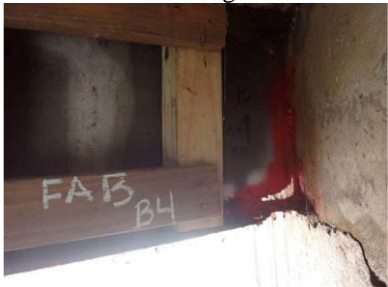
Near end	Beam	Far end
E-W1: $C_{L1} = 12$; $C_H = 1$; $t_w = 0.125$ (28%)	5	<p><i>E-M4: $b = 2$; $a = 2$</i></p> <p>E-W3: $C_{L3} = 12$; $C_{L1} = 2$; $C_{H1} = 2$; $C_{H2} = H_o$; $t_{w \min} = 0.19$ (43%) (away from M4) 100% loss of flange over 4 in.</p>  
E-W3: $C_{L3} = 5$; $C_{L1} = 2$; $C_{H1} = 3$; $C_{H2} = H_o$ $t_{w \min} = 0.06$ (14%) 12% loss of flange over 6 in.	6	<p>E-W3: $C_{L3} = 12$; $C_{L1} = 1$; $C_{H1} = 2$; $C_{H2} = H_o$; $t_{w \min} = 0.125$ (28%) 85% loss of flange over 4.5 in.</p>

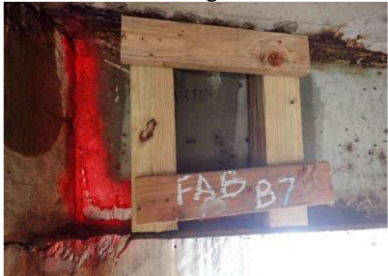
<p><i>E-M4: $b = 12$; $a = 1$</i></p> <p>E-W1: $C_{L1} = 23$; $C_H = 3$; $t_w = 0.25$ (57%) 85% loss of flange over 7 in.</p>

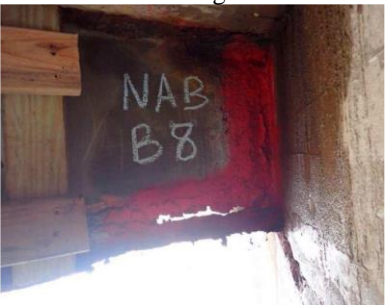
8	<p><i>E-M4: $19 = 12$; $a = 3$</i></p> <p>E-W3: $C_{L3} = 26$; $C_{L1} = 6$; $C_{H1} = 3$; $C_{H2} = H_o$; $t_{w \min} = 0.125$ (28%) (away from M4) 75% loss of flange over 10 in.</p>

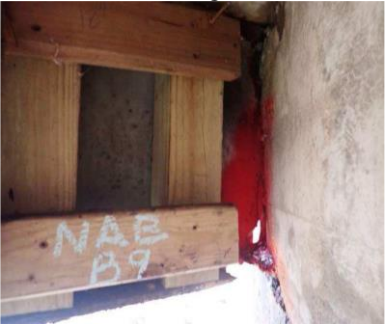
9	no reported damage

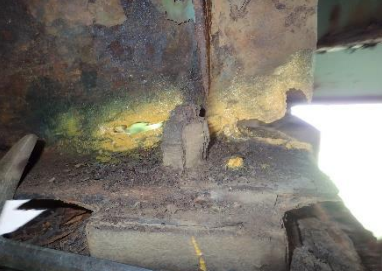
Pier 3 Span 4 Beam 3	M1: $b = 3.5$; $a = 2.5$ span 3 girder end seen on left

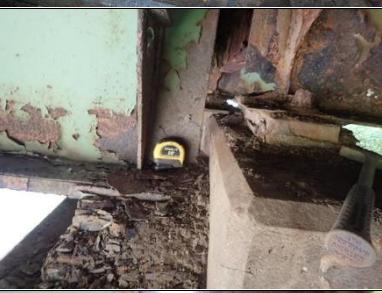
Pier 3 Span 3 Beam 1	W1: $C_L \approx B_L$; $C_H \approx$ $B_L/2$

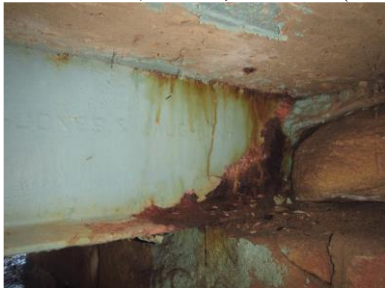
2	W5: $C_L \approx 2B_L$; $C_H \approx 8$; $t_w = 0.32$ (83%)

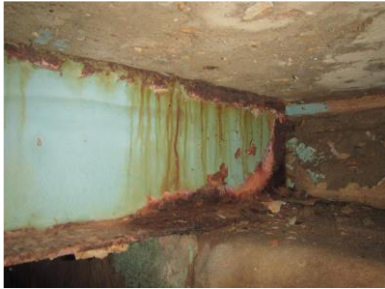
W2: $C_{L1} \approx C_{L2} \approx B_L$; $C_H \approx 3.5$; $t_w = 0.32$ (83%) 100% loss of bottom flange at end of beam

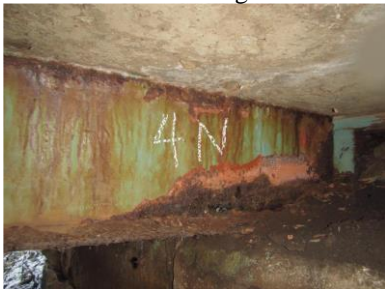
4	W3: $C_{L1} \approx B_L$; $C_{L2} \approx B_L/2$; $C_{H1} \approx 3.5$; $C_{H2} = 9$; $t_w = 0.32$ (83%) >50% loss of bottom flange at end of beam

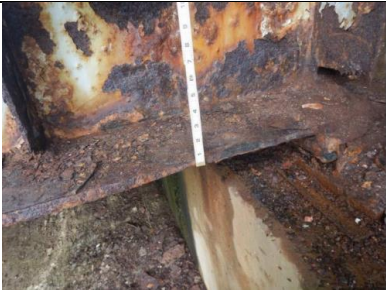
Span 1 Girder 1 Near Abutment	M1: $b = 5$; $a = 2$; bearing stiffener W1: $C_L \approx 24$; $C_H \approx 6$

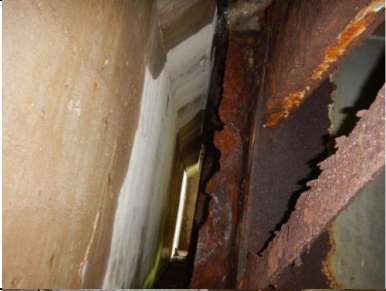
Span 1 Girder 2 Near Abutment	M3: $b \approx 2$; $a \approx 12$; behind CL bearing W1: $C_L \approx 12$; $C_H \approx 56$

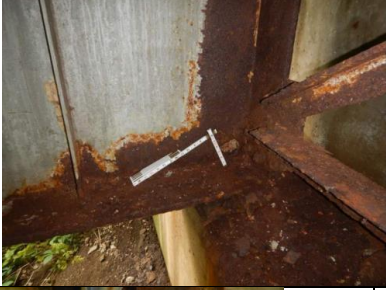
Span 1 Girder 6 Near Abutment	M1: $b = 3$; $a = 3$ W4: $C_{L1} \approx 20$; $C_{L2} \approx 40$; $C_{L3} \approx 12$; $C_{H1} \approx 6$; $C_{H2} \approx 56$;

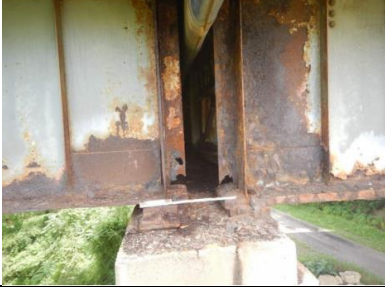
Pier 3 Span 3/4 Girder 6	Span 3 M1: $b = 6$; $a = 4$ (web) M1: $b = 6$; $a = 6$; (bearing stiffener) W4: $C_{L1} \approx 24$; $C_{L2} \approx 36$; $C_{L3} \approx 6$; $C_{H1} \approx 12$; $C_{H2} \approx 56$

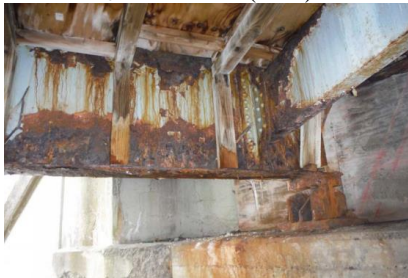
4	no reported damage
W1: $C_L \approx 144$; $C_H \approx 24$ $t_{w \min} = 0.505$ (81%) $t_{bf \min} = 0.279$ (31%)

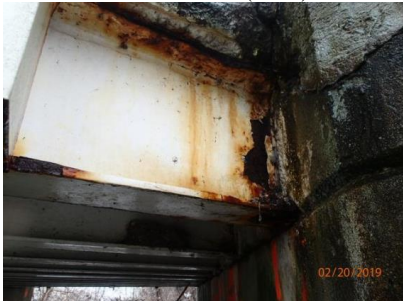
Near end	Beam	Far end
E-W1: $C_L = 6$; $C_H = 12$ $t_{w \min} = 0.195$ (63%)

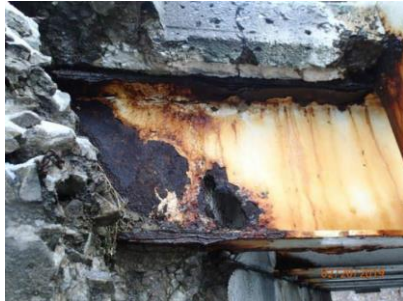
1	M1: $b = 4$; $a = 6$ E-W5: $C_L = 20$; $C_H = 14$

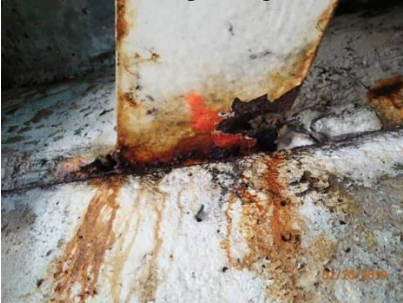
no report damage	6	2" of 100% loss along the right bottom flange

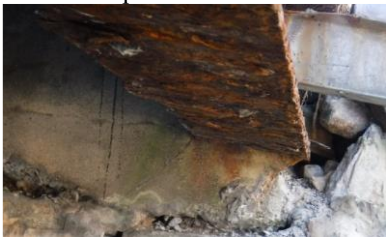
Near end	Beam	Far end
E-W1: $C_L = 4.5$; $C_H = 14$ beam reported to be 'twisted'

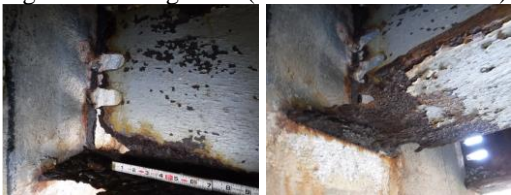
1	E-W1: $C_L = 3$; $C_H = 14$
E-W1: $C_L = 5$; $C_H = 14$	2	E-W1: $C_L = 1$; $C_H = 9$ significant flange loss (reduced to 7.5 in. wide)

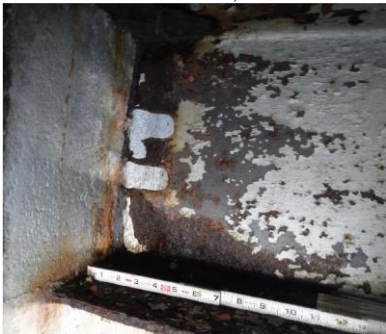
E-W1: $C_L = 3.5$; $C_H = 14$

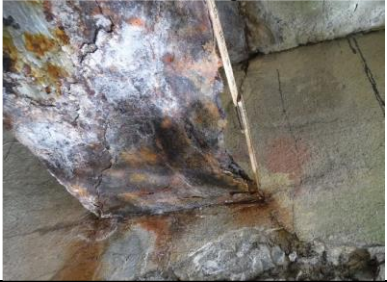
7	E-W1: $C_L = 3.5$; $C_H = 14$ section loss of bottom flange (reduced to 9 in.)

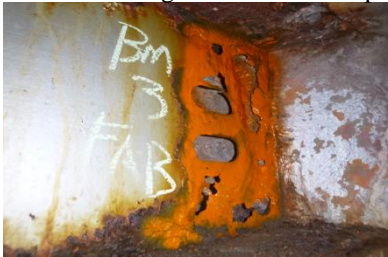
Near end	Beam	Far end
<p>M1: $b = 6$; $a = 1.5$ right side of bottom flange has 100% section loss; 8.5" remain of original 10.5"</p>	3	<p>1/8" web thickness remaining; dimensions and original section not reported</p>

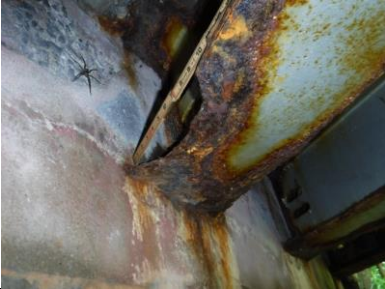
<p>9" of 100% section loss to bottom flange</p>

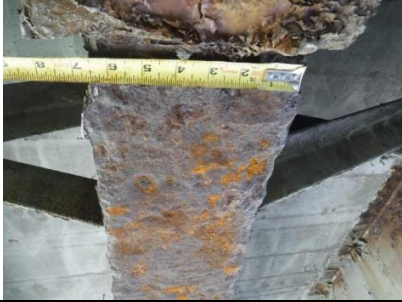
Pier 1 Span 1 Girders 2-5	$t_{bf \min} = 1/4''$ (67%) no section loss to web noted	
Pier 1 Span 2 Girders 2-5	$t_{bf \min} = 5/16''$ (71%) no section loss to web noted beam 4 shown at right

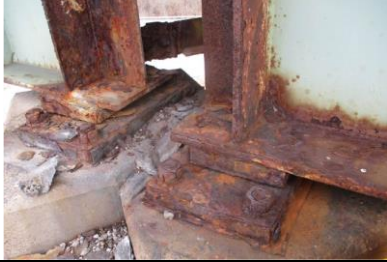
Pier 4 Span 5 Girder 1	W1: $C_L = 15$; $C_H = 2.5$ $t_{w \min} = 0.813''$ (81%)	
Pier 6 Span 6 Girder 1	M3: $b = 5$; $a = 3$ M3: $b = 0.375$; $a = 0.375$ W1: $C_L = 10$; $C_H = \text{full height}$ minor section loss noted

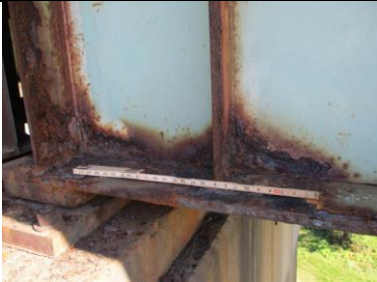
Pier 6 Span 7 Girder 1	M3: $b = 1.5$; $a = 1.5$ W1: $C_L = 6$; $C_H = \text{full height}$	
Pier 9 Span 9 Girder 1	W1: $C_L = 24$; $C_H = 5$ $t_{w \min} = 3/4''$ (75%) $t_{\text{stiffener, min}} = 1/4''$ (67%)

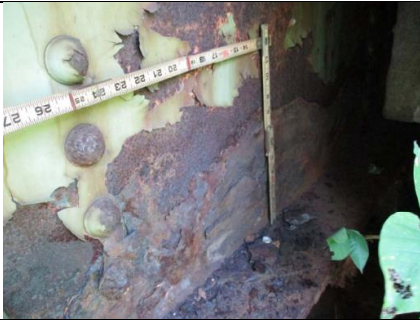
Near Abutment Span 1 Girder 1	W2: $C_{L1} = 132$; $C_{L2} = 12$; $C_H = 9$ $t_{w \min} = 0.493''$ (72%) $t_{bf \min} = 0.975''$ (89%)

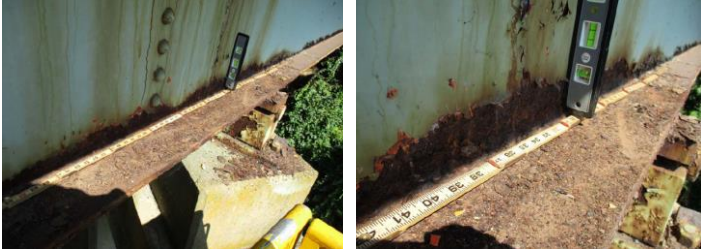
Near Abutment Span 1 Girder 8	W1: $C_L = 84$; $C_H = 6$ $t_{w \min} = 0.375''$ (55%) $t_{bf \min} = 0.538''$ (49%)	
Pier 1 Span 2 Girder 1	W1: $C_L = 96$; $C_H = 5$ $t_{w \min} = 0.493''$ (72%)	
Pier 2 Span 2 Girder 14	W1: $C_L = 120$; $C_H = 3$ $t_{w \min} = 0.493''$ (72%) $t_{bf \min} = 0.913''$ (83%)

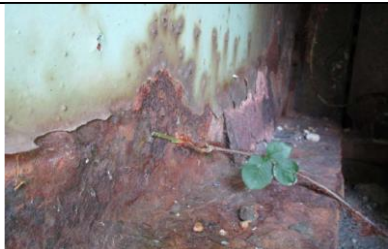
Far Abutment Span 3 Girder 1	W1: $C_L = 36$; $C_H = 3$	
Far Abutment Span 3 Girder 7	W1: $C_L = 132$; $C_H = 3$	
Far Abutment Span 3 Girder 14	W3: $C_{L1} = 12$; $C_{L2} = 120$; $C_{L3} = 132$; $C_{H1} = 9$; $C_{H2} = 34$; $C_{H3} = 9$ $t_{w \min} = 0.493''$ (72%)
