Interim Risk Reduction Measures for Seepage Mitigation and Stability Improvement at Laurel Mountain State Park Water Supply Impoundment

For: PITT IRISE

By: Fatma Ciloglu, Ph.D., P.E.
Geotechnical Department Manager

November 2020

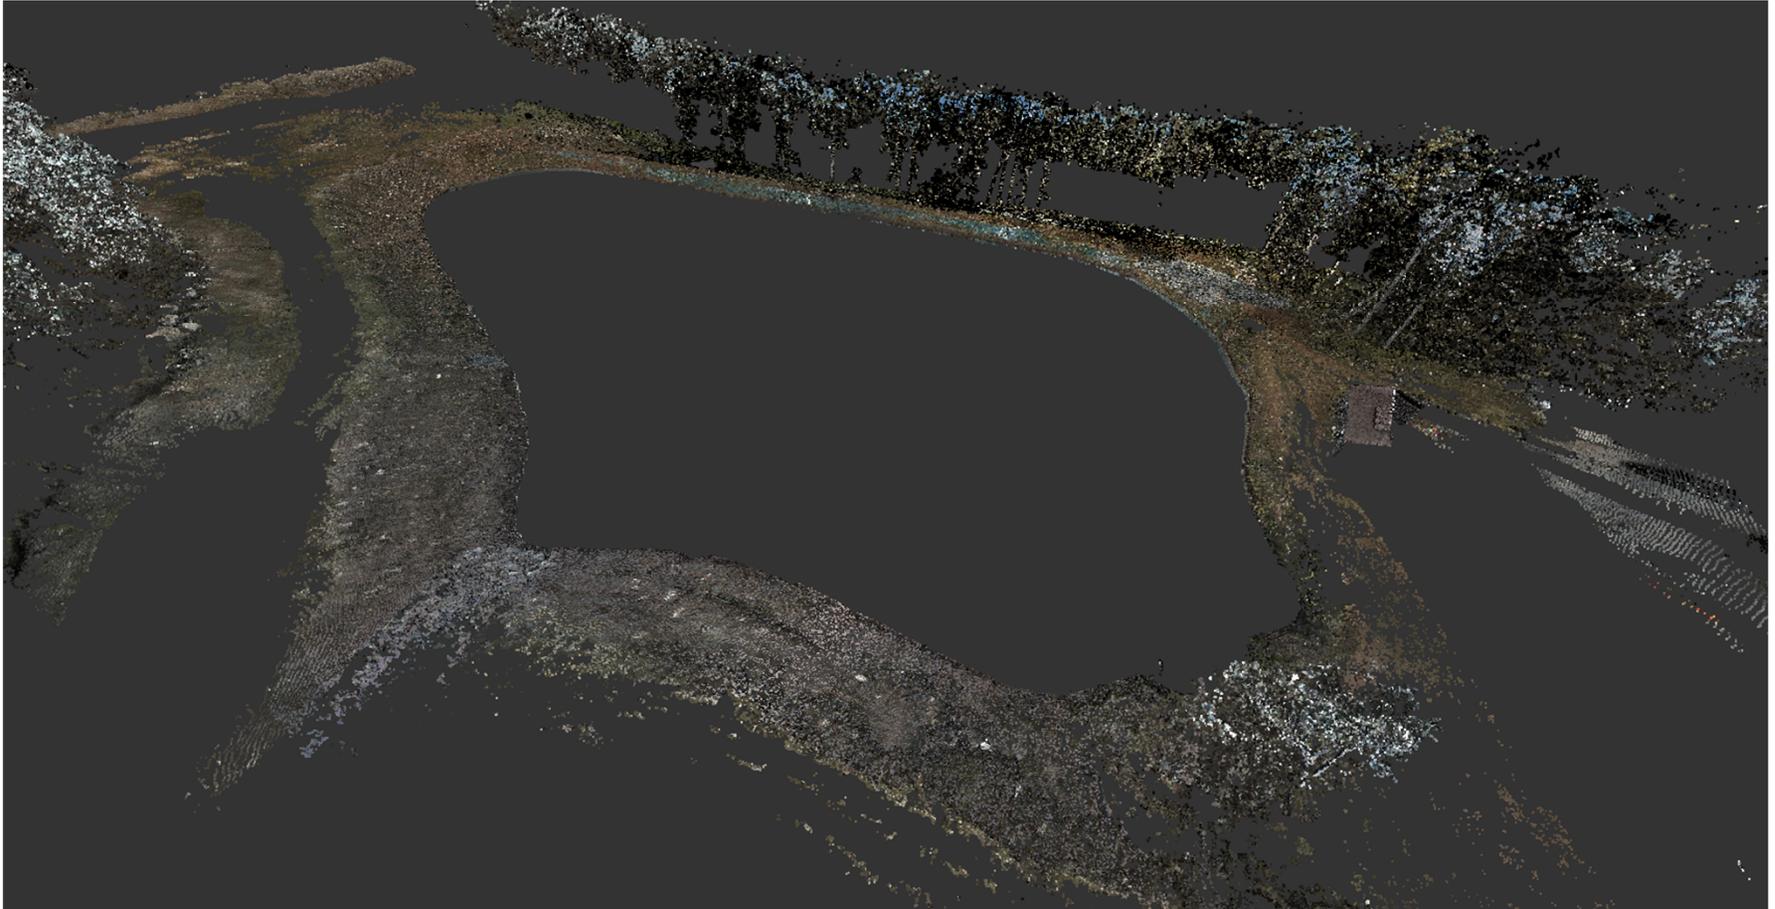
Static LiDAR (Light Detection and Ranging)

LiDAR Survey completed to map existing features, develop base plans & create seepage shape files using ArcMap

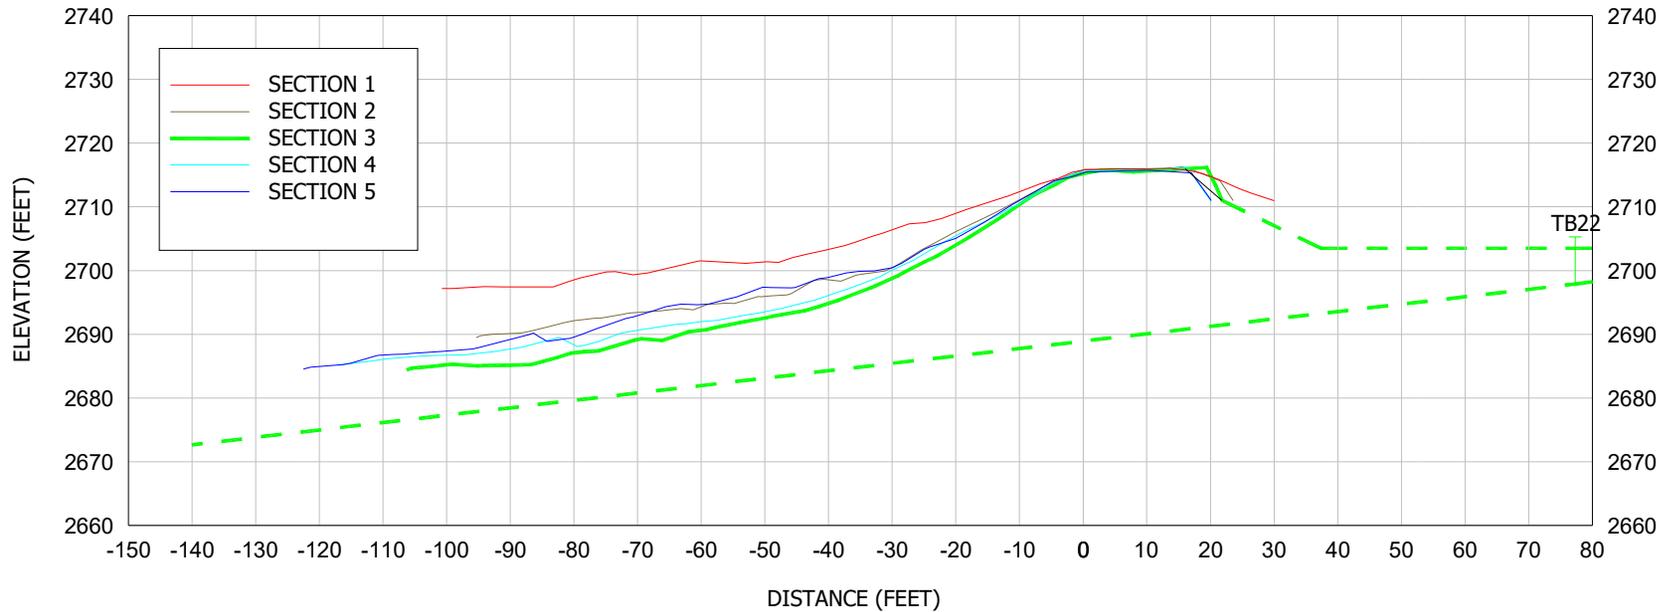
Post processed Static LiDAR in Civil 3D

Lidar surveyed cross-sections
